**BRETTON WOODS**  
DAVIS, CALIFORNIA

## **PHASE I ENVIRONMENTAL SITE ASSESSMENT**

**PROJECT NO.**  
11626.001.000

Subject: Bretton Woods  
West Covell Boulevard  
Yolo County, California

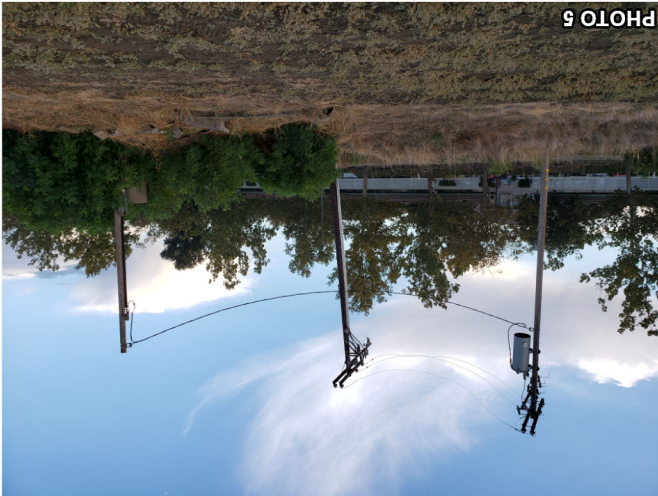
**PHOTO 5**  
POLE MOUNTED TRANSFORMER - SOUTHWESTERN CORNER OF PROPERTY

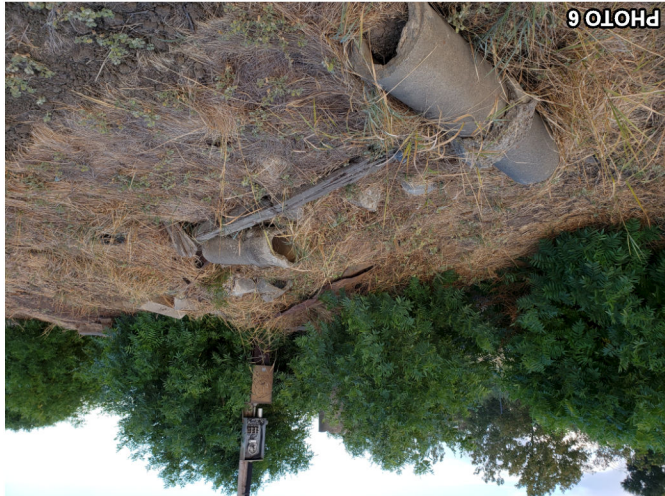
Stained Soil/Pavement	No stained soil or pavement was observed during the reconnaissance.
Stressed Vegetation	No stressed vegetation was observed during the reconnaissance.
Solid Waste/Debris	Some random litter and debris was observed in the southern portion of the Property and within the roundabout, located in the northern portion of the Property. Random pieces of concrete pipe debris were observed within the southern portion of the Property.
Stockpiles/Fill Material	A berm was observed bisecting the center portion of the Property in an east-west direction. We understand the berm is stockpiled site soils added to over the years as part of the former farming operations. Additionally, several piles of soils were observed along the southern portion of the Property. These piles appeared to be soil removed from the adjacent drainage channel that runs parallel to the Property's southern border and W. Covell Boulevard.

**PHOTO 6**  
RANDOM DEBRIS - SOUTHWESTERN CORNER

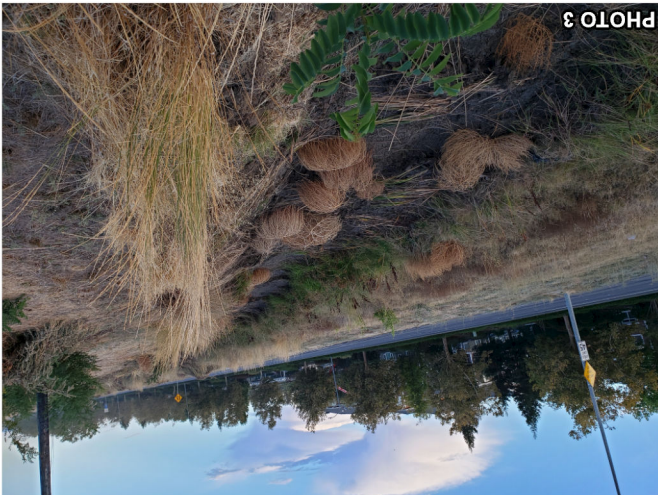
**PHOTO 3**  
DRAINAGE CHANNEL - SOUTHERN PORTION OF PROPERTY

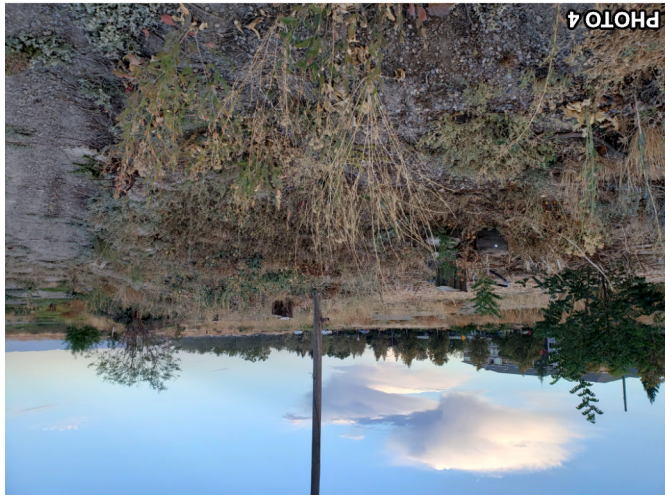
**PHOTO 4**  
POLE AND RANDOM DEBRIS - SOUTHERN PORTION OF PROPERTY

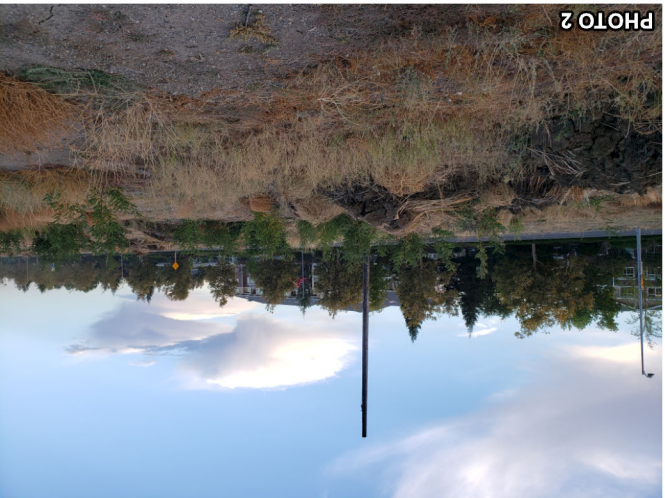
**PHOTO 2**  
STOCKPILES AND POLE IN SOUTHERN PORTION OF PROPERTY
