**ARBORIST REPORT
HALLMARK MICRO PROJECT, OLIVE DRIVE
DAVIS, CALIFORNIA**

**Prepared for
HALLMARK PROPERTIES
Davis, California**

**Prepared by
TREE ASSOCIATES
John M. Lichter, M.S.**

January 17, 2020

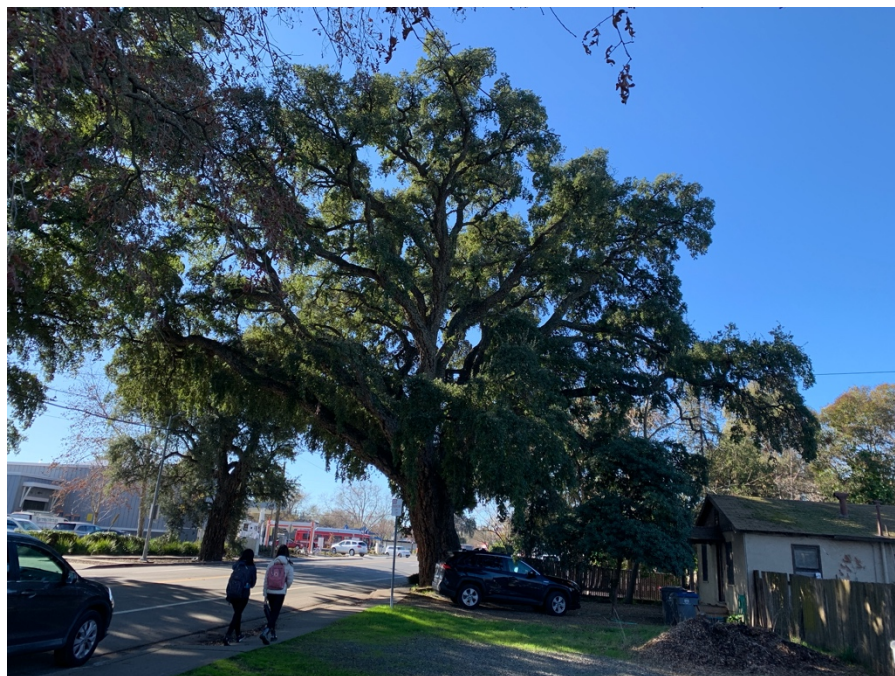
Figure 4. Tree #901.

Tree #	Species	Trunk Dia.	Max. Drip (radius, ft.)	TPZ (radius, ft.)	Comments	Health Rating	Structural Rating	Form Rating	Recommendations
901	cork oak (<i>Quercus suber</i>)	66	56	66	multiple trunks; deadwood to 5" diameter; adjacent to and lifting sidewalk and roadway	good	fair-good	good	crown clean.
902	tree of heaven (<i>Ailanthus altissima</i>)	5,3	14	7	suppressed by 901; bowed, unbalanced; adjacent to property line; displacing small wall; invasive species	fair-good	poor	poor	remove tree.
903	tree of heaven (<i>Ailanthus altissima</i>)	11	24	11	trunk lean; unbalanced crown; under edge of dripline of 901; invasive; near property line	good	fair	poor-fair	remove tree.
904	Chinese pistache (<i>Pistacia chinensis</i>)	13	20	13	trunk and lower 22 feet of tree covered with ivy; trunk obscured from view; unbalanced crown; codominant trunks; low vigor; 5' from property line	fair	fair	fair	remove ivy. select leader, drop crotch competing trunks or primary limbs.

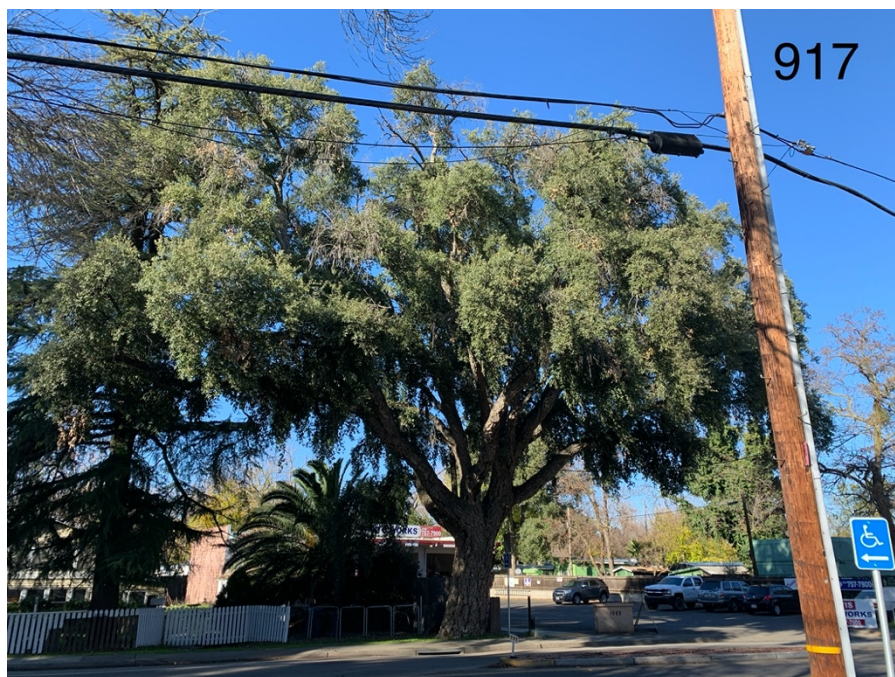
Figure 5. Tree #917.

Tree #	Species	Trunk Dia.	Max. Drip (radius, ft.)	TPZ (radius, ft.)	Comments	Health Rating	Structural Rating	Form Rating	Recommendations
917	cork oak (<i>Quercus suber</i>)	54	44	54	moderate amount of limb dieback; overextended primary limbs; touching and lifting walk; 5' from roadway	fair	fair	good	crown clean. use reduction cuts to remove 10-20% of the foliage/buds of primary limbs > 1/3 the trunk diameter at their attachment.
918	deodar cedar (<i>Cedrus deodara</i>)	33	28	33	top dead; limb dieback; broken, hanging limbs; declining health; overextended primary limbs; poor suitability for preservation	poor-fair	fair	fair	remove tree.
919	tree of heaven (<i>Ailanthus altissima</i>)	12	16	12	codominant trunks; unbalanced crown; 2' from property line wall; touching and lifting shed; invasive species	fair-good	fair	fair-good	remove tree.
920	Modesto ash (<i>Fraxinus velutina</i> 'Modesto')	8	10	8	trunk and root growth displacing cinder block wall; at property line; codominant trunks with included bark; declining health; limb dieback; one of three trunks removed; adjacent to property line wall	very poor	very poor	poor	remove tree.

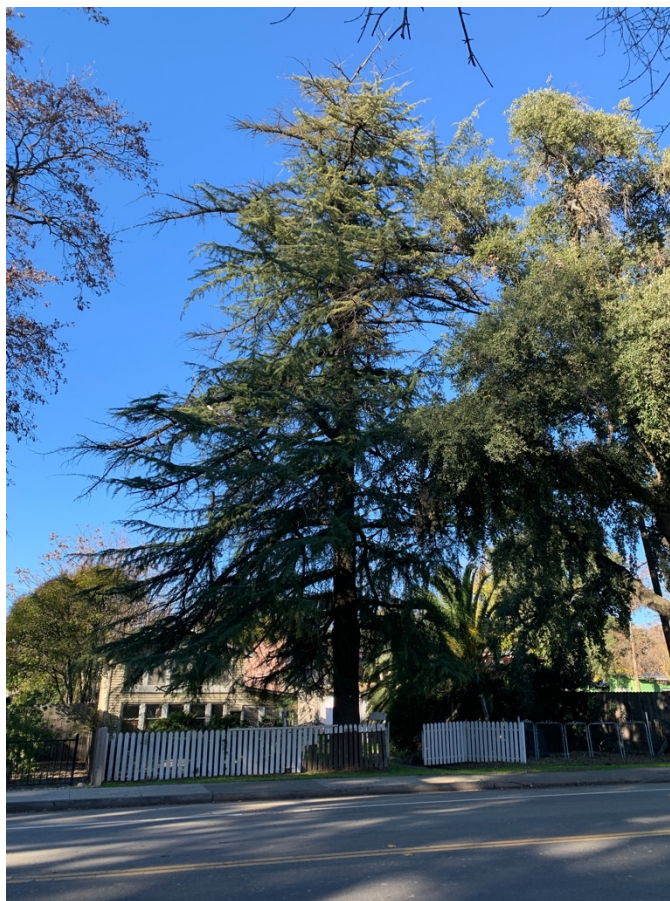
I recommended that roughly three quarters of on-site trees be removed (23 trees or 77%). I recommended that the mature deodar cedar (#918) be removed due to its declining health (Figure 6).

Figure 6. Tree #918. Note dead top, limb dieback and declining health.

918	deodar cedar (<i>Cedrus deodara</i>)	33	33			Removal recommended by Arborist

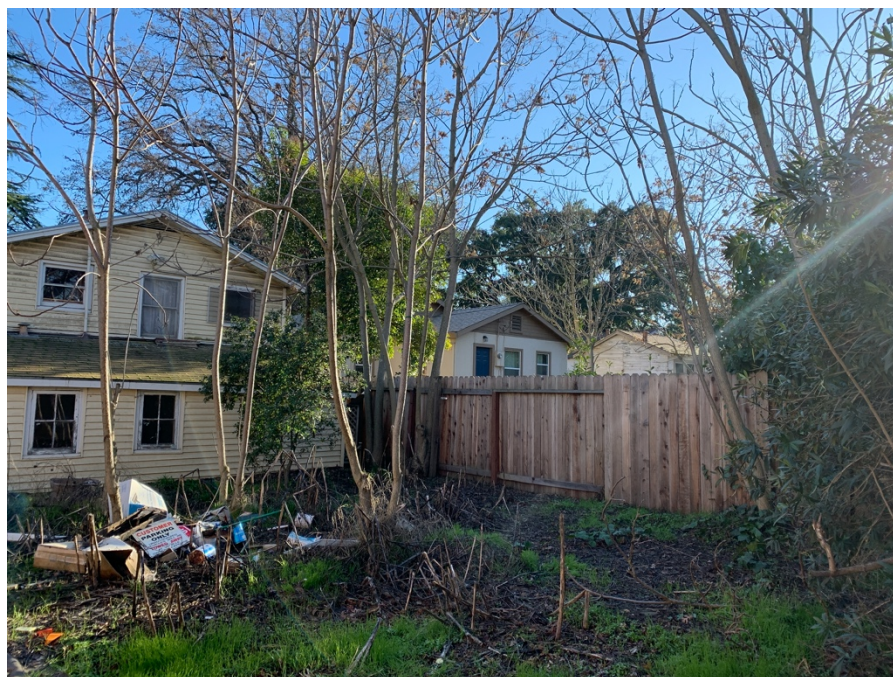
I also recommended that all 17 of the tree of heaven (57% of the trees on site) be removed. There were several reasons I recommended that they be removed. Tree of heaven is a particularly invasive species which spreads quickly by root suckers and seedlings. The tree and its large, relatively shallow root system grow vigorously and the tree produces copious amounts of seeds (up to 300,000 per tree). Indeed, the trees have created a thicket over portions of the site (Figure 7).

Figure 7. Tree of heaven volunteers.

The tree of heaven on site were apparently all volunteers and many were located adjacent to walls, fences and property lines or adjacent to other trees. For these reasons and due to a lack of maintenance (pruning), most of the tree of heaven were structurally compromised. Exhibit 1 contains recommendations to improve the health or structure of trees (if they are to be preserved) where appropriate.
