Contamination and Toxic Substances (Multifamily and Non-Residential Properties) – PARTNER

BRETTON WOODS
DAVIS, CALIFORNIA

PHASE I ENVIRONMENTAL SITE ASSESSMENT

Subject: Bretton Woods
West Covell Boulevard
Yolo County, California

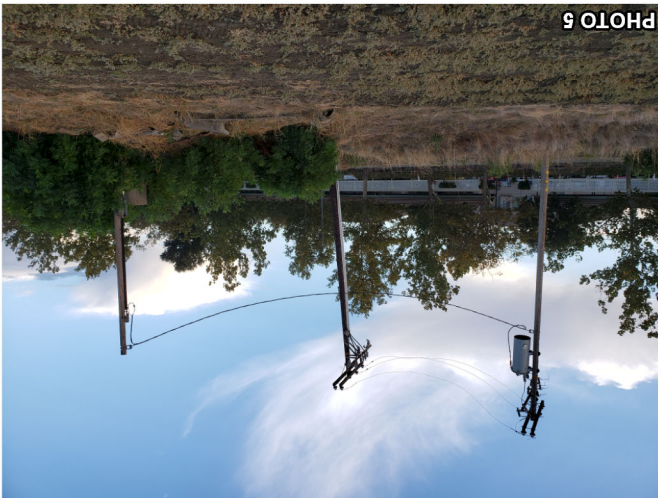
PHOTO 5
POLE MOUNTED TRANSFORMER - SOUTHWESTERN CORNER OF PROPERTY

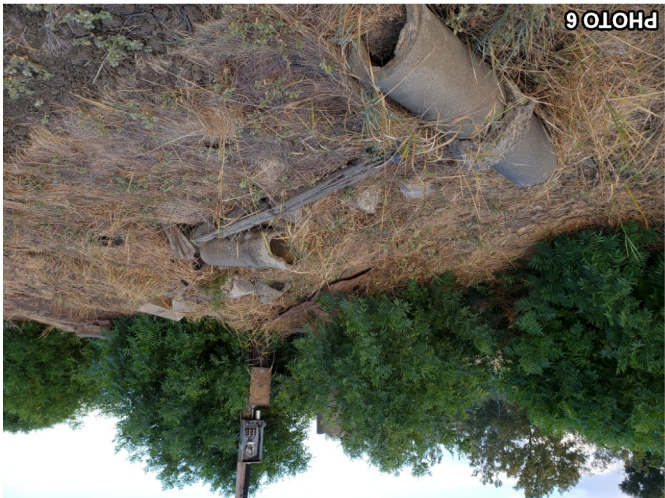
Stained Soil/Pavement	No stained soil or pavement was observed during the reconnaissance.
Stressed Vegetation	No stressed vegetation was observed during the reconnaissance.
Solid Waste/Debris	Some random litter and debris was observed in the southern portion of the Property and within the roundabout, located in the northern portion of the Property. Random pieces of concrete pipe debris were observed within the southern portion of the Property.
Stockpiles/Fill Material	A berm was observed bisecting the center portion of the Property in an east-west direction. We understand the berm is stockpiled site soils added to over the years as part of the former farming operations. Additionally, several piles of soils were observed along the southern portion of the Property. These piles appeared to be soil removed from the adjacent drainage channel that runs parallel to the Property's southern border and W. Covell Boulevard.

PHOTO 6
RANDOM DEBRIS - SOUTHWESTERN CORNER

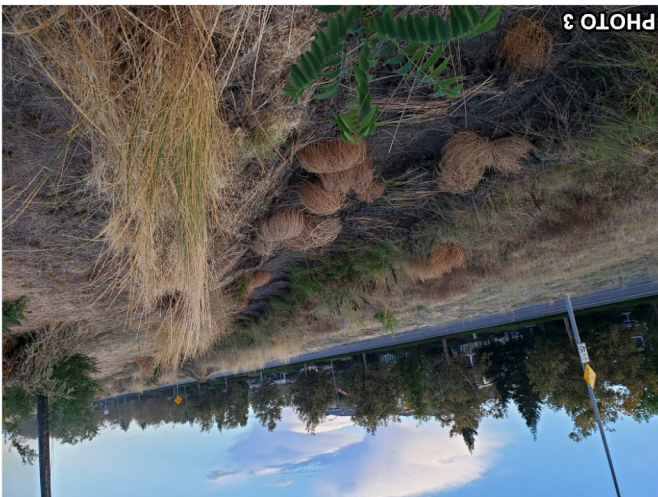
PHOTO 3
DRAINAGE CHANNEL - SOUTHERN PORTION OF PROPERTY

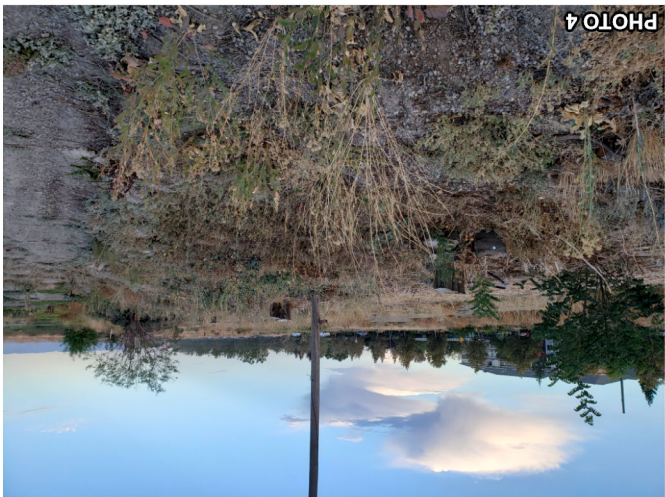
PHOTO 4
POLE AND RANDOM DEBRIS - SOUTHERN PORTION OF PROPERTY

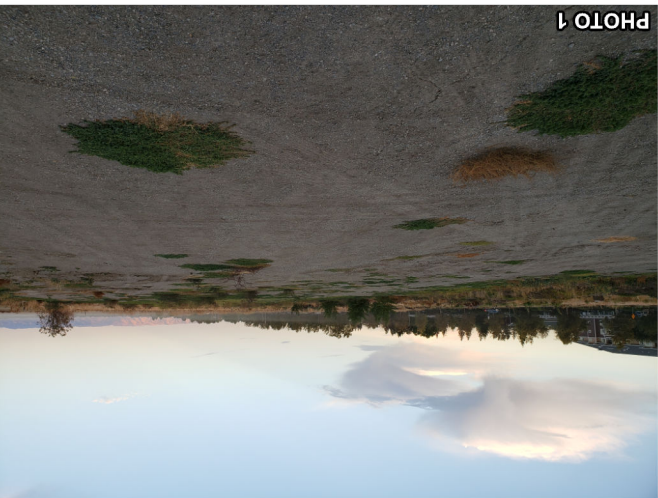
PHOTO 1
SOUTHERN PORTION OF THE PROPERTY

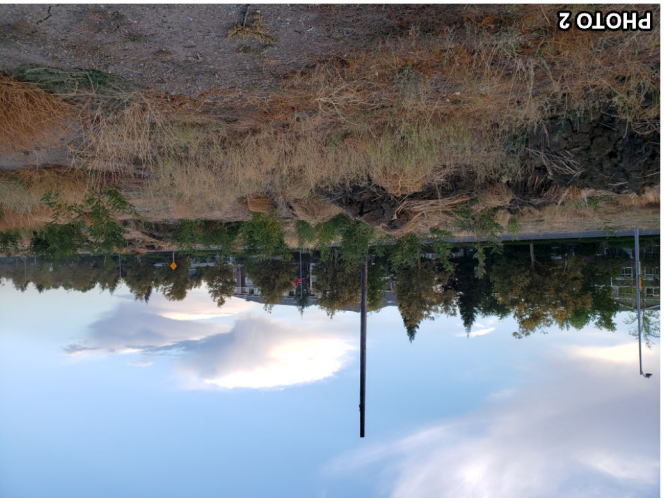
PHOTO 2
STOCKPILES AND POLE IN SOUTHERN PORTION OF PROPERTY

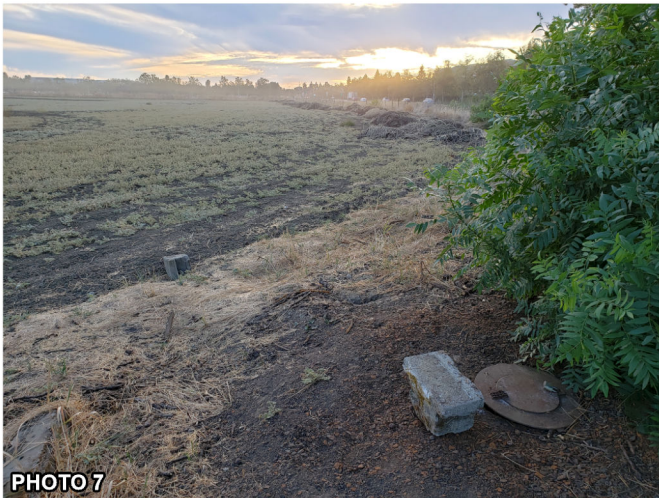
Wastewater	No wastewater was observed during the reconnaissance.
Wells	One water supply well was observed in the southeastern corner of the Property.
Septic Systems	No septic systems were observed during the reconnaissance.

PHOTO 7
**WELL HEAD SOUTHWESTERN CORNER OF PROPERTY
LOOKING EAST**

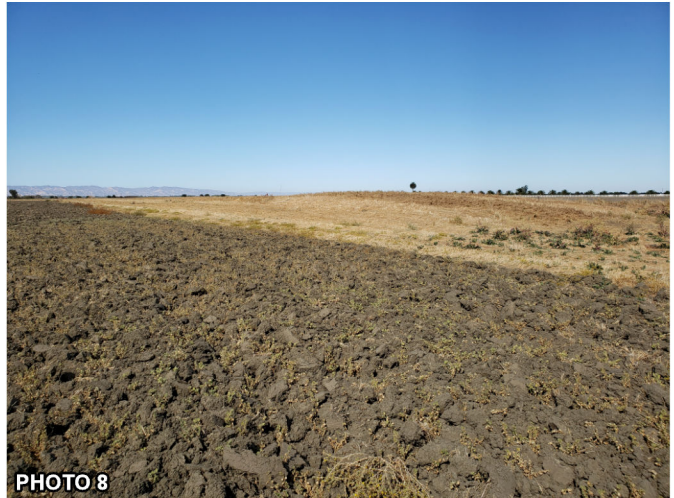
PHOTO 8
BERM - CENTER PORTION OF PROPERTY

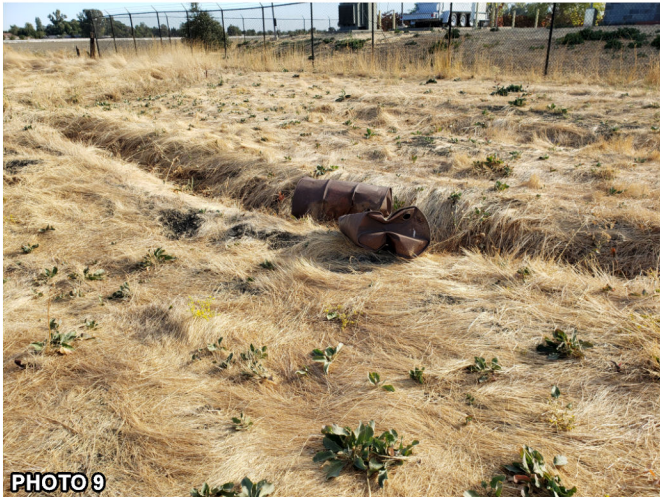
PHOTO 9
EMPTY DRUMS - CENTER PORTION OF THE PROPERTY

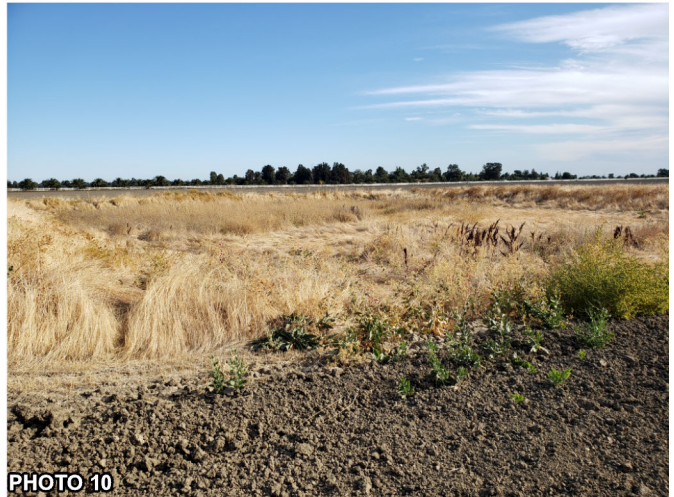
PHOTO 10
BASIN - CENTER PORTION OF PROPERTY

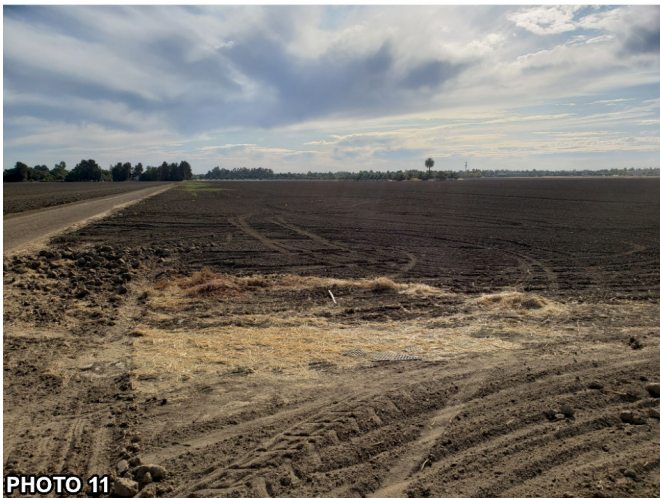
PHOTO 11
**TYPICAL SITE CONDITIONS - NORTHWESTERN CORNER OF
PROPERTY LOOKING EAST**

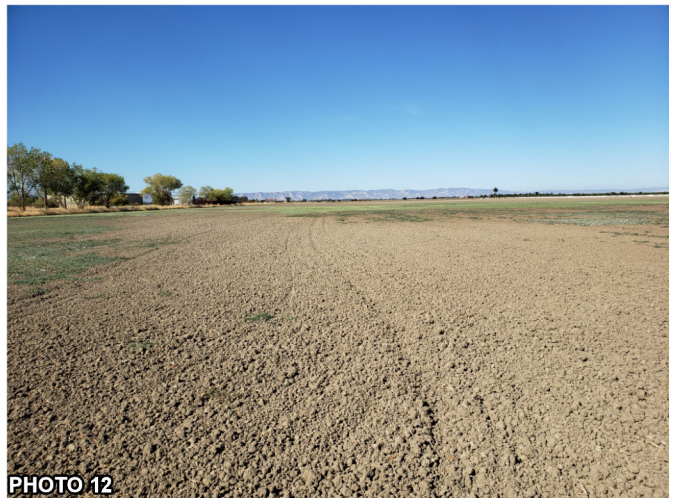
PHOTO 12
**TYPICAL SITE CONDITIONS - EASTERN BORDER
LOOKING WEST**
