**ARBORIST REPORT  
THE DAVIS COLLECTION PROJECT  
DAVIS, CALIFORNIA**

**Prepared for  
BRIXMOR PROPERTY GROUP**

**Prepared by  
TREE ASSOCIATES  
John M. Lichter, M.S.  
President, Principal Consulting Arborist  
ASCA Registered Consulting Arborist #375  
ISA Certified Arborist #863  
ISA Qualified Tree Risk Assessor  
ASCA Qualified Tree and Plant Appraiser**

**September 29, 2022**

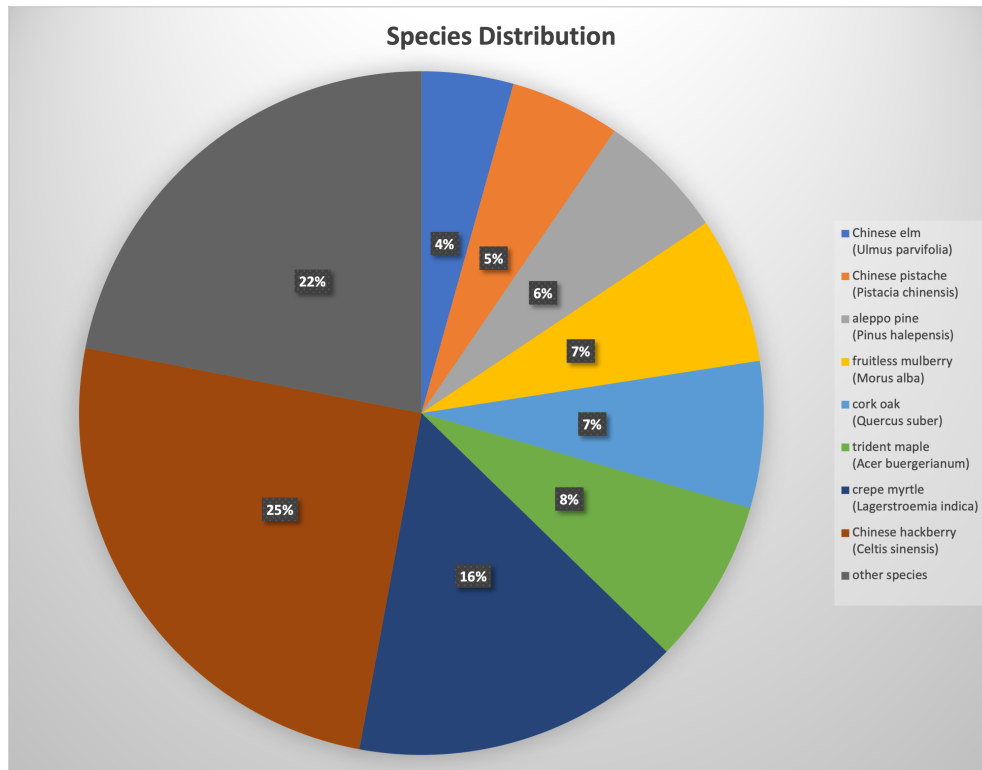
Figure 1. Species distribution of existing on-site trees.

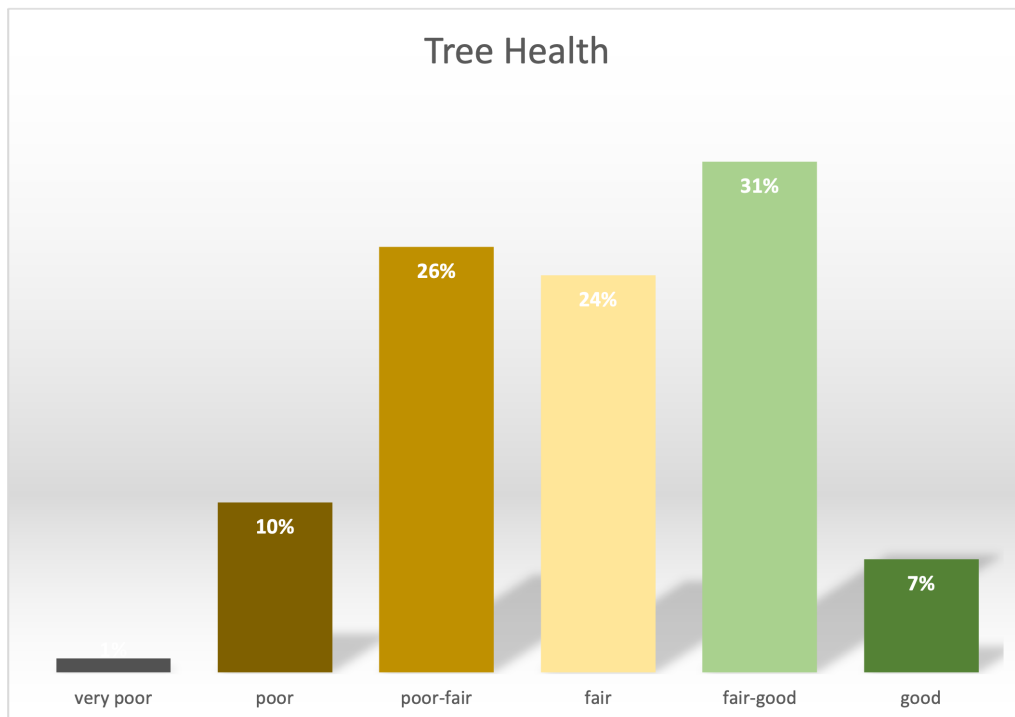
The health of the trees had been impacted by drought stress as many of the sites appear to either not be irrigated or the irrigation system was in disrepair. I suspect that the health of the trees in the parking lot planters, especially the trident maple and, to a lesser degree, the fruitless mulberry is also being compromised, at least in part, by either a soil sterilant (under the asphalt) or an herbicide.

Figure 2. Health ratings for on-site trees.

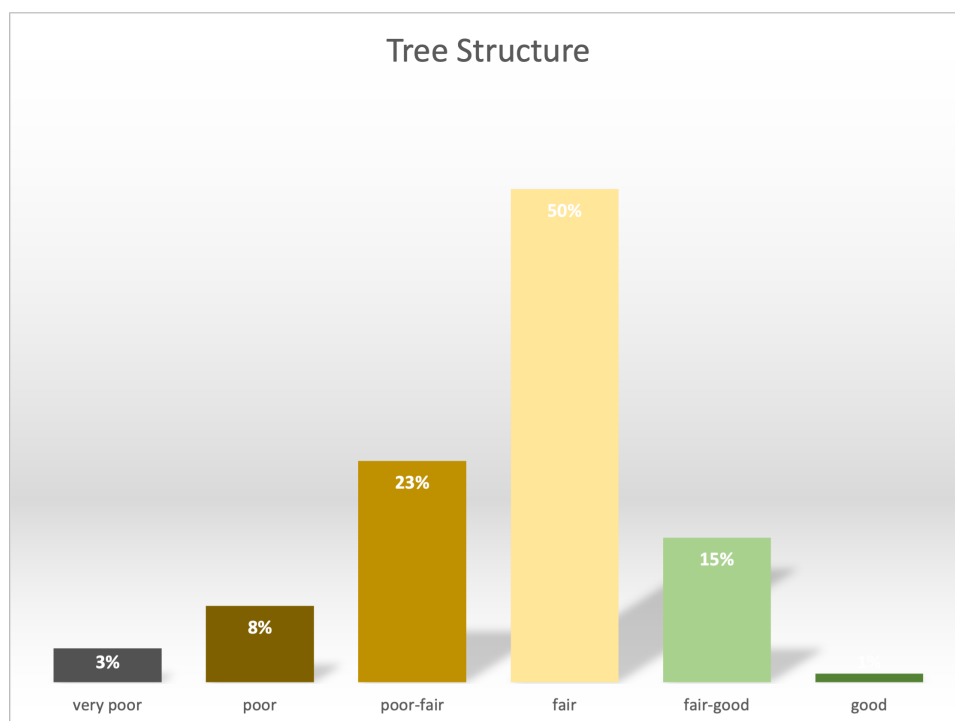
Structural deficiencies were caused by root, trunk or limb decay, defective trunk or limb attachments, overextended limbs and/or dead wood. The pruning recommended in Exhibit 1 would significantly improve the structure of many of the trees.

**Figure 3. Structural ratings for on-site trees.**
