PRELIMINARY GEOTECHNICAL ASSESSMENT

DAVIS INNOVATION CENTER

YOLO COUNTY, CALIFORNIA

October 20, 2014

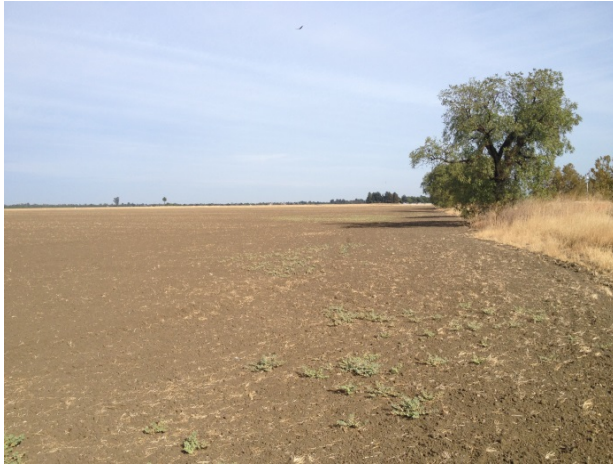
- The majority of the site was disked and relatively free of grass and weeds. In the disked areas, the soil was easily penetrated with the hand probe approximately 12 inches.

Disked Field Looking North

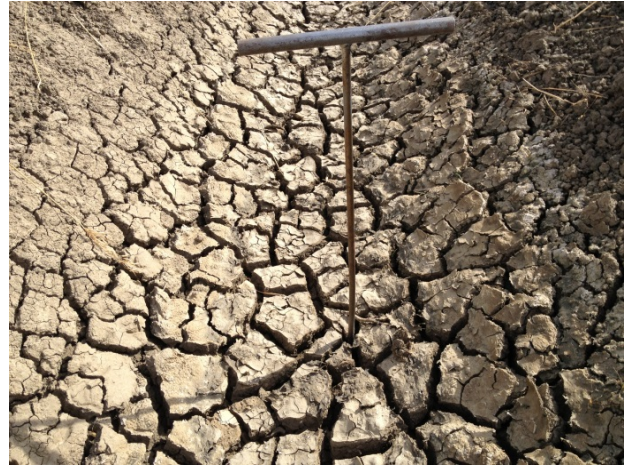
- Irrigation ditches were located as depicted on Figure 3 and were approximately 2 to 3 feet deep. In some locations, extensive desiccation cracking was apparent in the bottom of the ditches.

Desiccation Cracking in Irrigation Ditch

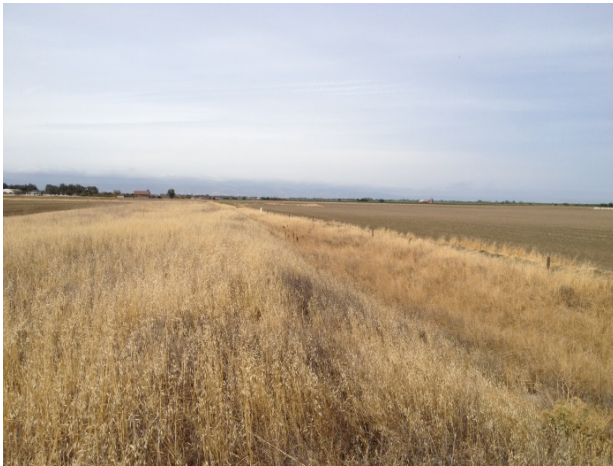
- An east-west oriented stockpile was located in the central portion of the site. The stockpile was approximately 4 to 6 feet tall, about 1,000 feet long, and about 50 to 70 feet wide.

Soil Stockpile, Looking West

Based on our aerial photograph review and site reconnaissance, we identified an existing fill stockpile in the central portion of the site. In addition, it appears historic irrigation ditches throughout the northern portion of the site have been filled. Non-engineered low density stockpiled fills can undergo excessive settlement, especially under new fill or building loads.

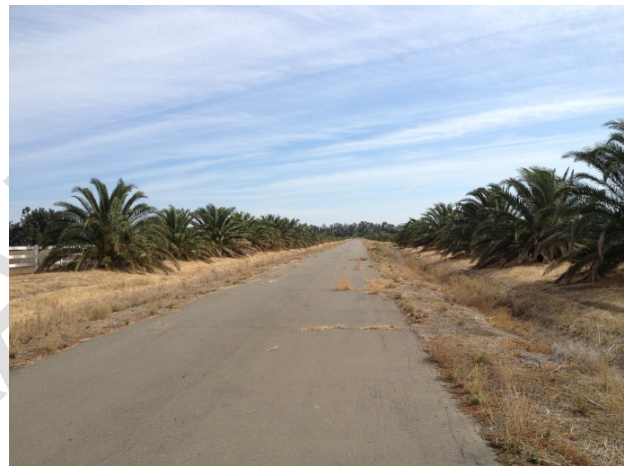
- An east-west oriented asphalt concrete road lined with palm trees extended west from John Jones Road into the site. The entrance included walls and a gate. Electricity and communication vaults were located near the end of the road. We observed extensive cracking in the asphalt parallel to the road edge, likely caused by expansive soil.

Palm Tree Lined Road, Looking East

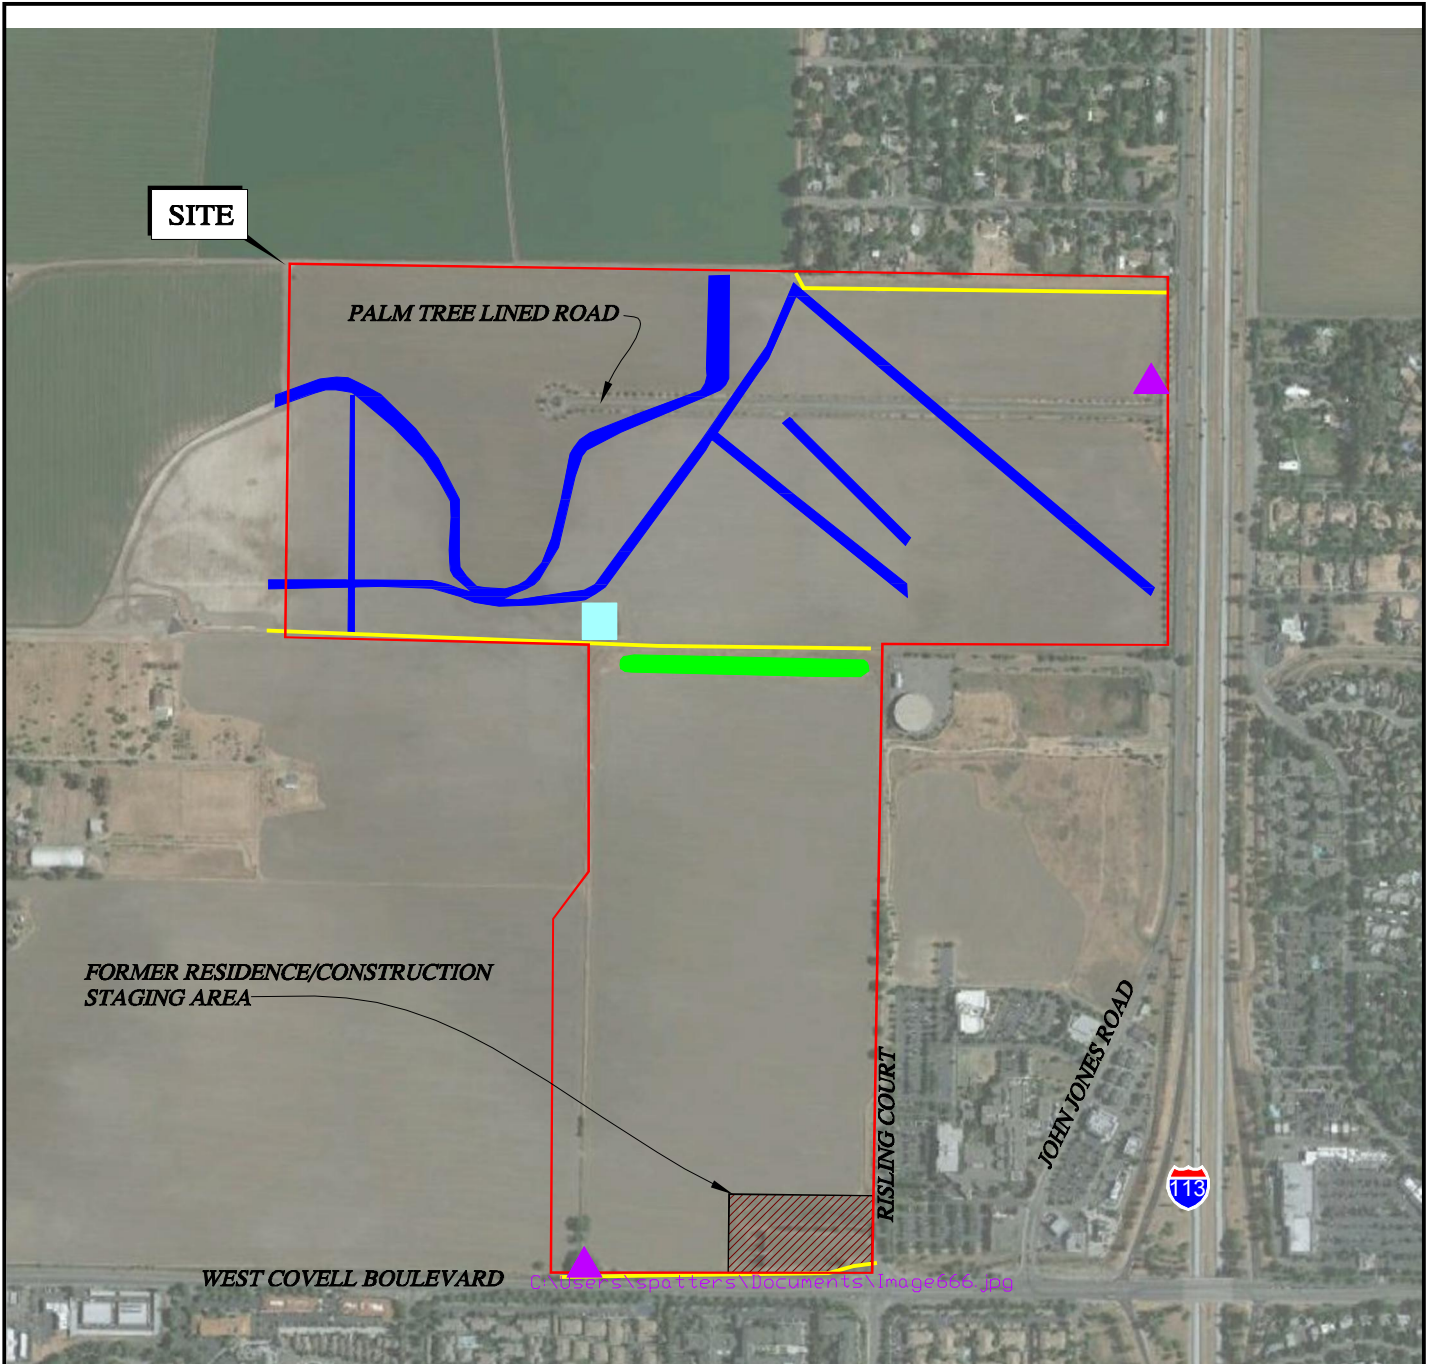
FIGURE NO.
3

Figure 3, Site Features, depicts key site features observed in the aerial photographs.

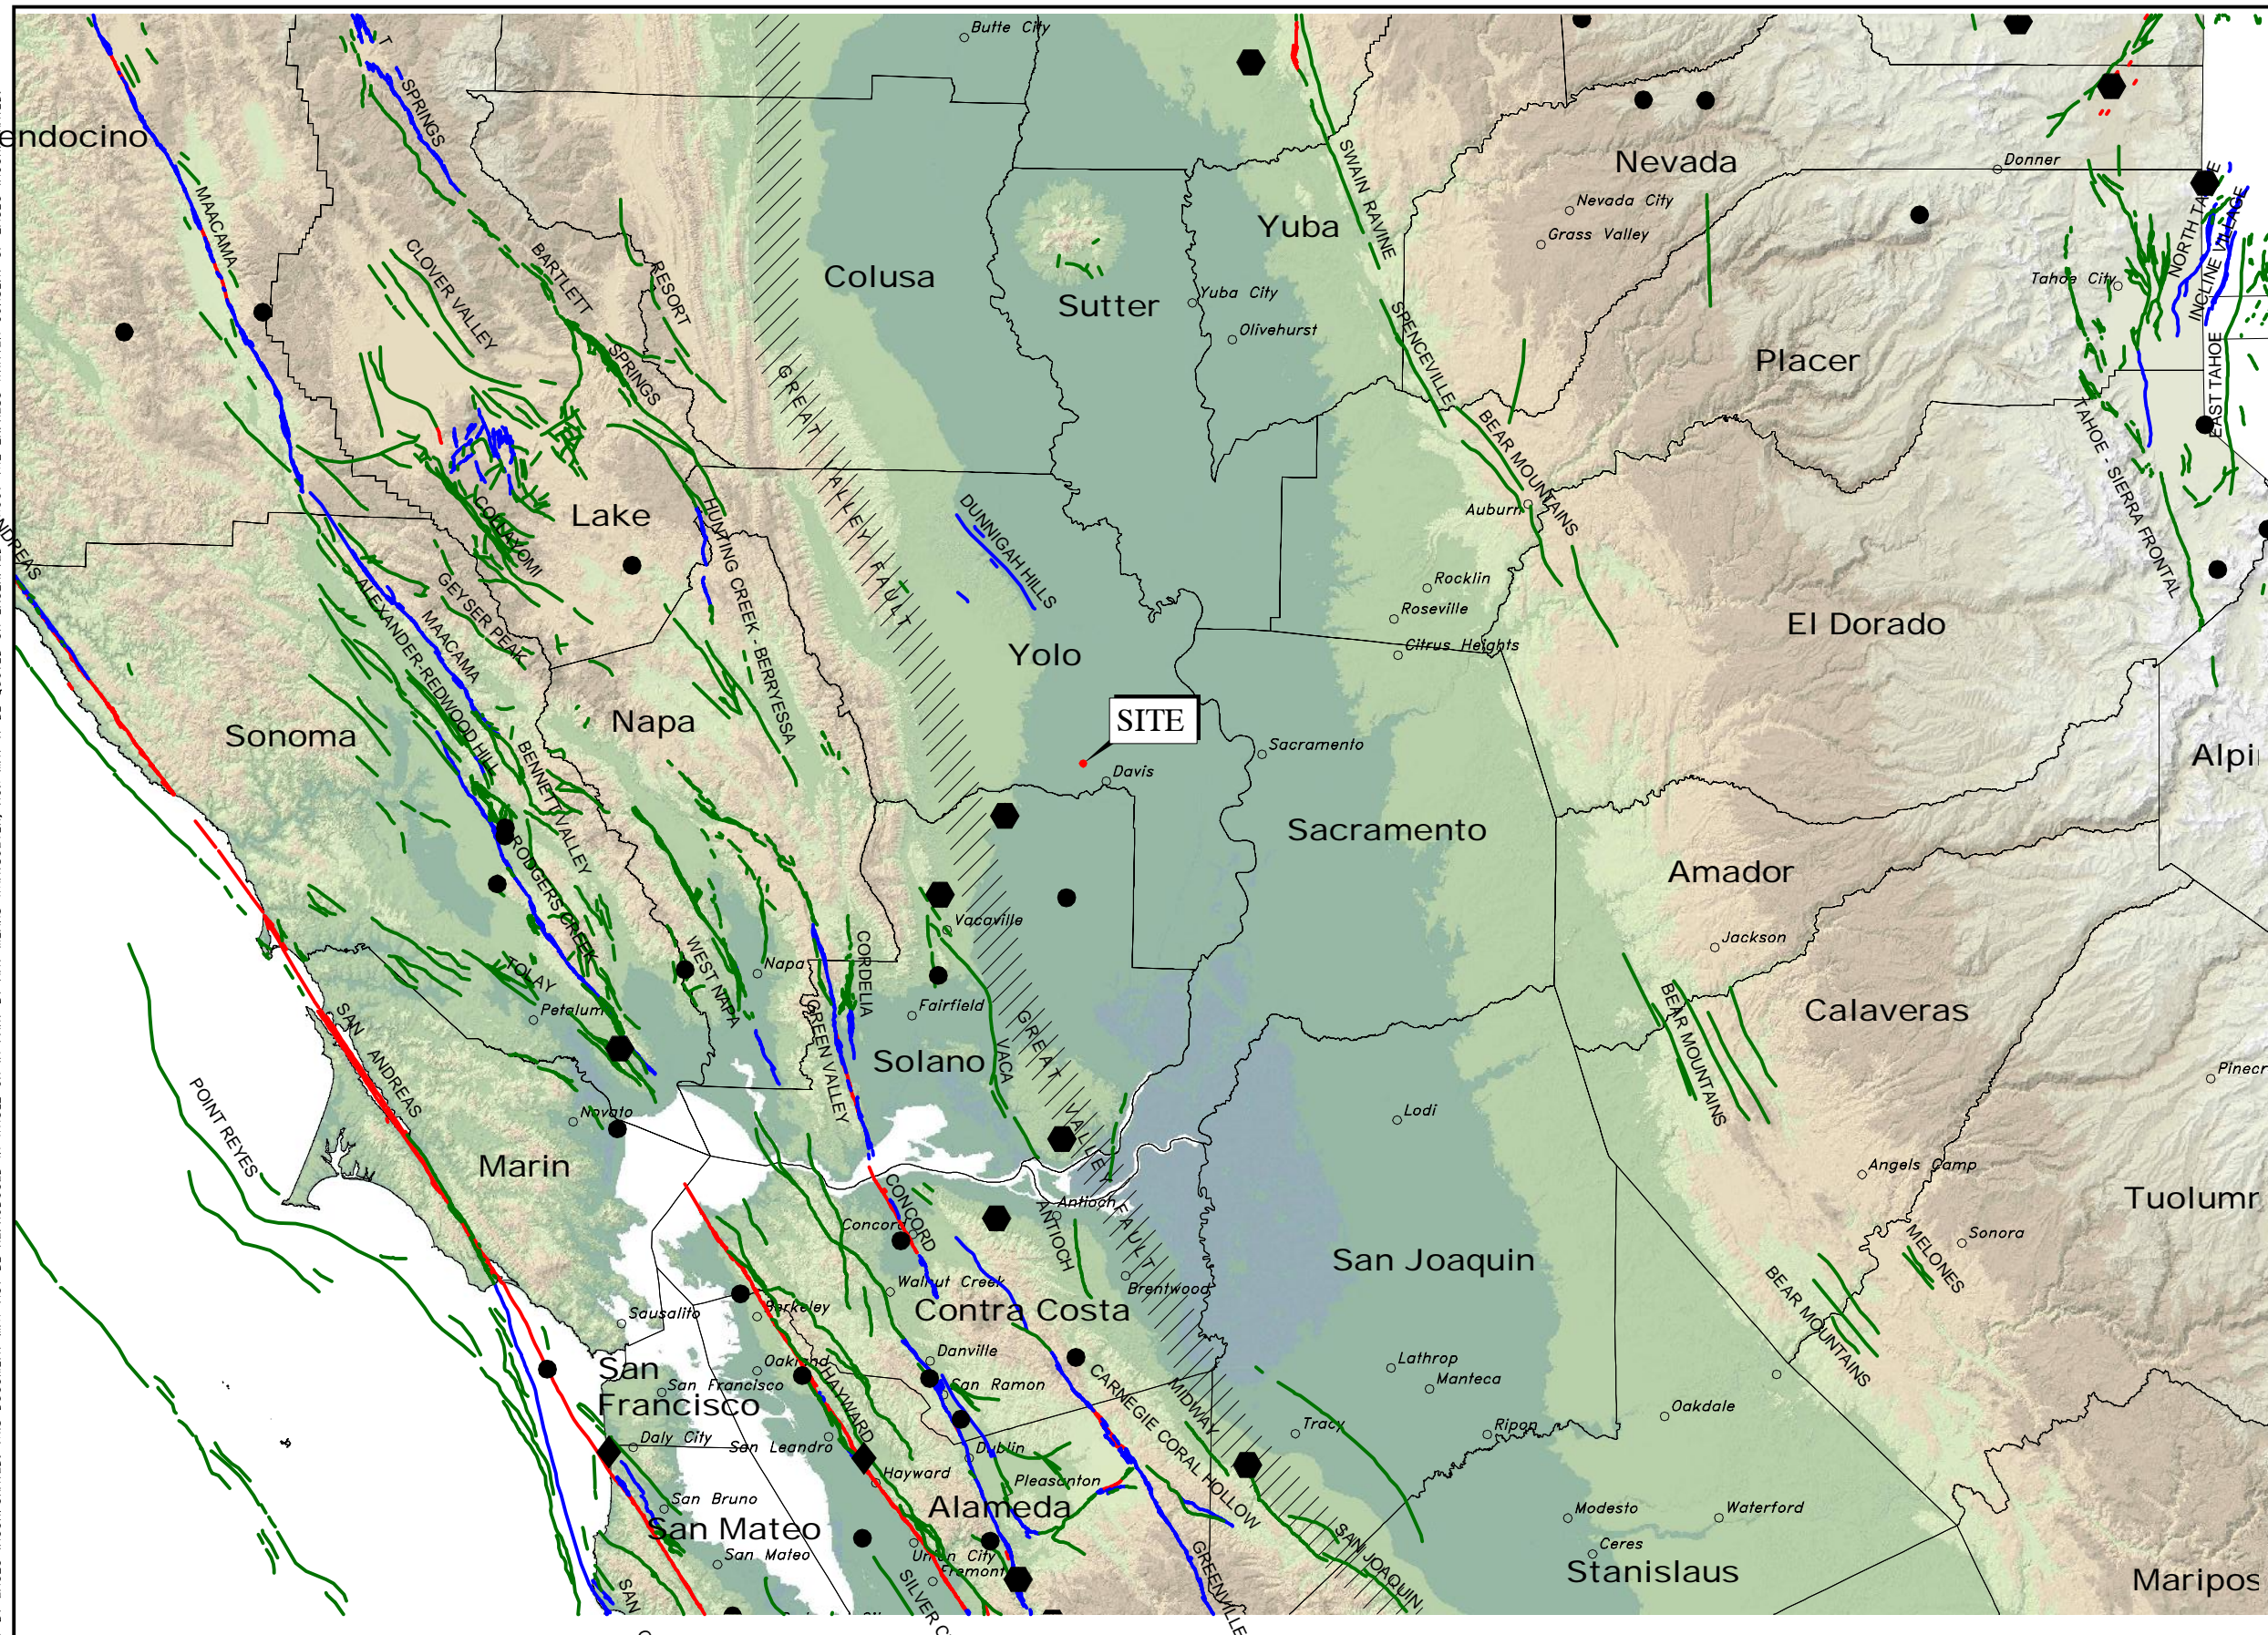
REGIONAL FAULTING AND SEISMICITY DAVIS INNOVATION CENTER DAVIS, CALIFORNIA		PROJECT NO.: 11626.000.000 SCALE: AS SHOWN DRAWN BY: SRP CHECKED BY: PC	FIGURE NO. 4

The site does lie within a seismically active region, as California has numerous faults that are considered active. Generally, a fault is considered active if it has ruptured within the Holocene epoch (11,700 years before present). The following table summarizes the distances to mapped, active regional faults and estimated maximum magnitude within approximately 50 miles using the USGS Spatial Query tool. Refer to Figure 3 for a Regional Faulting and Seismicity Map that depicts nearby active faults and historic earthquake epicenters and magnitudes.

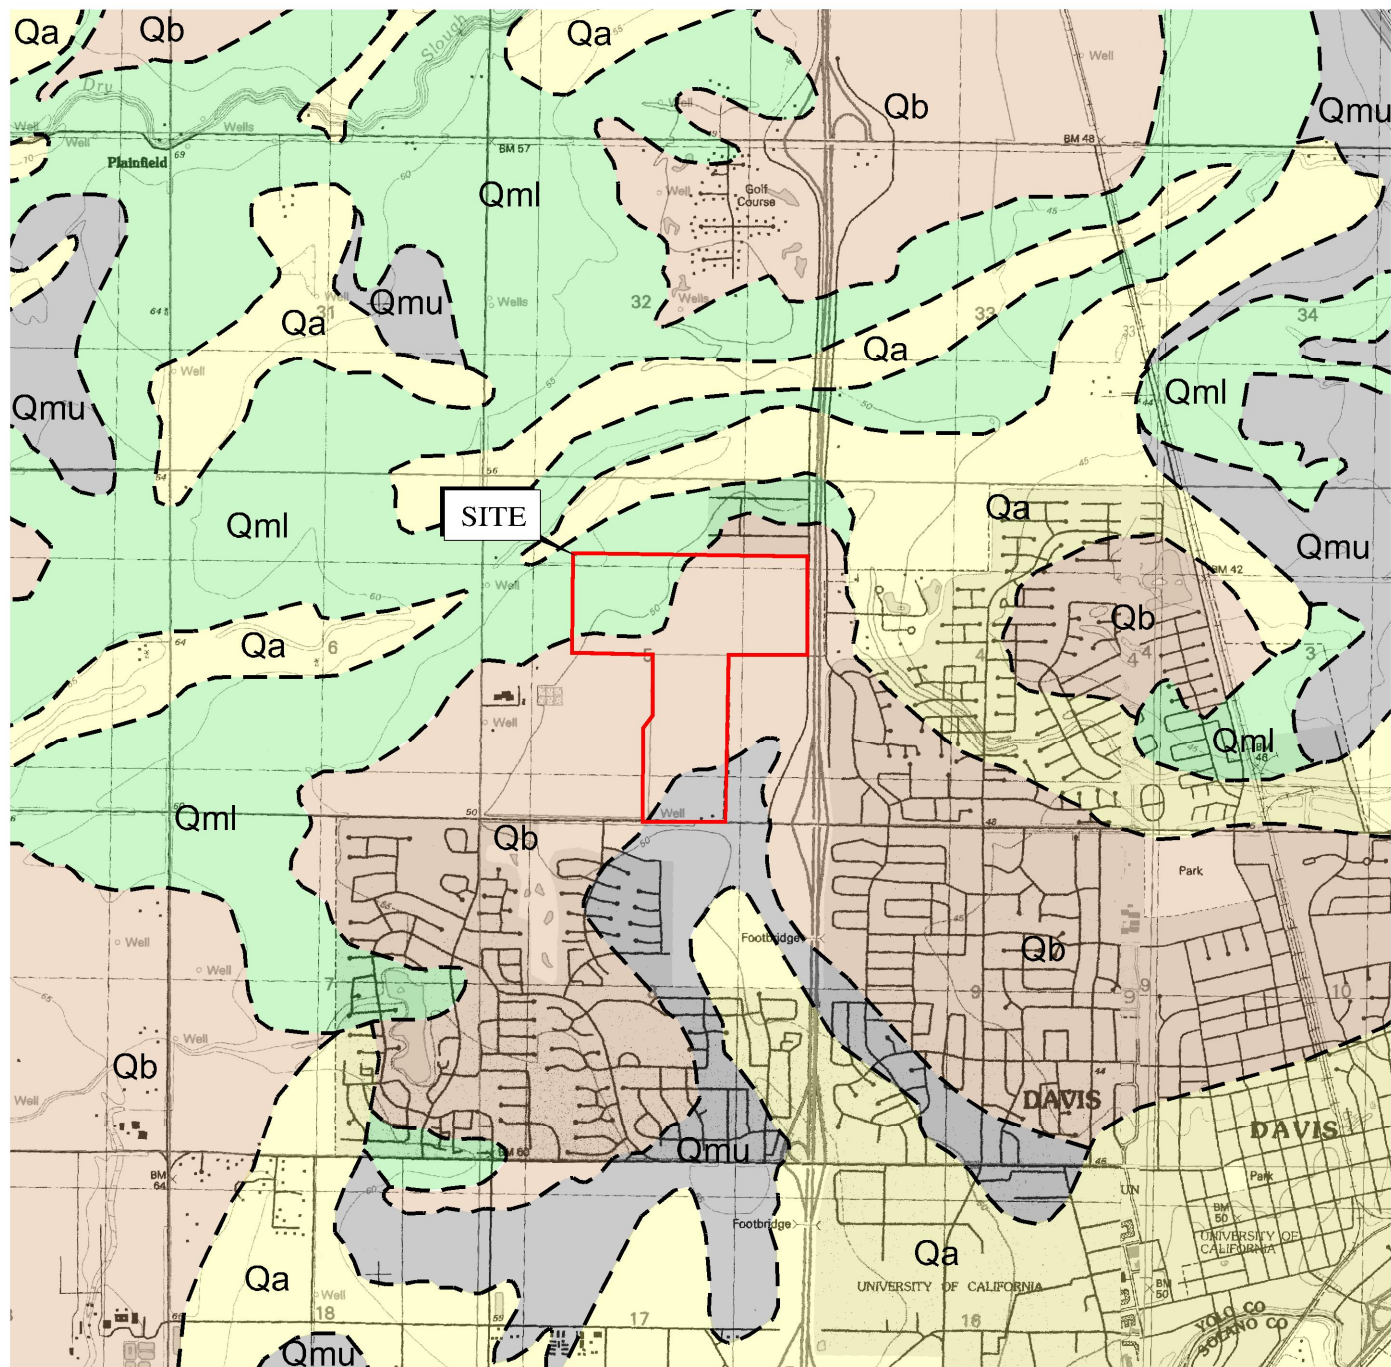
GEOLOGIC MAP
DAVIS INNOVATION CENTER
DAVIS, CALIFORNIA

The following geologic units are mapped at the site (Helley, 1985) as shown on Figure 3, Geologic Map.

Quaternary (Holocene) Basin Deposits (Qb) – This relatively young deposit (less than 10,000 years old) consists of dark grey to black silt and clay deposited by modern day alluvial processes with thickness that can range from 3 feet to 120 feet. This deposit underlays the majority of the site.

Upper Modesto Formation (Qmu) – The Upper Modesto Formation is an alluvial deposit that generally consists of unweathered gravel, sand, silt, and clay derived primarily from the Tioga glaciation in the Sierra Nevada. The sediments in this formation are typically very stiff or dense. This formation is mapped in the southern portion of the site.

Lower Modesto Formation (Qml) – The Lower Modesto Formation is an alluvial deposit similar to the Upper Modesto Formation, except older and slightly more weathered with an increased clay content from more advanced soil development. The weathering of this deposit commonly results in a distinct reddish color. This formation is mapped in the northwest portion of the site.

Holocene Basin Deposits are mapped underlying the majority of the site. These deposits could be potentially weak and compressible under new loads.
