Aquatic Resources Delineation Report

West Davis Active Adult

Davis, Yolo County, California
September 2019

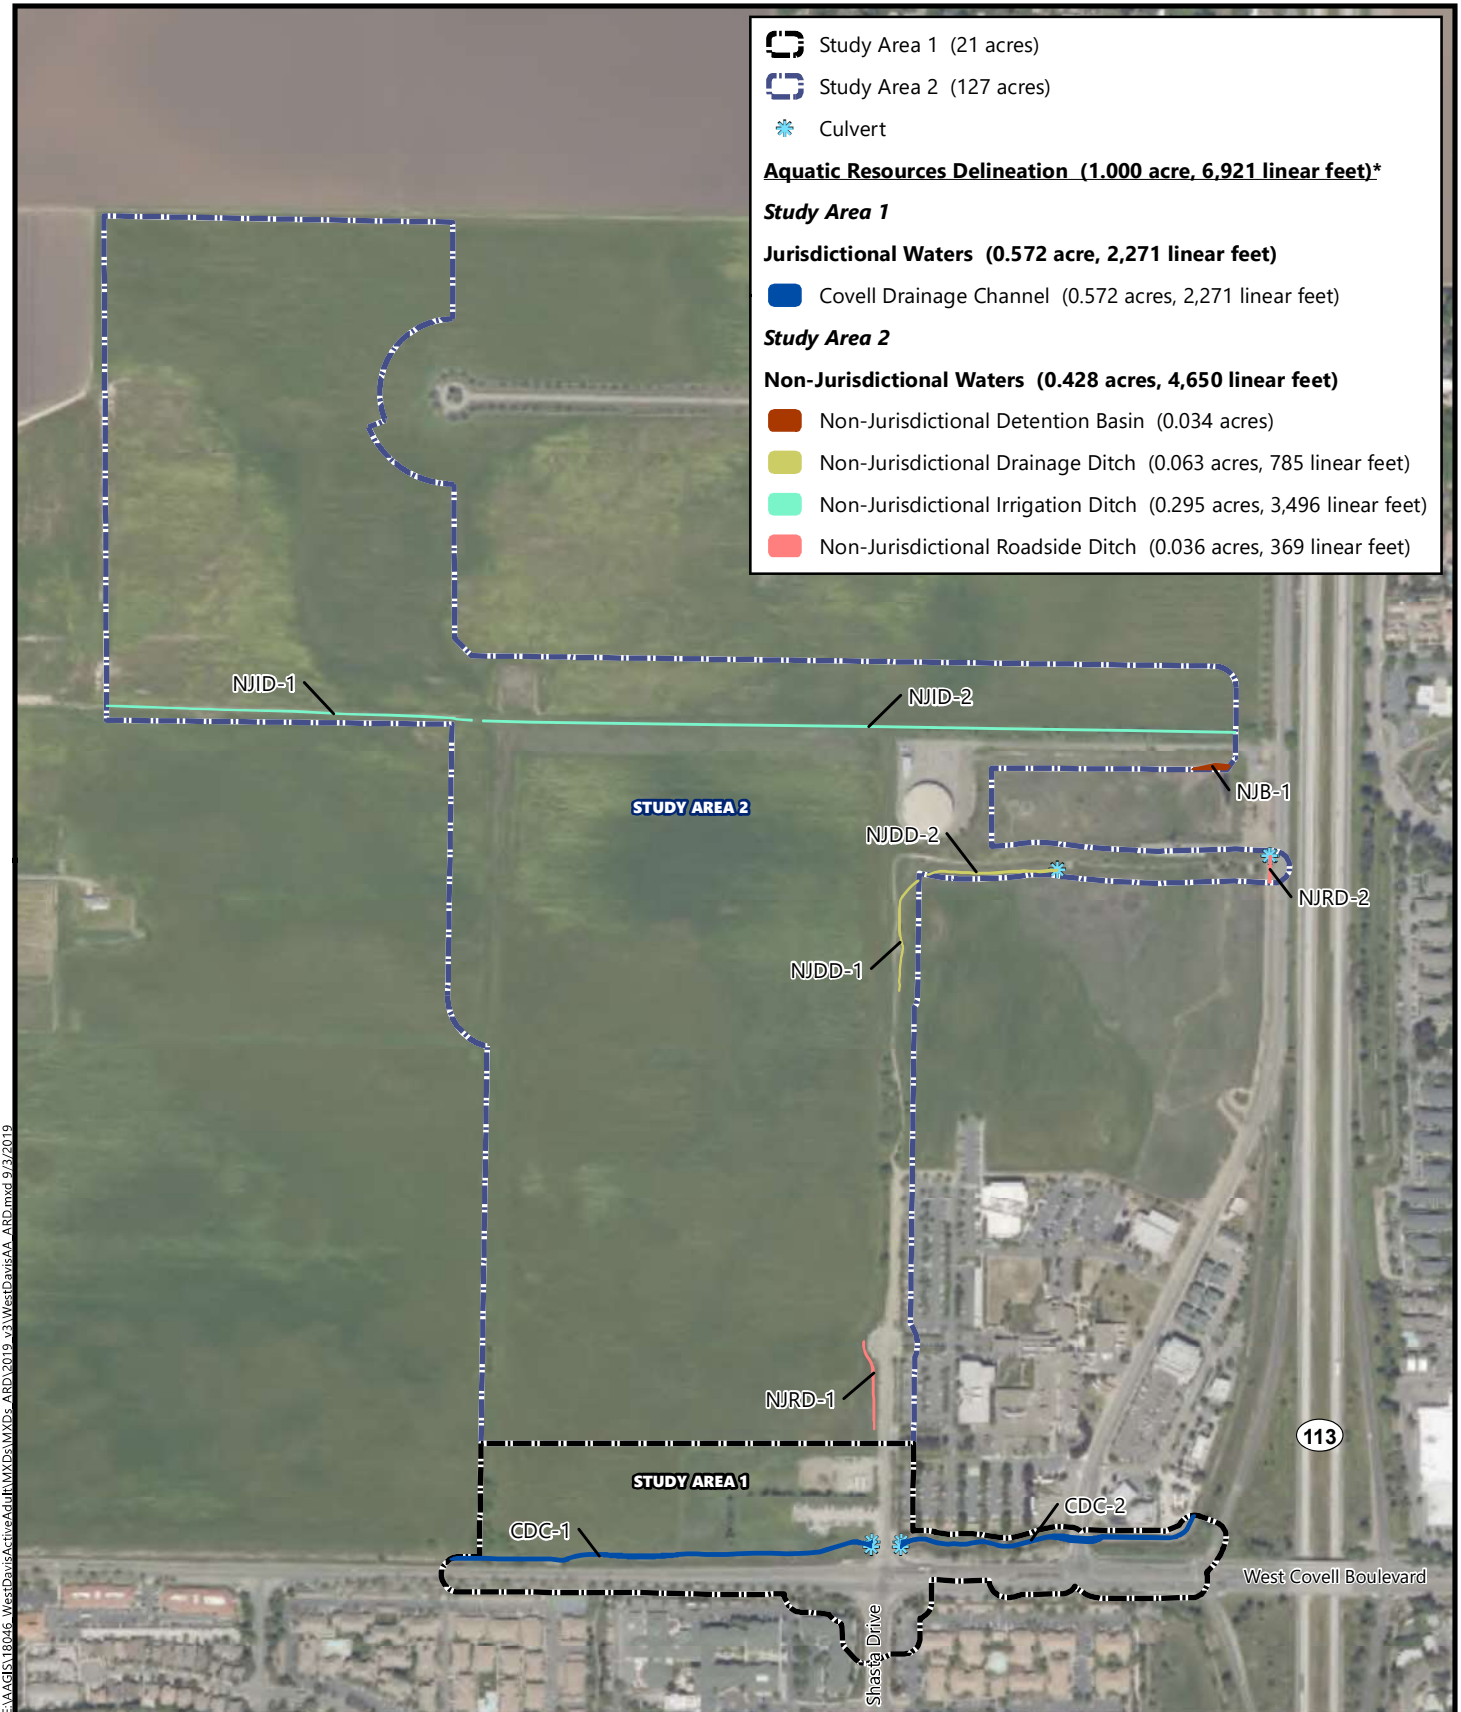
Figure 3. Aquatic Resources

Data sheets are included in Attachment A. Maps of the aquatic resources within the Study Areas are included as Figure 3 and Attachment B, and a list of the plant species observed in the Study Areas with their wetland indicator status is included in Attachment C. Representative site photographs are included in Attachment D. GIS Shapefiles and the *Aquatic Resources Excel Spreadsheets* for the aquatic resources shown on Figure 3 and Attachment B are included on a CD in Attachment E. Each of the feature types is described below.

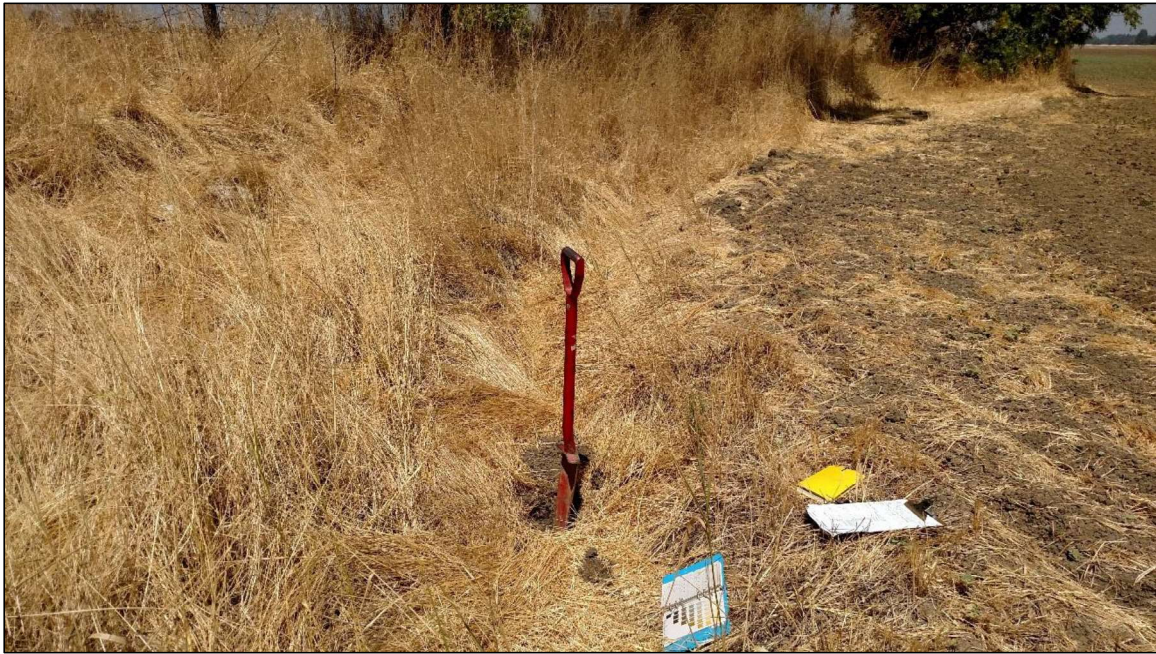
Data Point DP-01 – 16 August 2018

Hydrophytic Vegetation Present? Yes <u>X</u> No _____ Hydric Soil Present? Yes _____ No <u>X</u> Wetland Hydrology Present? Yes _____ No <u>X</u>	Is the Sampled Area within a Wetland? Yes _____ No <u>X</u>
Remarks: Heavily vegetated ditch along agricultural field. Appears to not have been in use for some time. Constructed in uplands to drain/irrigate field. *Climactic conditions abnormal, rainfall totals well-above average for the 2018-2019 winter, and rain events occurred late in season.

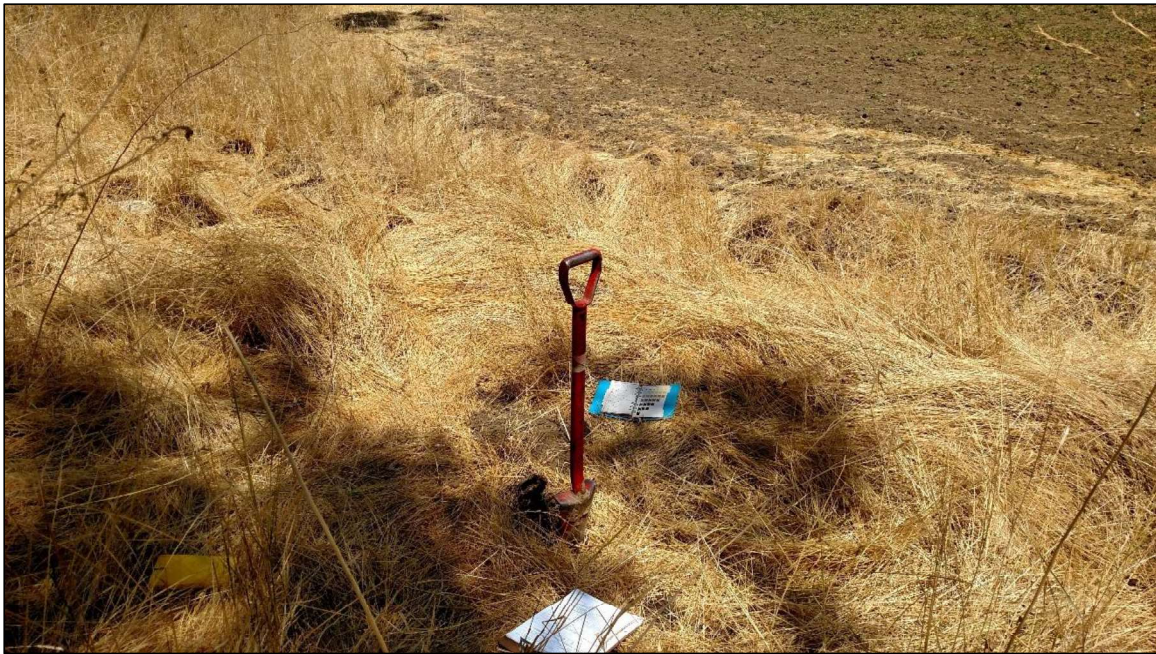
Data Point DP-02 – 16 August 2018

Hydrophytic Vegetation Present? Yes <u>X</u> No _____ Hydric Soil Present? Yes _____ No <u>X</u> Wetland Hydrology Present? Yes _____ No <u>X</u>	Is the Sampled Area within a Wetland? Yes _____ No <u>X</u>
Remarks: Upland point paired w/ DP 01. *Climactic conditions abnormal, rainfall totals well-above average for the 2018-2019 winter, and rain events occurred late in season.

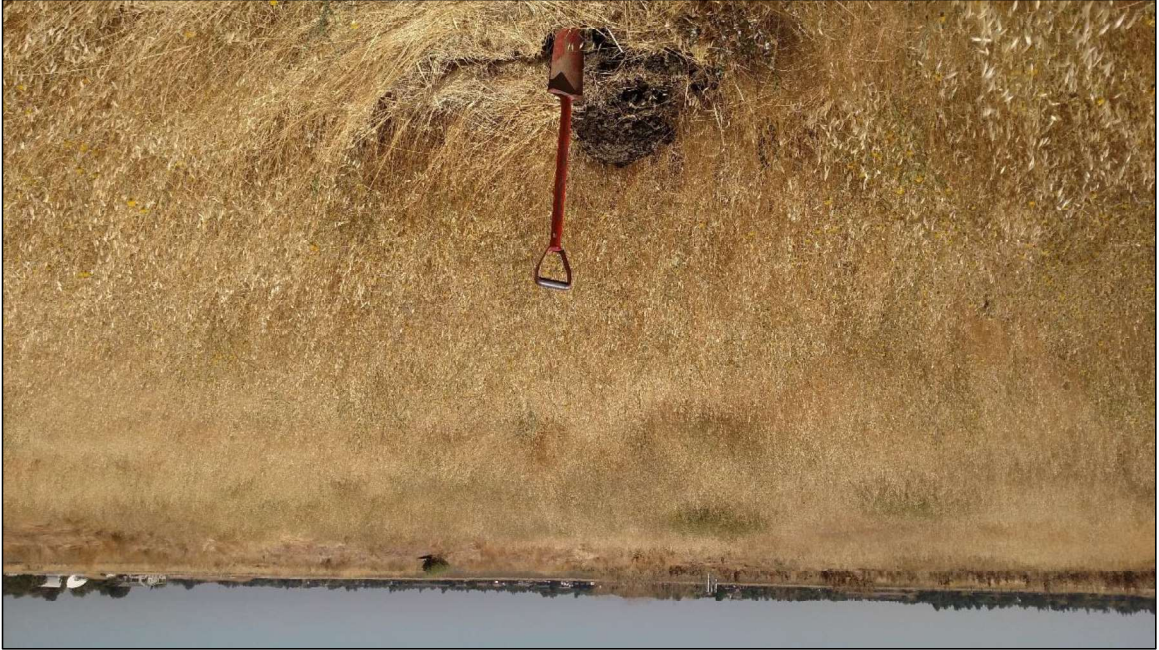
Data Point DP-03 - 17 August 2018

Remarks: Raised berm of basin; paired with DP 04. *Climatic conditions abnormal, rainfall totals well-above average for the 2018-2019 winter, and rain events occurred late in season.

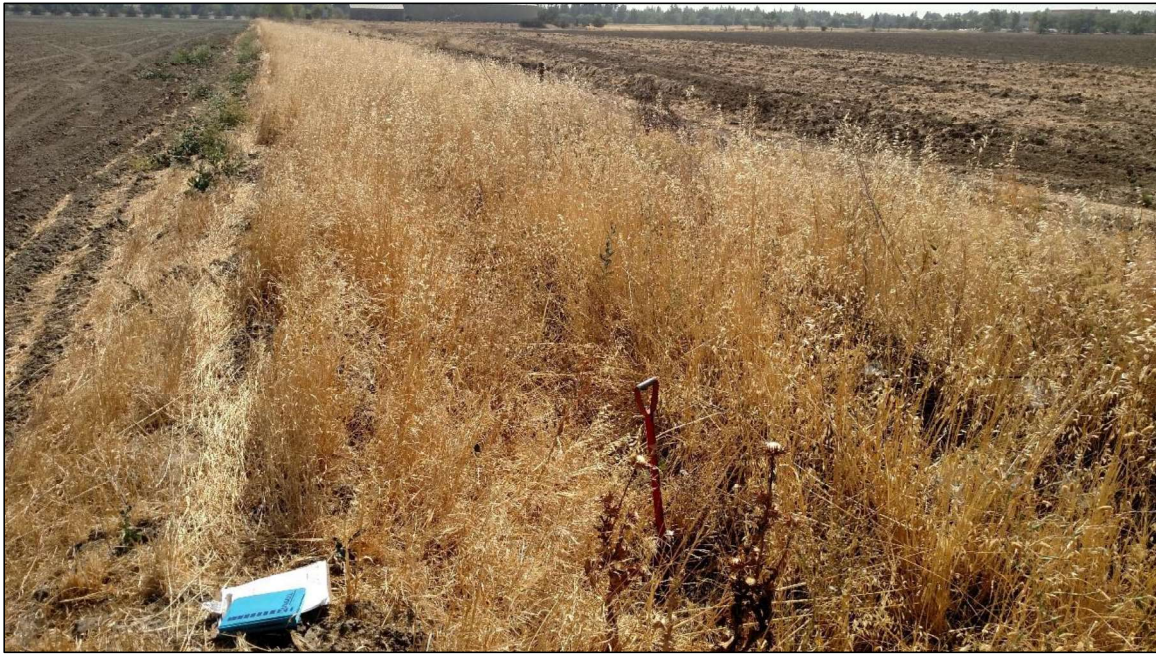
Data point DP-05 – 17 August 2018

Remarks: Point in irrigation ditch. *Climactic conditions abnormal, rainfall totals well-above average for the 2018-2019 winter, and rain events occurred late in season.

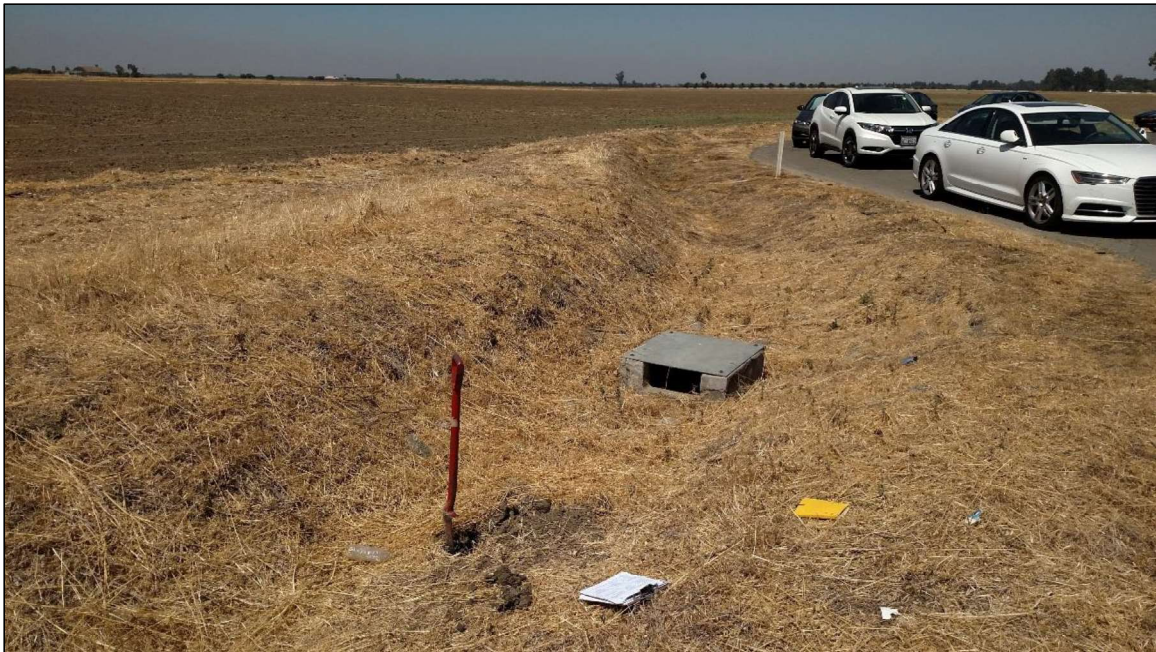
Data point DP-06 – 17 August 2018

Hydrophytic Vegetation Present? Yes _____ No <u>X</u> Hydric Soil Present? Yes _____ No <u>X</u> Wetland Hydrology Present? Yes <u>X</u> No _____	Is the Sampled Area within a Wetland? Yes _____ No <u>X</u>
Remarks: Roadside ditch for stormwater drainage. Large stones within ditch. *Climactic conditions abnormal, rainfall totals well-above average for the 2018-2019 winter, and rain events occurred late in season.

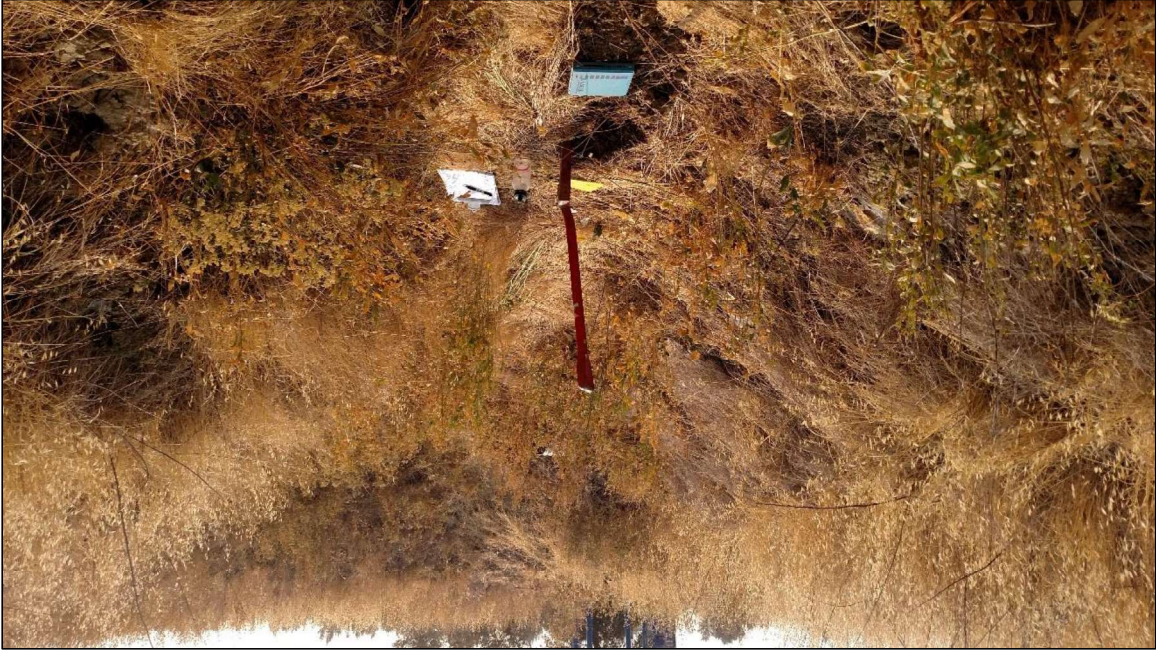
Data point DP-07 – 17 August 2018

Hydrophytic Vegetation Present? Yes <u>X</u> No _____ Hydric Soil Present? Yes <u>X</u> No _____ Wetland Hydrology Present? Yes <u>X</u> No _____	Is the Sampled Area within a Wetland? Yes <u>X</u> No _____
Remarks: DP within perennial drainage (Covell Drainage Channel). *Climactic conditions abnormal, rainfall totals well-above average for the 2018-2019 winter, and rain events occurred late in season.

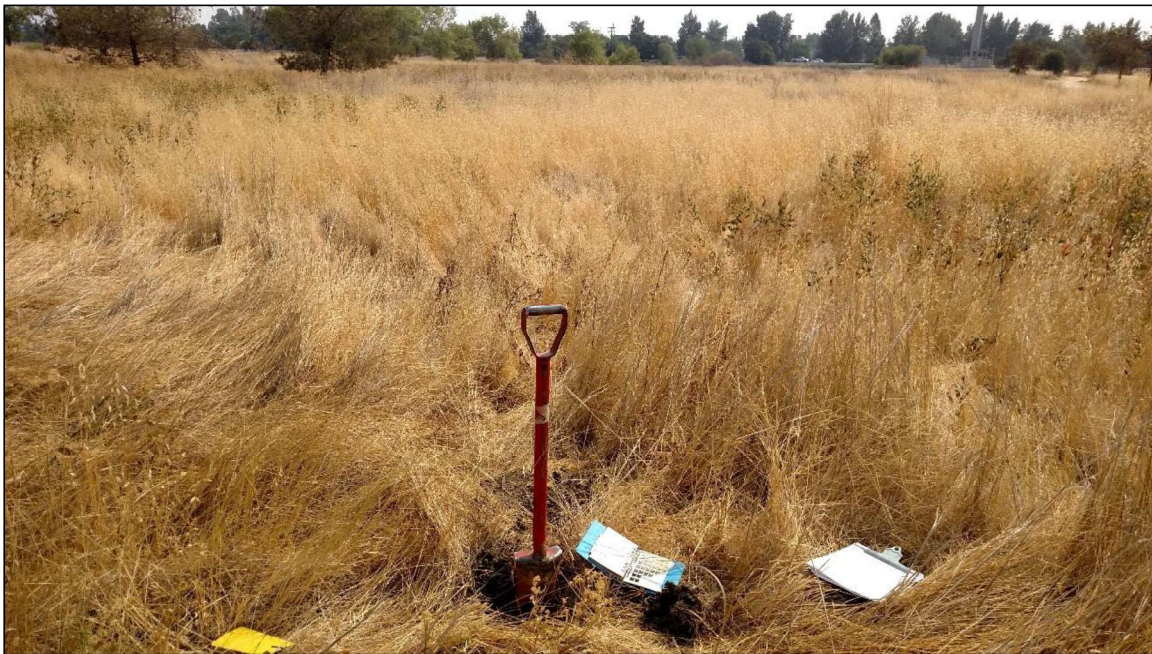
Data point DP-09 – 21 August 2018

Hydrophytic Vegetation Present? Yes <u>X</u> No _____ Hydric Soil Present? Yes _____ No <u>X</u> Wetland Hydrology Present? Yes _____ No <u>X</u>	Is the Sampled Area within a Wetland? Yes _____ No <u>X</u>
Remarks: Suspect patch of <i>Festuca perennis</i> in an otherwise <i>Avena fatua</i> dominant annual grassland. *Climactic conditions abnormal, rainfall totals well-above average for the 2018-2019 winter, and rain events occurred late in season.

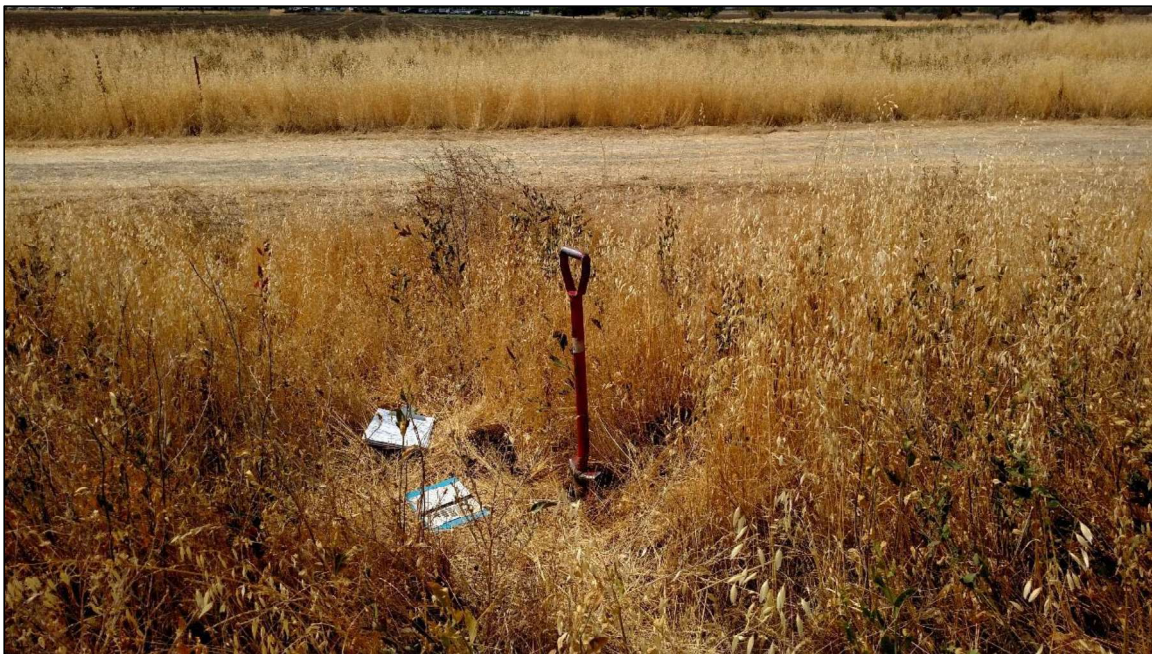
Data point DP-10 – 21 August 2018

Remarks: Upland DP paired with DP 09. *Climactic conditions abnormal, rainfall totals well-above average for the 2018-2019 winter, and rain events occurred late in season.

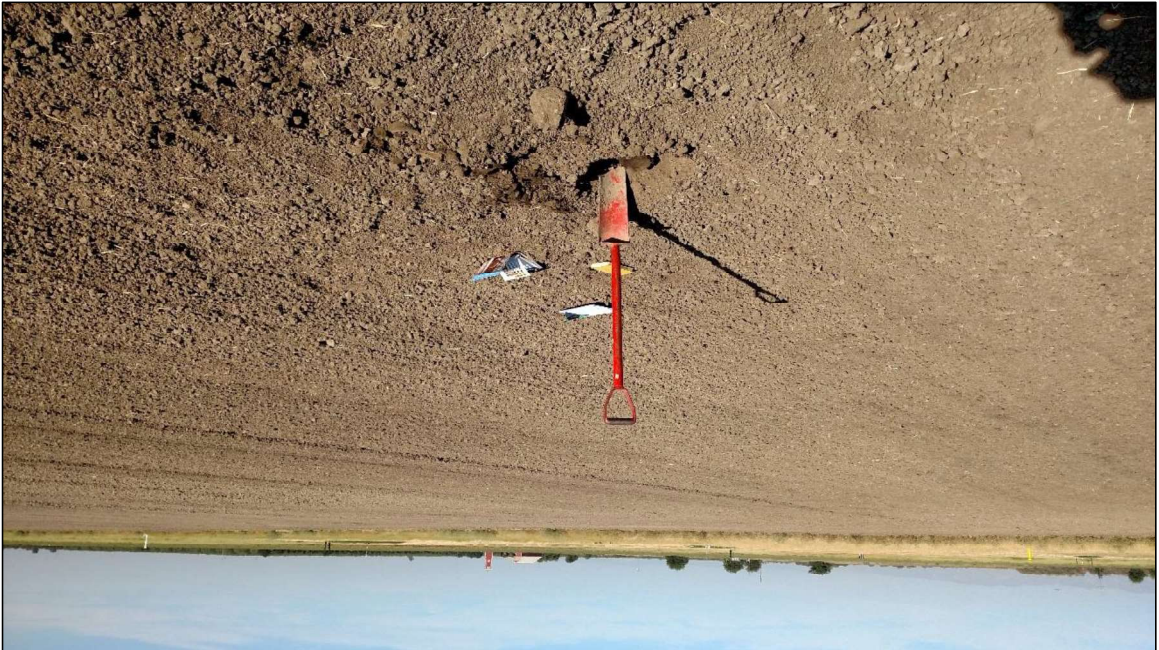
Disturbed area, facing northeast – 19 August 2019

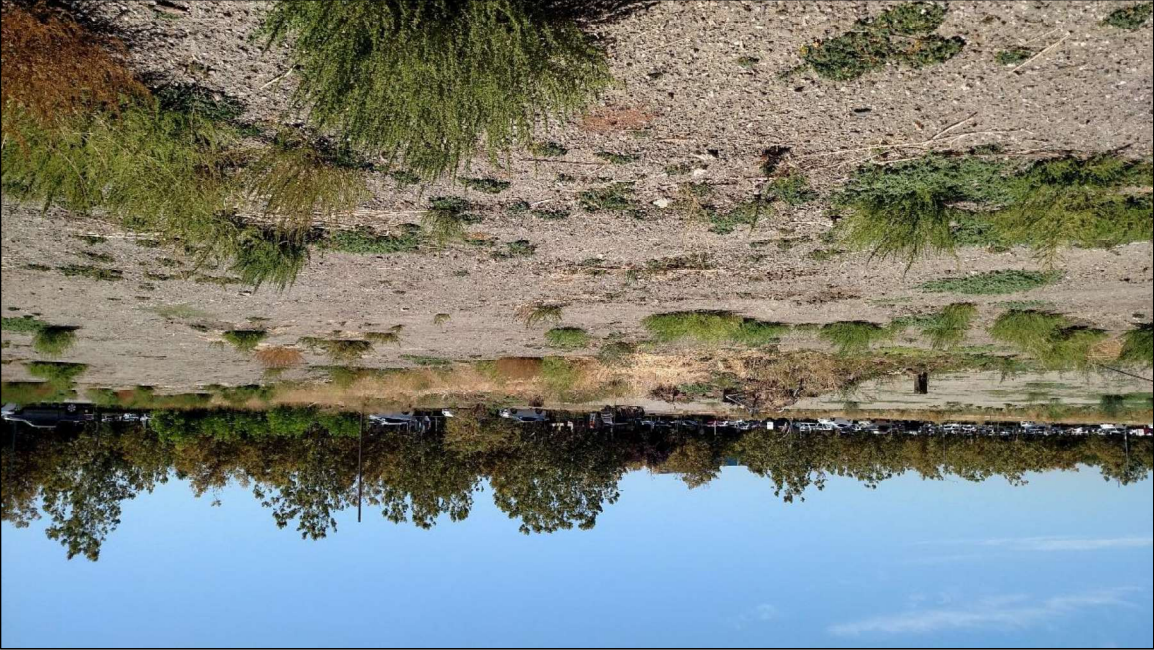
Constructed basin, facing southeast – 19 August 2019

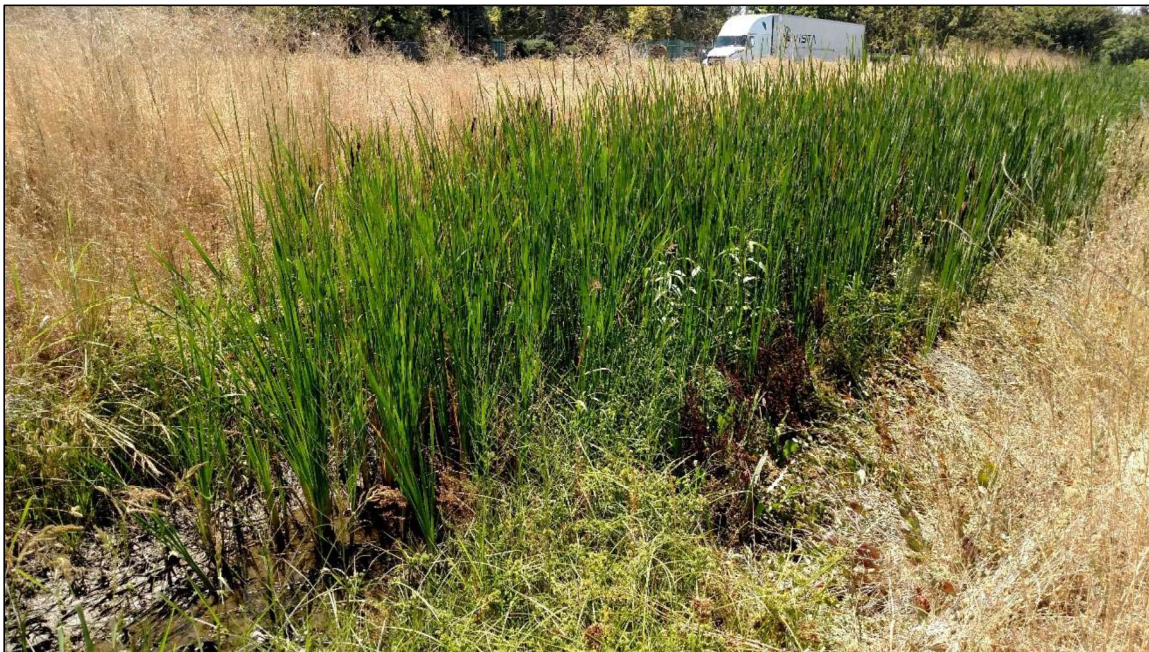
Covell Drainage Channel (CDC-1, CDC-2) flows from west to east through Study Area 1. Flows within the channel are perennial in nature, with slow-flowing water observed during the site visits. The channel runs along the southern portion of the site in two segments (0.572 acre), paralleling West Covell Boulevard. It passes beneath Risling Court and John Jones Road via a double culvert and underpass, respectively. The channel is a manmade trapezoidal ditch approximately 10-feet in depth. Vegetation within the channel is dominated by broad-leaved cattail (*Typha latifolia*) and tall flatsedge (*Cyperus eragrostis*). Other species growing within the feature include western yellowcress (*Rorippa curvisiliqua*), watergrass (*Echinochloa crus-galli*), curly dock (*Rumex crispus*), rabbitsfoot grass (*Polypogon monspeliensis*), common knotweed (*Persicaria lapathifolia*), tall wheat grass (*Elymus ponticus*), and johnsongrass (*Sorghum halepense*). The slopes of the channel are covered in upland vegetation including wild oat, ripgut brome, and prickly lettuce. Scattered native trees such as Fremont cottonwood (*Populus fremontii*), western sycamore (*Platanus racemosa*), and Goodding's black willow (*Salix gooddingii*) occur along the channel, as well as some non-native ornamental trees associated with the surrounding development. The channel is an indirectly connected tributary to the navigable Sacramento River, as previously described, and is therefore likely to be a jurisdictional water of the U.S. The channel was mapped at the Ordinary High Water Mark (OHWM), which was identified based on sediment deposits, water marks, vegetation, and topographic breaks.

Covell Drainage Channel (CDC-1), facing southwest – 17 August 2018

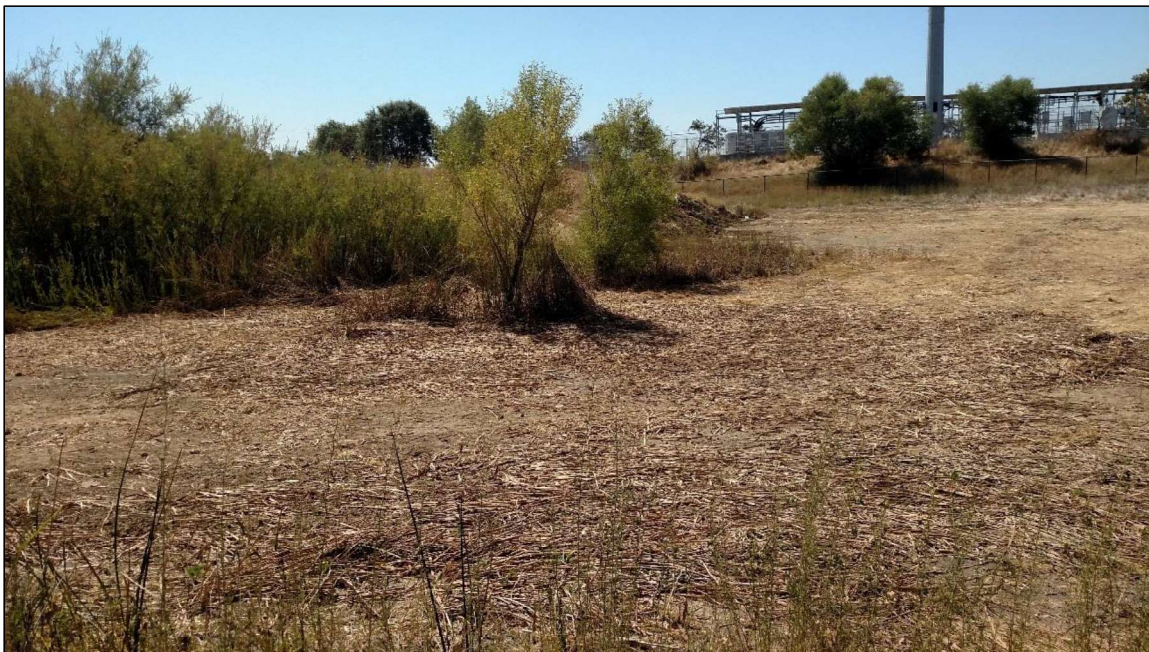
Non-jurisdictional detention basin (NJB-1), facing south – 19 August 2019

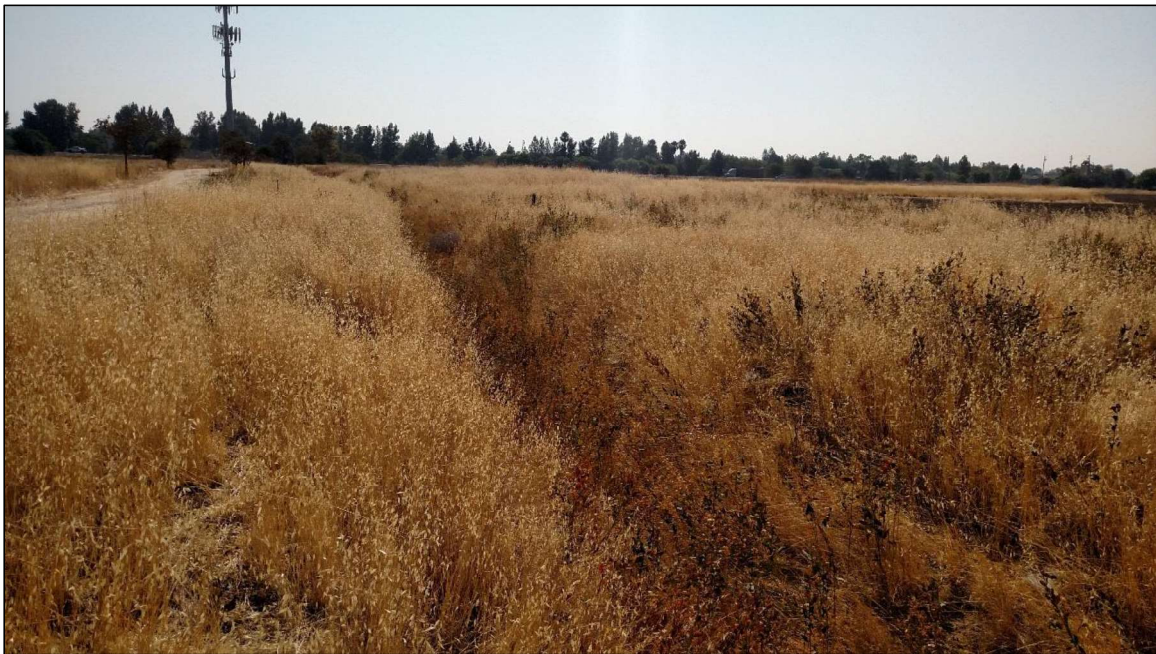
Non-jurisdictional drainage ditch (NJDD-2), facing east – 16 August 2018

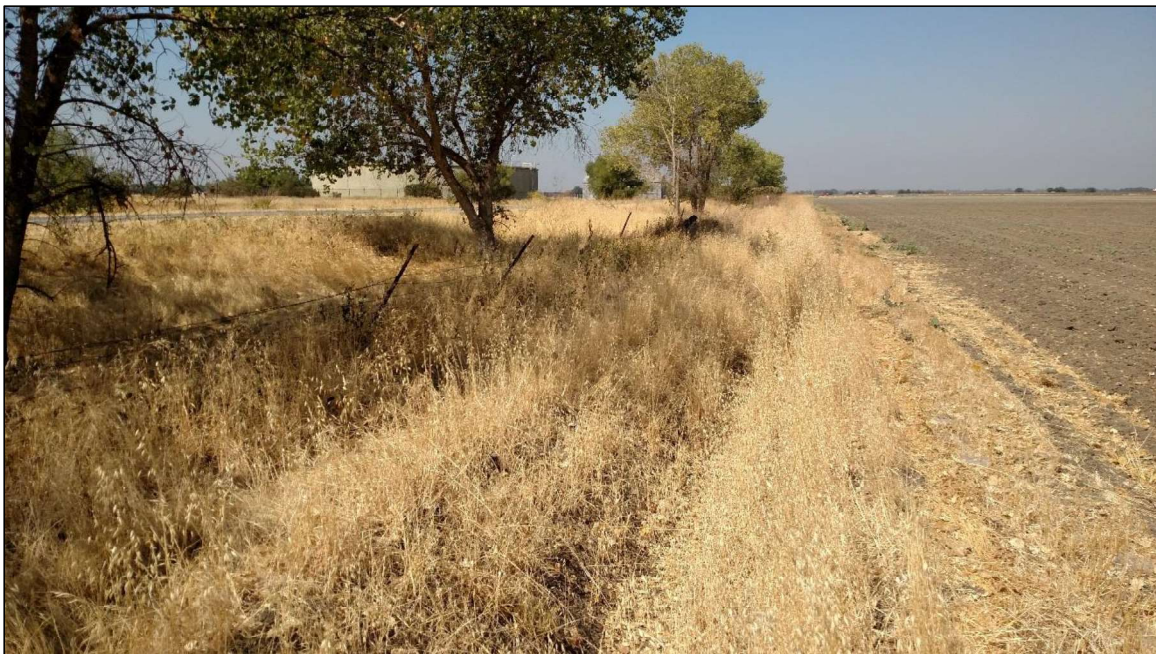
Non-jurisdictional irrigation ditch (NJID-2), facing west – 16 August 2018

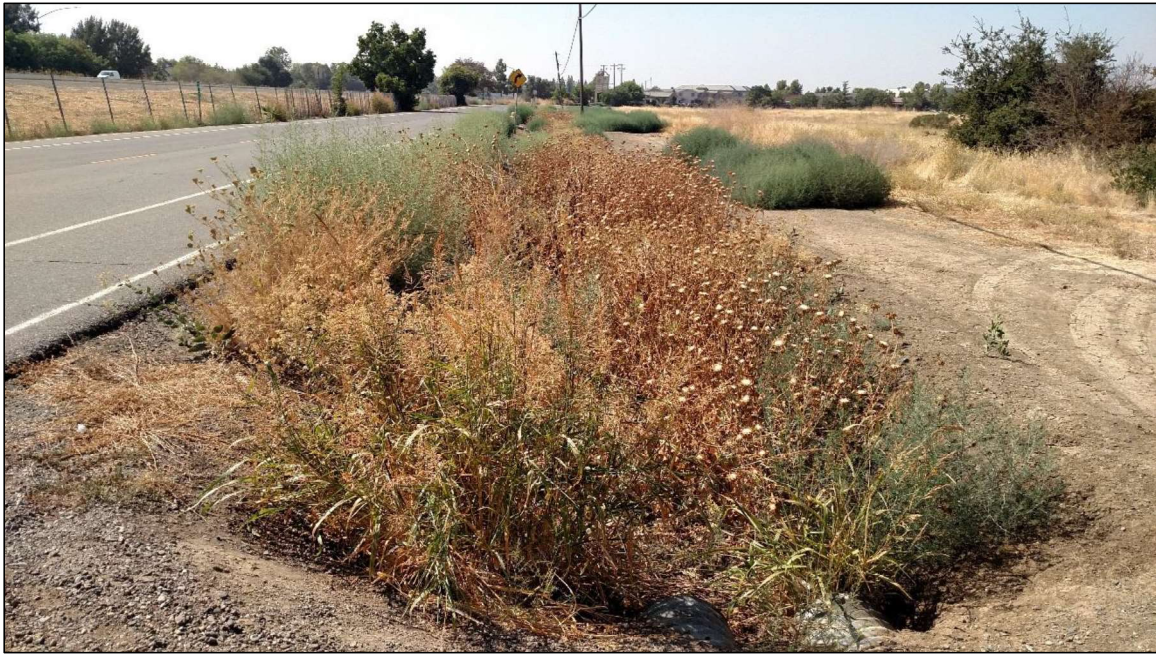
Non-jurisdictional roadside ditch (NJR-2), facing south – 16 August 2018
