Historical Resources Analysis

Proposed Olive Drive Area Building Demolition
115 Hickory Lane and 1233 Olive Drive
Davis, California

Dennis J. Dahlin
Dahlin and Essex, Inc.
2120 Loyola Drive, Davis CA 95618

February 23, 2015

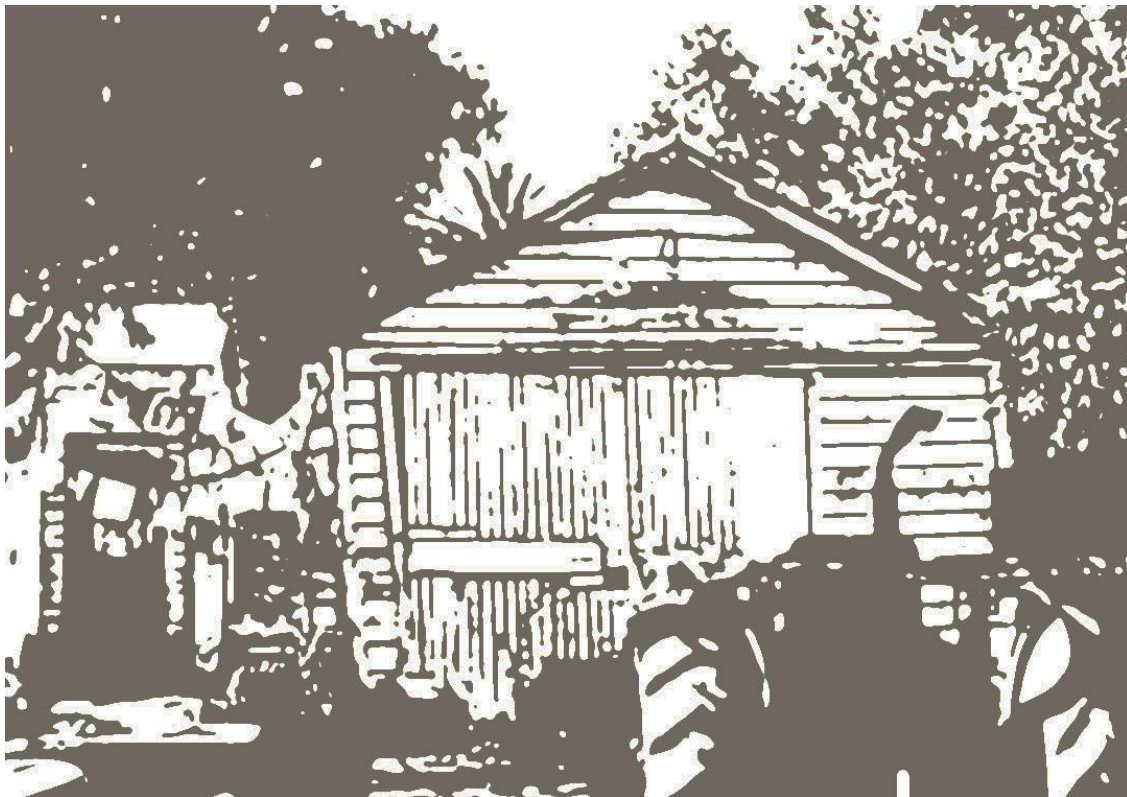
Garage, 115 Hickory Lane

Photos A and B show the current condition of this structure, a rectangular building previously used as a garage. The gable roof is surfaced with asphalt roll roofing in poor condition (Photo B). Two wood doors are located on the east elevation, with two double hung windows on the north side. Walls are sheathed with horizontal wood clapboard siding. The garage door on the south elevation has narrow vertical wood sheathing.

Condition. Structural problems are evident in Photos A and B. A structural engineering evaluation was completed by Pemberton Engineering in June 2014. The summary report notes that the wood structure is leaning heavily. The roof and siding have many gaps that have allowed water intrusion. The report concludes that the garage structure is posing a safety threat and should be demolished.¹⁷

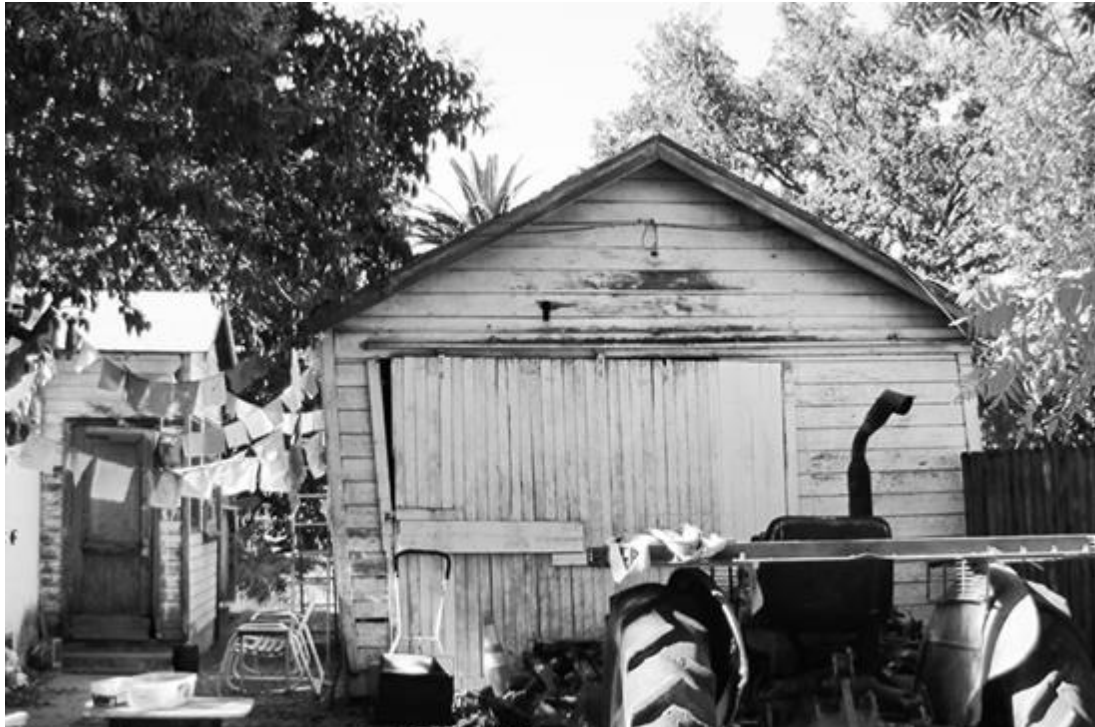
Photo A. South elevation of garage, 115 Hickory Lane.
Note leaning wall at left.

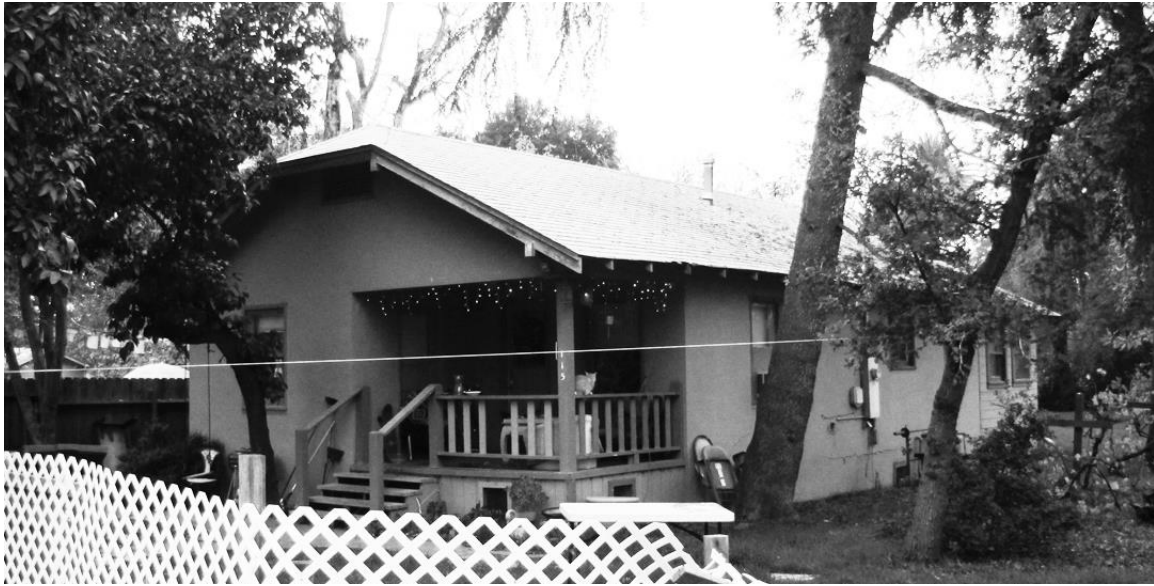
Photos C and D show the residence at 115 Hickory Lane. As with the garage, the house can be characterized as early twentieth-century vernacular architecture. There is no significant ornamentation or stylistic treatment. The primary structure has a half-hipped roof, featuring a predominant gable roof shape with hip treatment at the ends. A covered porch is located at the southeast corner. The structure currently is used as a single family residence. Main floor building area is approximately 1,080 square feet, plus a porch and basement.

Condition. Remedial interior structural work was completed in 2010. A subsequent structural engineering evaluation was completed by Pemberton Engineering in June 2014. The summary report notes that at some point in the near future, the structure will be considered unsafe and will likely need to be demolished. The report notes that it is unlikely that the structure can be feasibly repaired and salvaged.¹⁸

Photo C. Porch on southeast corner of residence, 115 Hickory Lane.

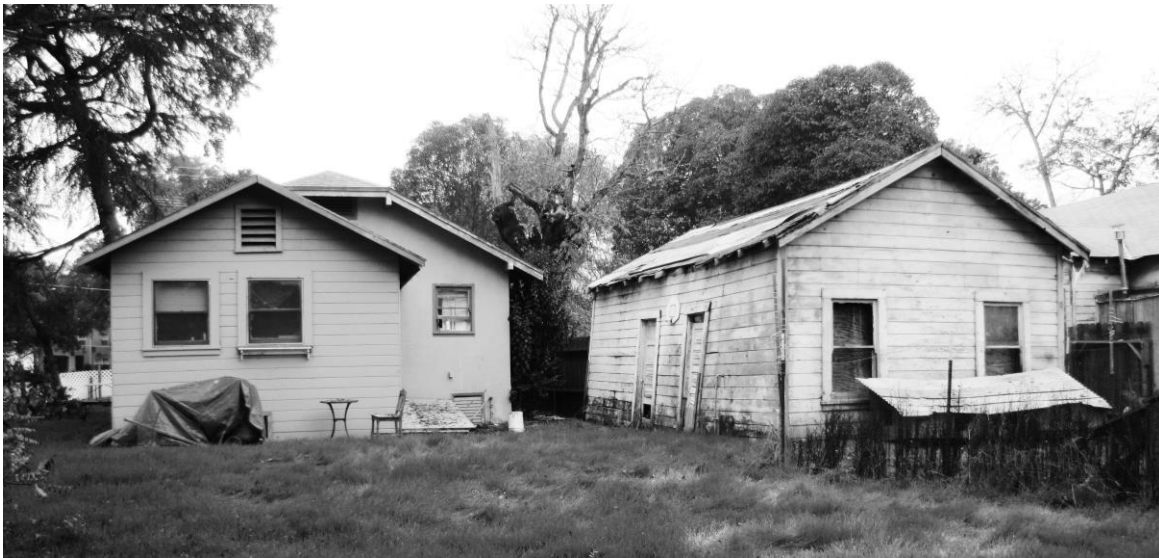
Photo D. North elevation, residence and garage, 115 Hickory Lane. Walls are surfaced with wood clapboard siding, except for the primary residential structure which has stucco treatment.

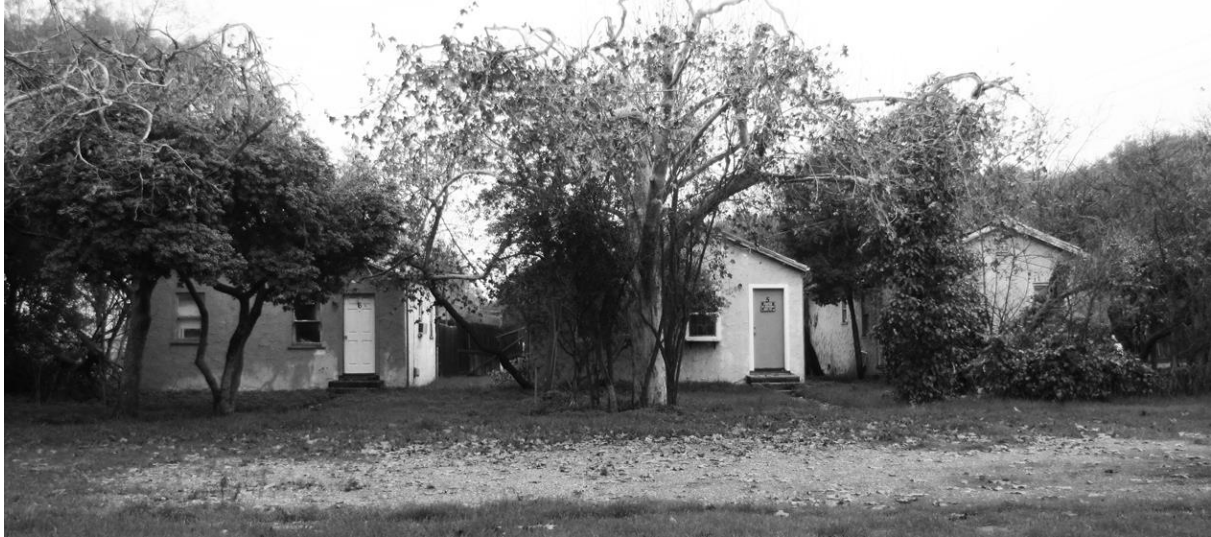
Construction materials and methods are typical of the period. The facades of the three structures include residential window and door openings. Louvered roof vents are located on gable ends. The roof surface treatment is asphalt roll roofing. Electrical utility service for the three buildings is located on the east wall of Unit 5.

Photo E. From left to right: west elevation of Units 6, 5, and 4, 1233 Olive Drive. Sidewalk remnants extend from the gravel driveway in foreground to the entrances for Units 5 and 6.

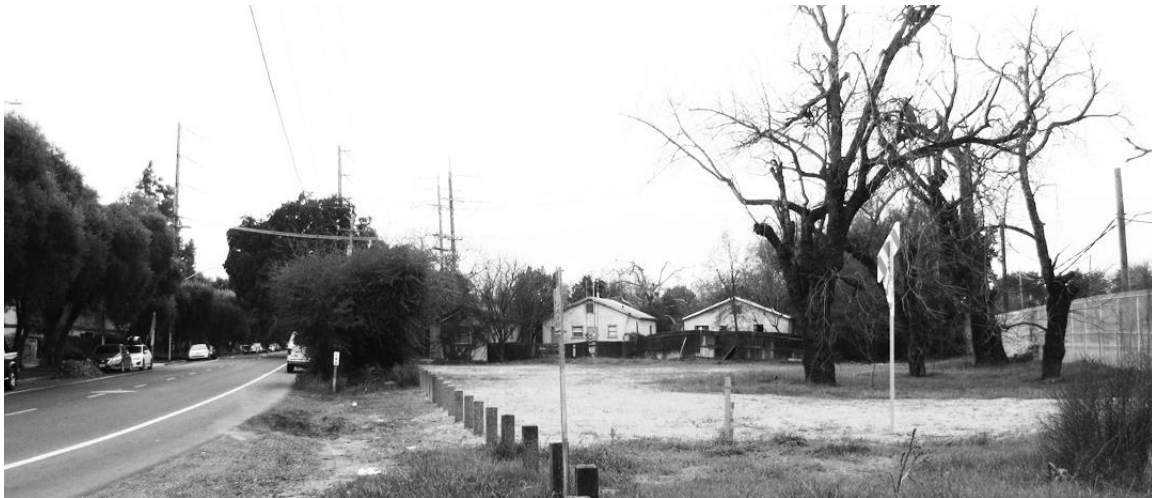
This structure was built in about 1944.²³ The building has a porch on the south side, facing Olive Drive (Photo F). Unit 4 is surrounded by dense landscaping, including euonymus and other shrubs. Three walnut trees (*Juglans* sp.) with approximately 20" diameter trunks are located south of this unit, near the Olive Drive property line. A low picket fence is located west of Unit 4. Building area is approximately 480 square feet plus a porch of 94 square feet.

Photo F. East elevations of units at 1233 Olive Drive, looking west along Olive Drive. Unit 4 next to the street is hidden by foliage. A recently-constructed chain link fence on the railroad property line is visible on the far right.

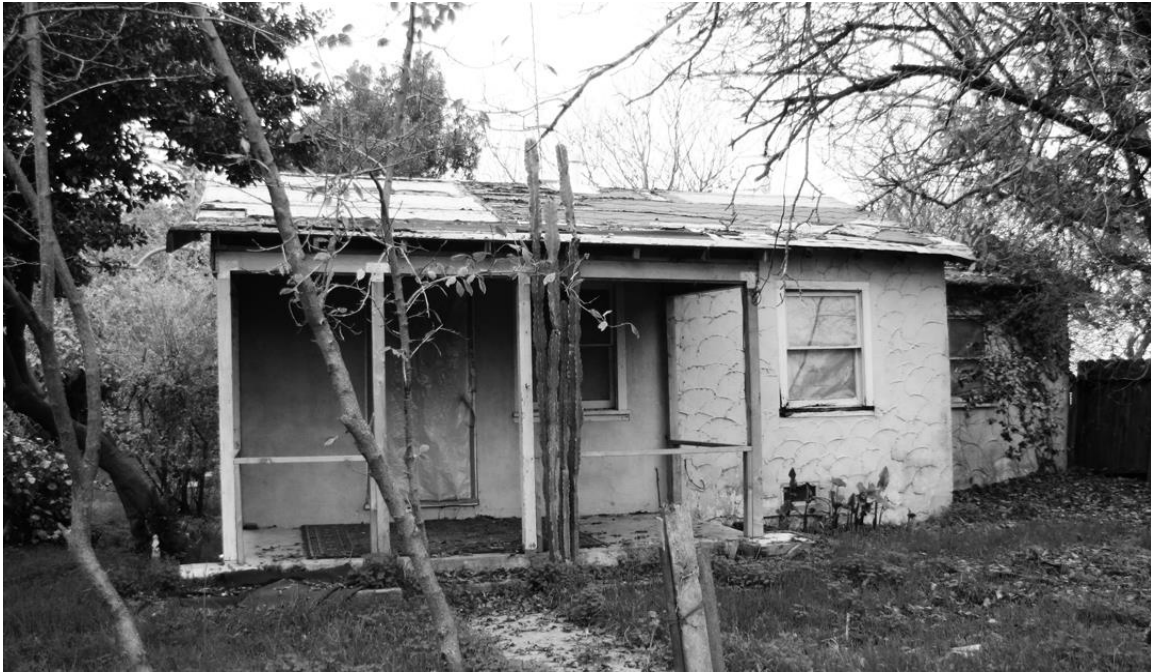
Condition. The deteriorated condition of the existing roof is shown in Photo G. A structural inspection of Unit 4 was completed in November 2010. The structural engineer noted that the exposed rafter tails and roof sheathing at the eaves are in varying stages of damage due to moss and root growth. The gravity load path for the roof rafters has likely been compromised at this point by the rot damage along the eaves, and continued damage could result in partial roof collapse. The porch roof is unstable at this point and poses a life safety threat. Other issues include likely weakening of wall framing by continual water intrusion, stucco cracks, and inadequacy of existing roof sheathing. The existing electrical system poses several safety hazards, and mold was noted on walls. The structure is nearing the end of its useful life span, and it may not be economically feasible to upgrade this home to an appropriate level of comfort and safety.²⁴

Photo G. South elevation of Unit 4, with entrance and porch facing Olive Drive. Roof is in poor condition. The porch has been identified as a safety hazard.

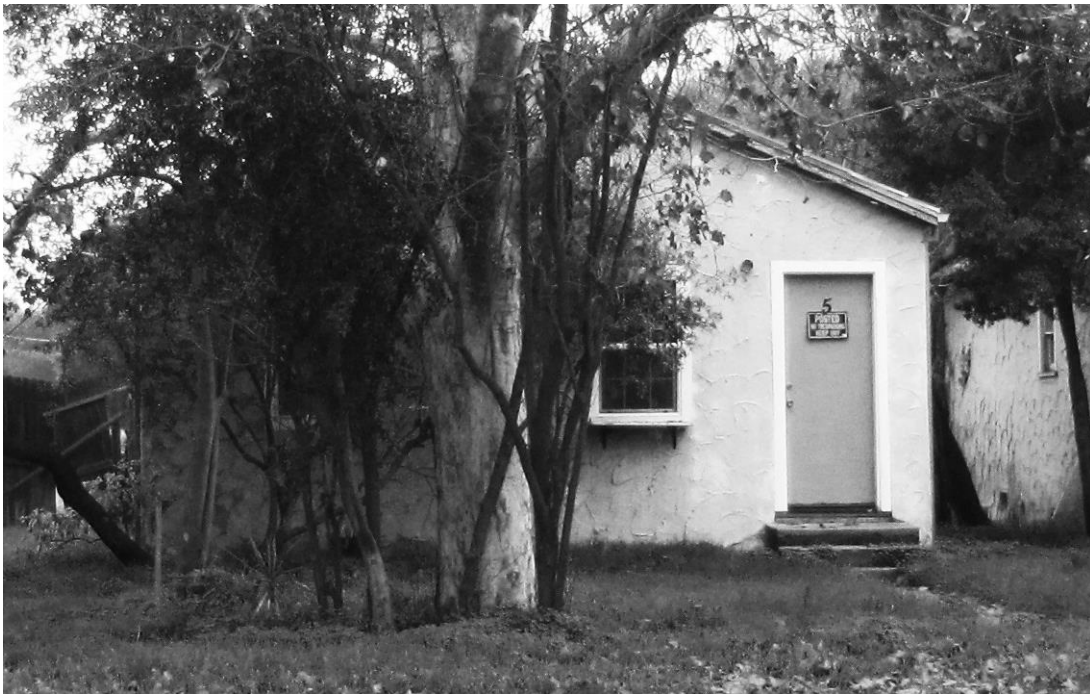
Integrity. The setting for this unit has been altered by the removal of four Callori Court units. Modifications have been made to the original structure, and its condition has deteriorated. The original wood siding has been surfaced with stucco. The structure has a recently-replaced asphalt roll roof. Original windows and the entrance door have been replaced. Electrical panels recently have been installed on the east wall.

Photo H. West elevation of Unit 5. Original windows and the entrance door have been replaced, with stucco added over the original wood siding.

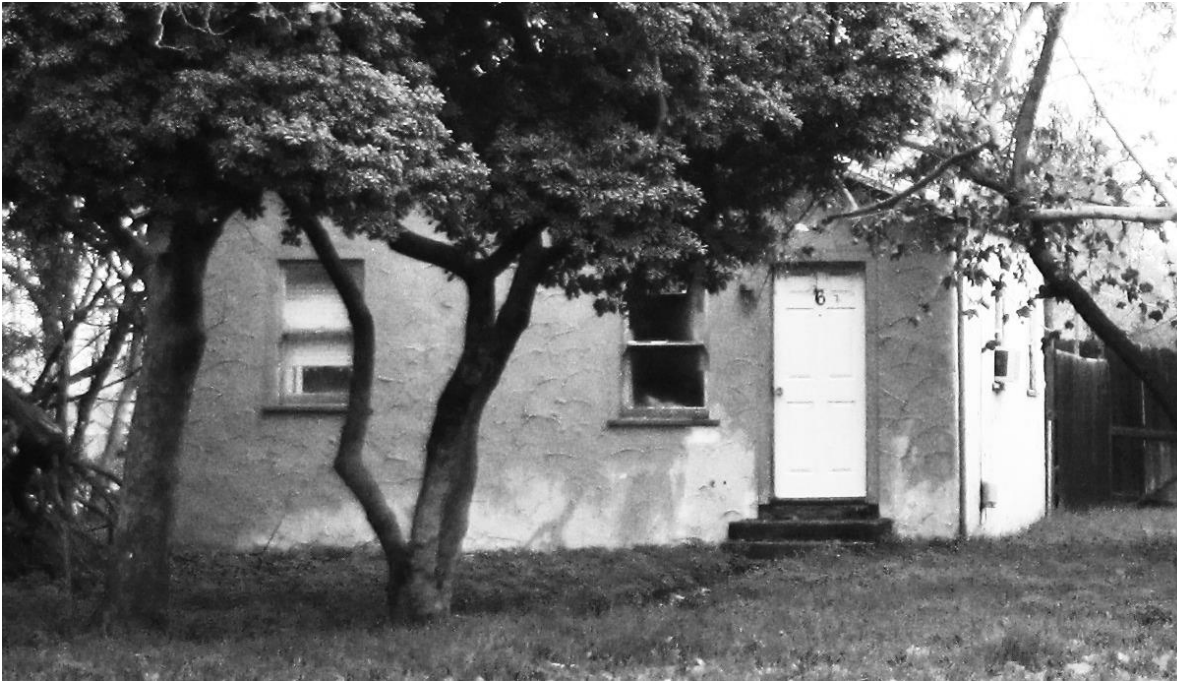
Integrity. The setting for this unit has been altered by the removal of four Callori Court units. The structure has a recently-replaced asphalt roll roof, and the original wood siding has been surfaced with stucco.

Photo I. West elevation of Unit 6. Stucco has been added over the original wood siding.

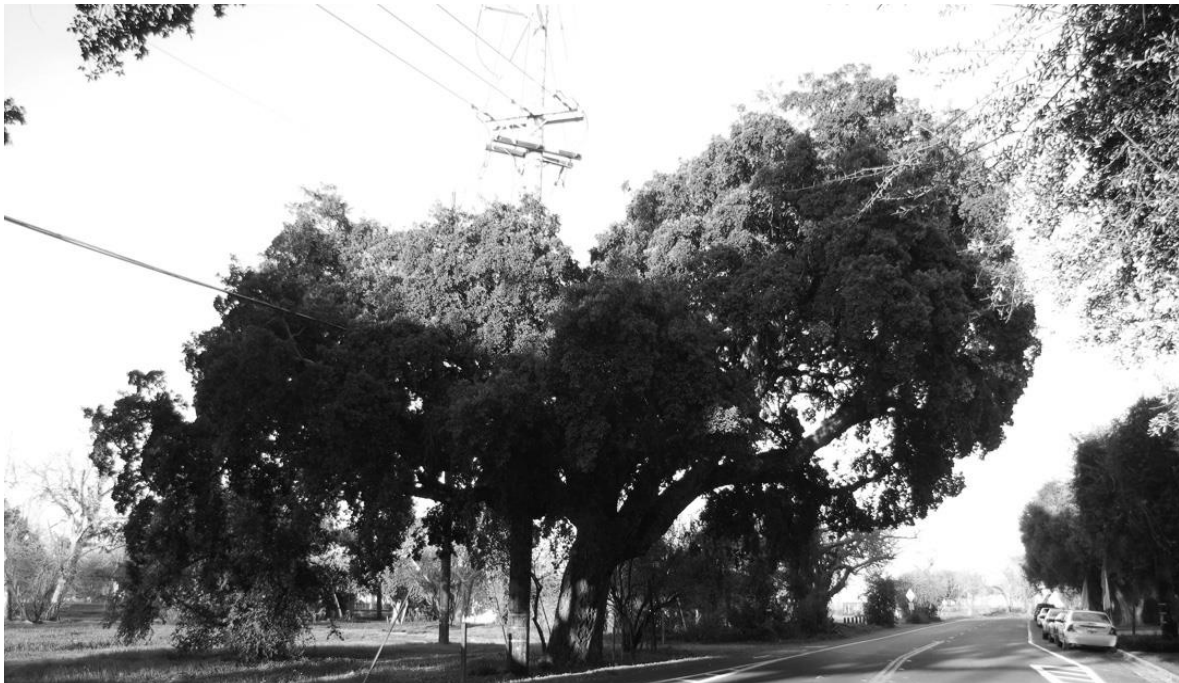
Photo J. Cork oak along Olive Drive, a designated City of Davis Landmark Tree. Unit 4 in the background is nearly hidden by foliage.

Photo J illustrates the cork oak (*Quercus suber*) at 1233 Olive Drive. This tree is listed as a Landmark Tree.³⁷

A 40" diameter cork oak Landmark Tree is located about 100' southwest of the proposed demolition at 1233 Olive Drive (Photo J). The cork oaks along Olive Drive are noted as a cultural resource in the 1996 City inventory of historical resources. The proposed demolition area of activity would not adversely impact the existing Landmark Tree or other cork oaks along East Olive Drive.
