RE: **Phase I Environmental Site Assessment**
Lincoln40
1111, 1165, 1185, 1223, 1225 and 1231 Olive Drive and 113, 115 and 118 Hickory Lane
Davis, California 95616
ERC Project #15-PH1-160

PHASE I ENVIRONMENTAL SITE ASSESSMENT

**Lincoln40
1111, 1165, 1185, 1223, 1225 and 1231 Olive Drive,
and
113, 115 and 118 Hickory Lane
Davis, Yolo County, California 95616**

December 10, 2015, *revised* August 12, 2016

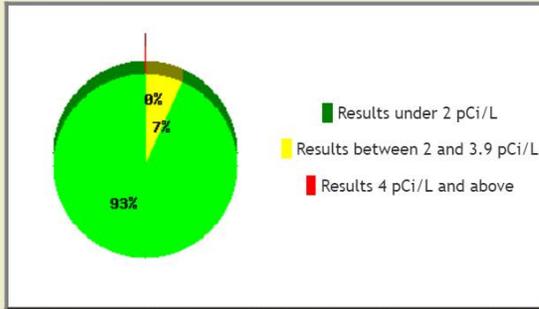
The following chart was generated from aggregate test data supplied by [Air Chek, Inc](#)

State of California
Radon Survey
Results for
Yolo County,
CA

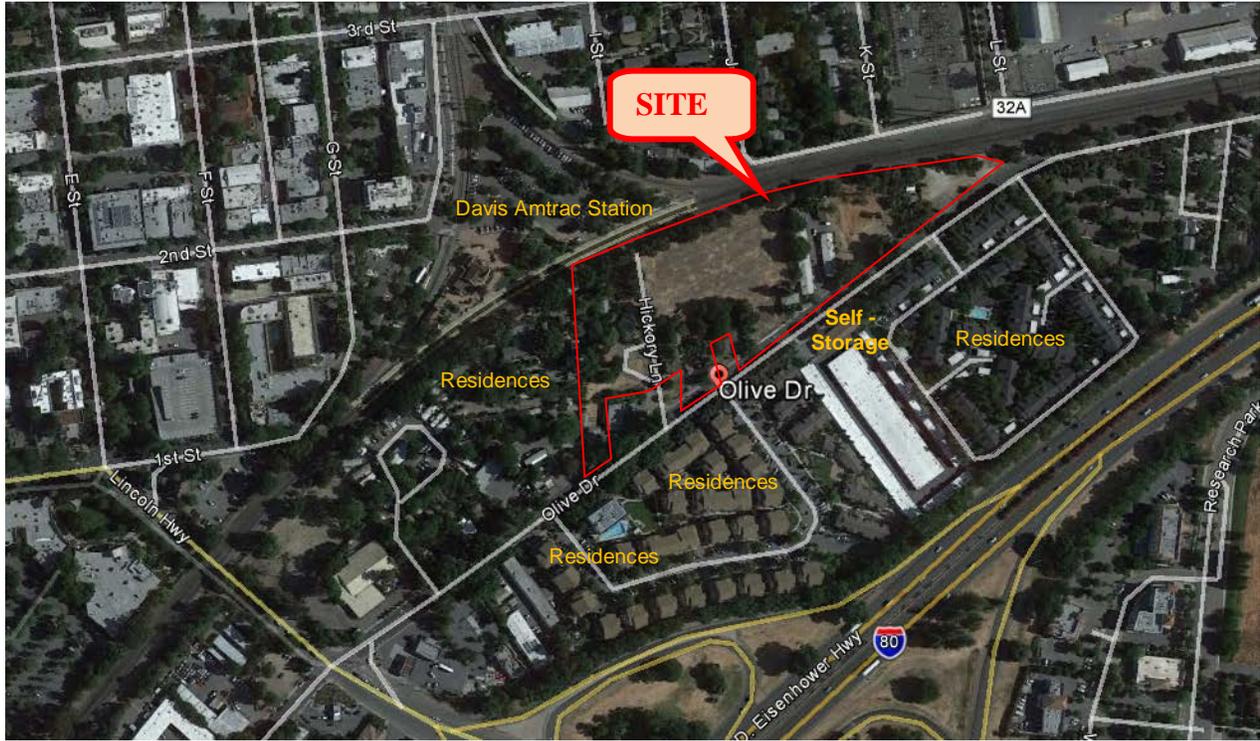
SITE PLAN

1111, 1165, 1185, 1223, 1225 and 1231 Olive Drive and 113, 115 and 118 Hickory Lane, Davis, California

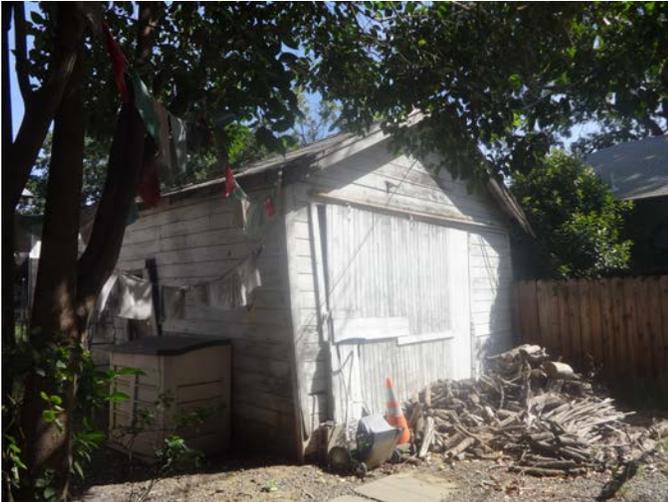
Barn next to 115 Hickory Lane and not safe to enter.

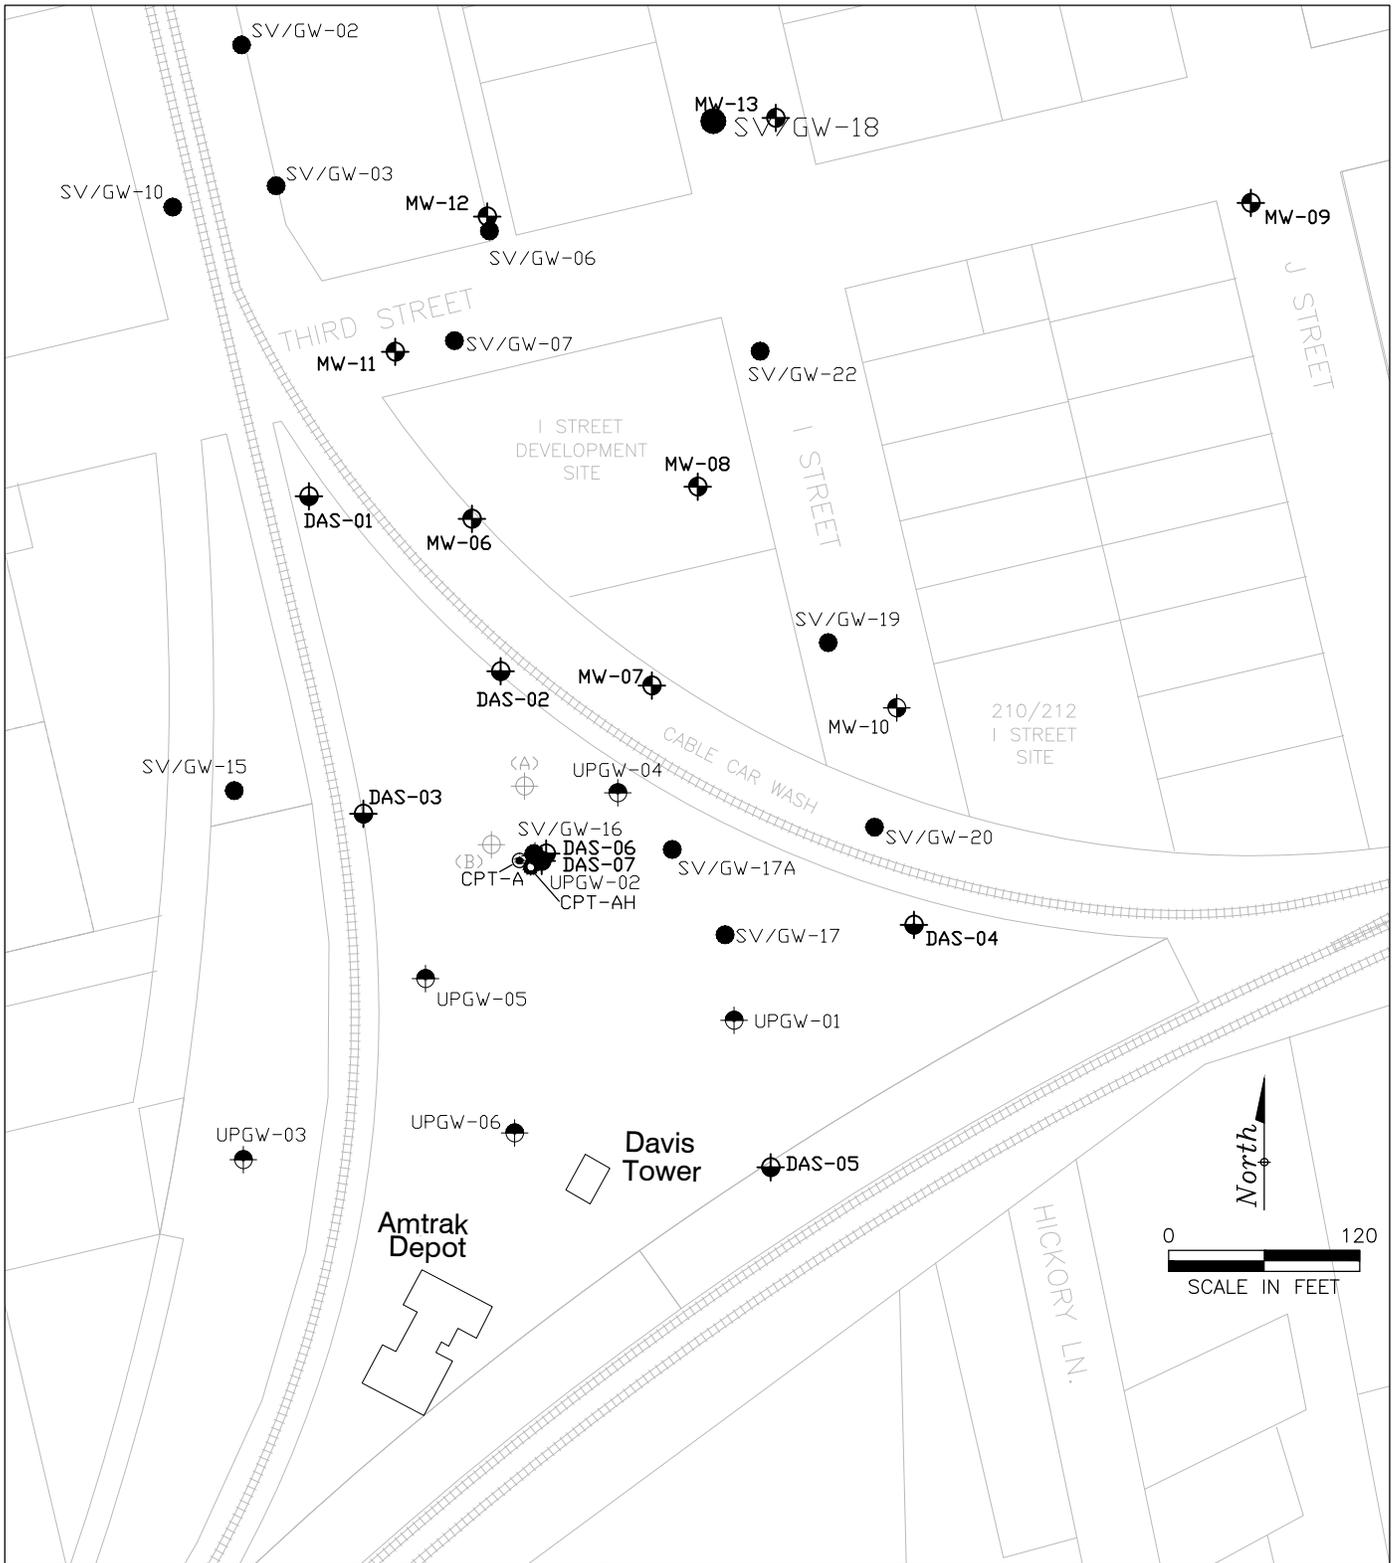
FIGURE 2 SITE PLAN DAVIS WYE TRACK SITE DAVIS, CALIFORNIA		
PROJECT NO. UPR8209	PREPARED BY NP	DRAWN BY JH
DATE 5/7/12	REVIEWED BY LH	FILE NAME UPR8209CA

LEGEND	
DAS-1	MONITORING WELL, UNION PACIFIC
MW-7	MONITORING WELL, NON-UNION PACIFIC
UPGW-04	DECEMBER 1999, UNION PACIFIC SOIL BORING LOCATION
SV/GW-22	GROUNDWATER SAMPLING LOCATION, NON-UNION PACIFIC BORING
(A)	MUNICIPAL WELL, ABANDONED
CPT-A	CPT BORING
CPT-AH	HYDROPUNCH BORING

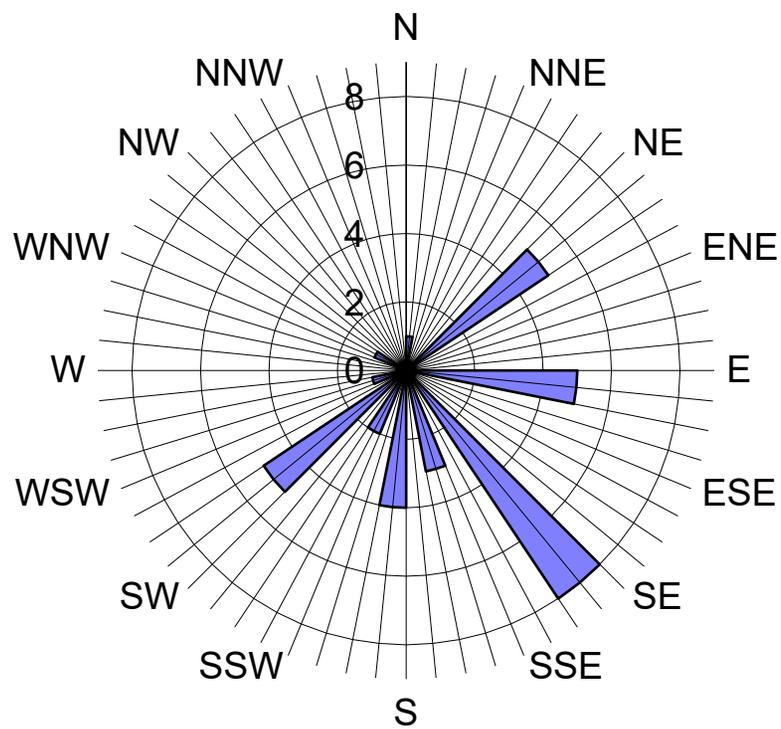
FIGURE 5
HISTORICAL GROUNDWATER FLOW DIRECTION (ROSE) DIAGRAM
 UNION PACIFIC RAILROAD
 WYE VOC SITE
 DAVIS, CALIFORNIA

■ Groundwater Flow Direction

Legend
 Concentric circles represent monitoring events from August 2000 through March 2016

35 data points shown

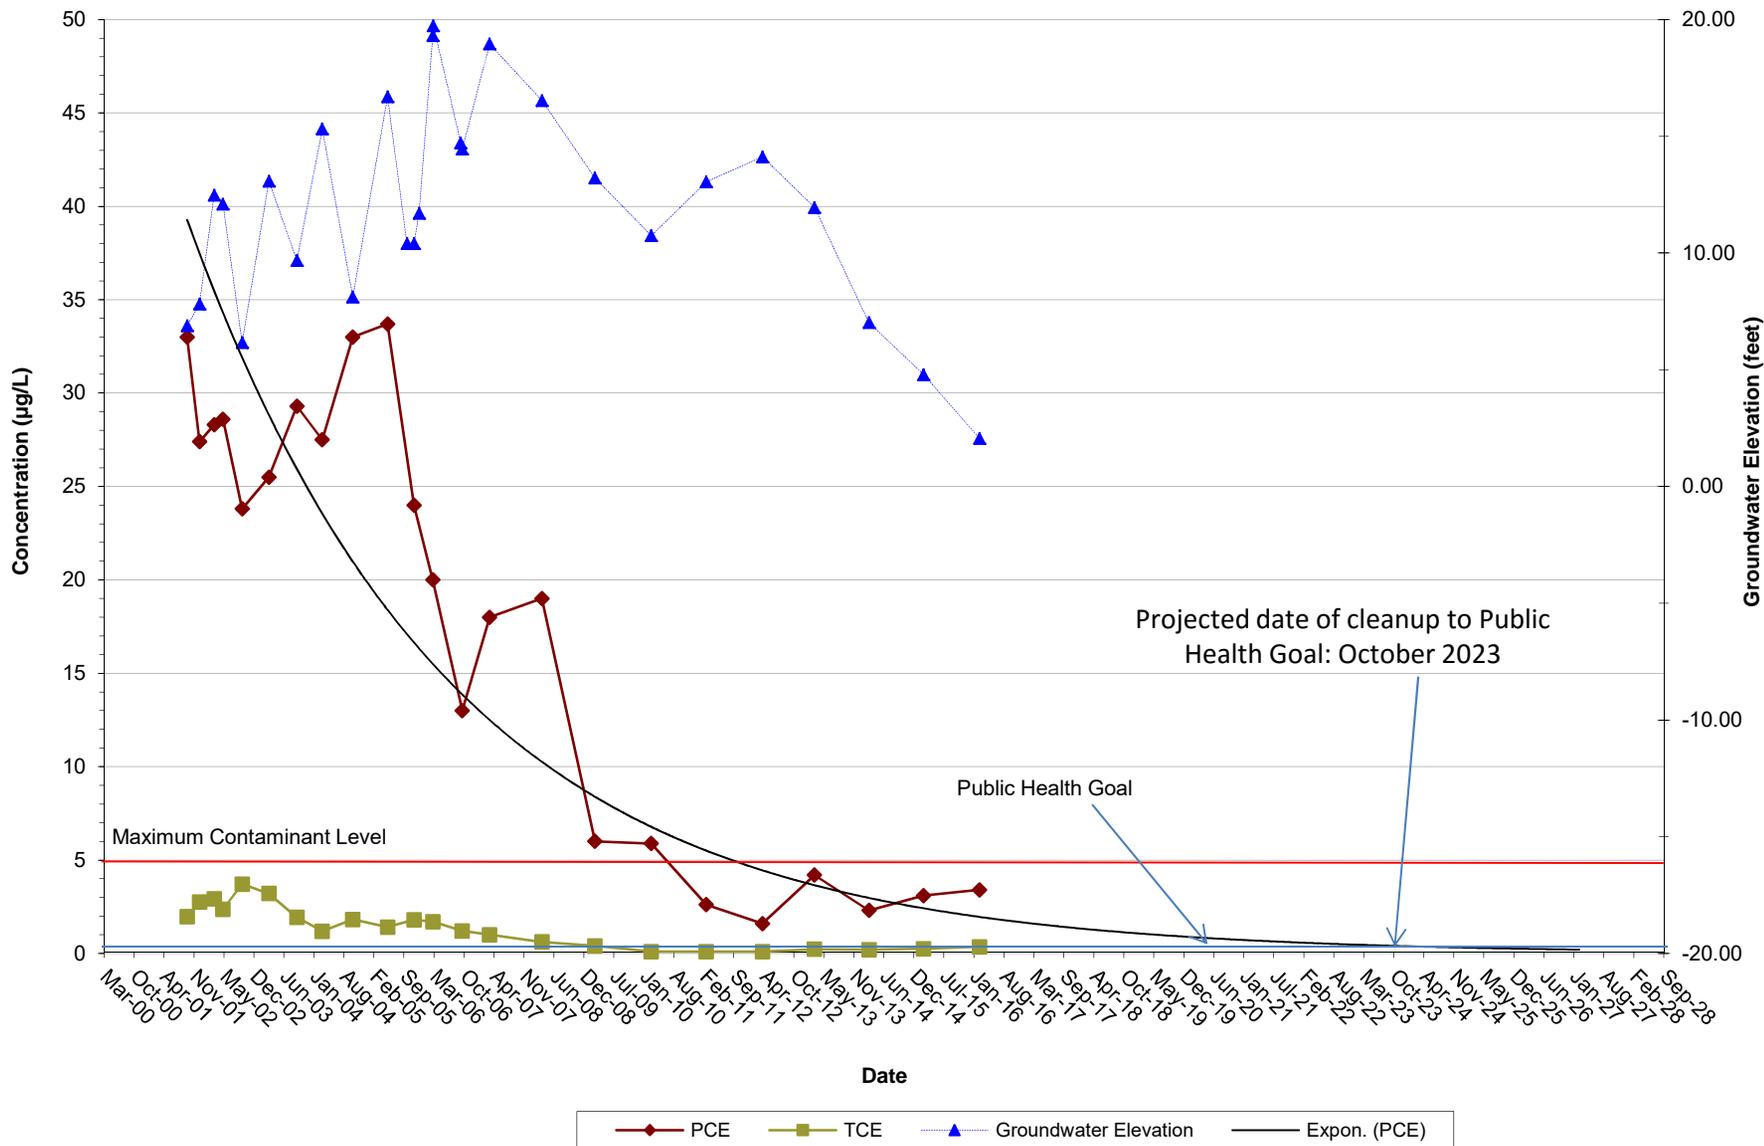
WELL DAS-06 PCE AND TCE CONCENTRATIONS AND GROUNDWATER ELEVATION VERSUS TIME

UNION PACIFIC RAILROAD
WYE VOC SITE
DAVIS, CALIFORNIA

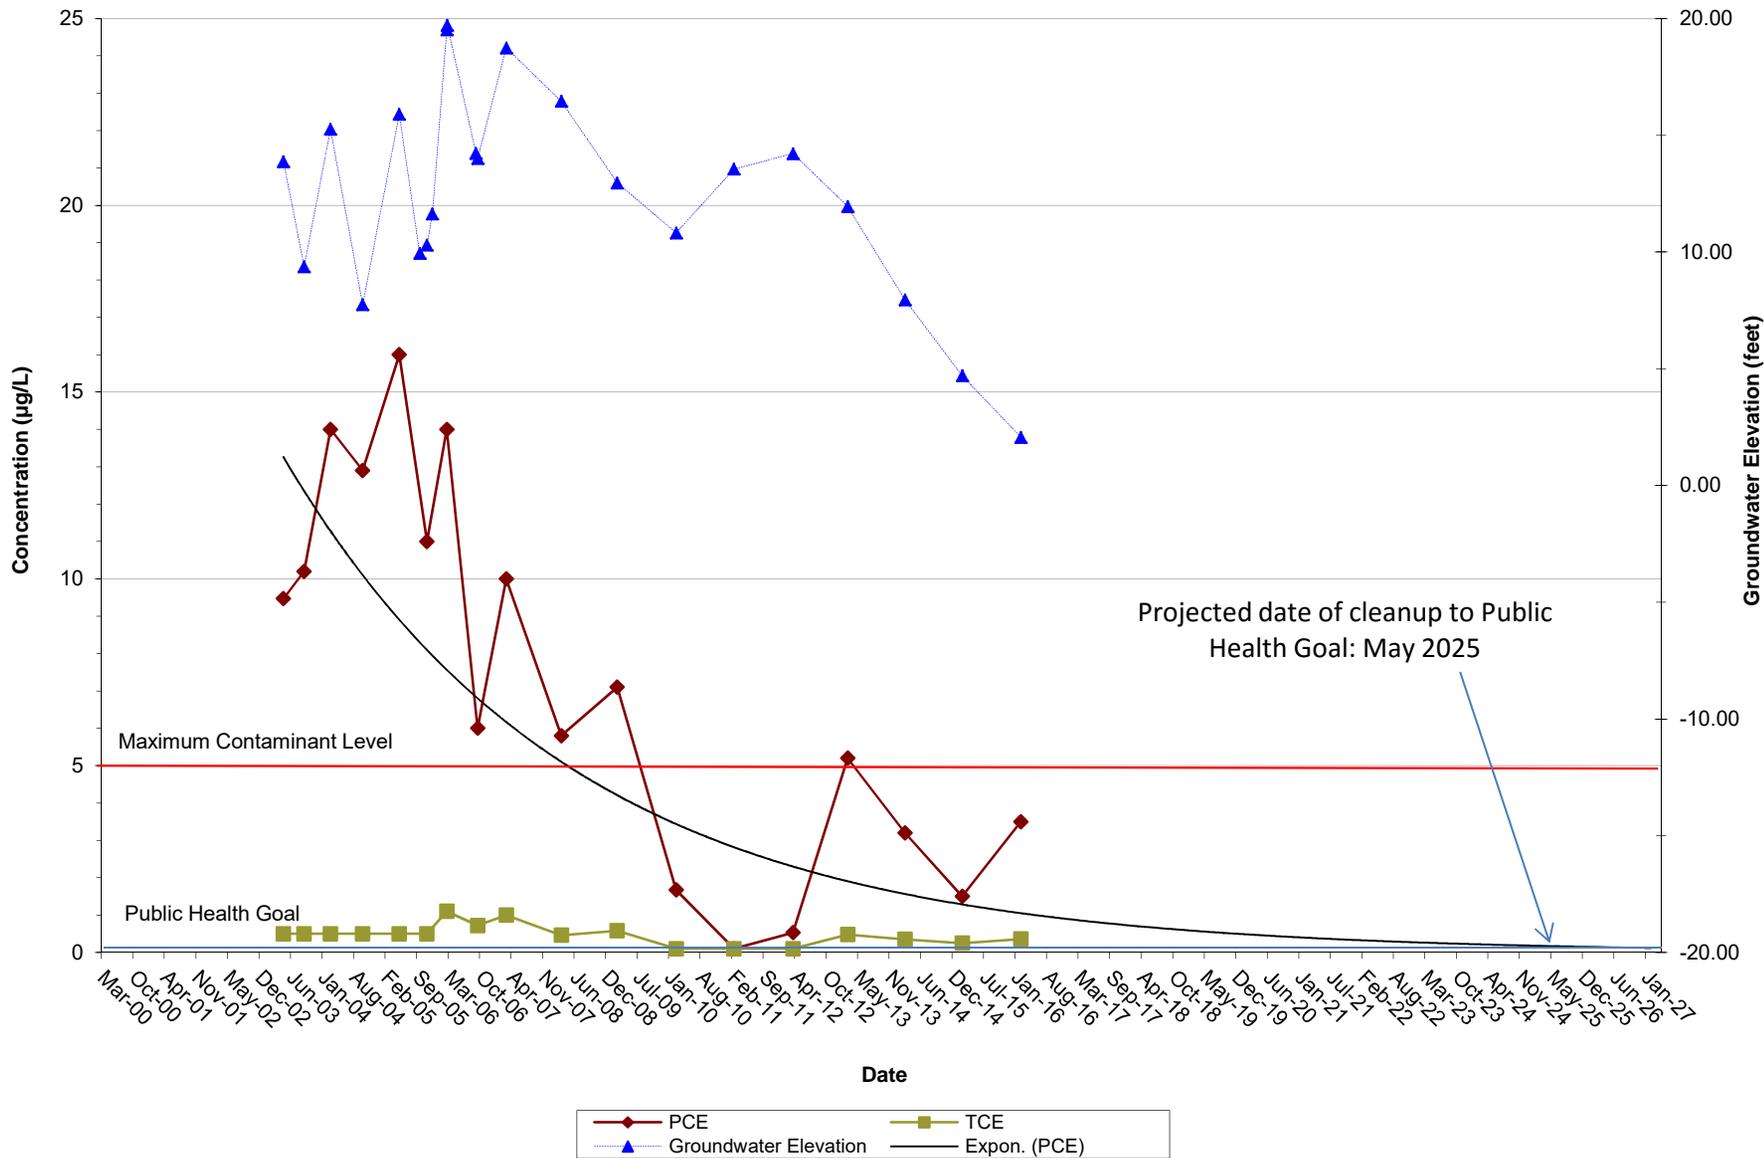
WELL DAS-07 PCE AND TCE CONCENTRATIONS AND GROUNDWATER ELEVATION VERSUS TIME

UNION PACIFIC RAILROAD
WYE VOC SITE
DAVIS, CALIFORNIA
