**HISTORICAL RESOURCE ANALYSIS STUDY OF
503, 509, AND 515 1ST STREET, DAVIS,
YOLO COUNTY, CALIFORNIA 95616**

OCTOBER 2016

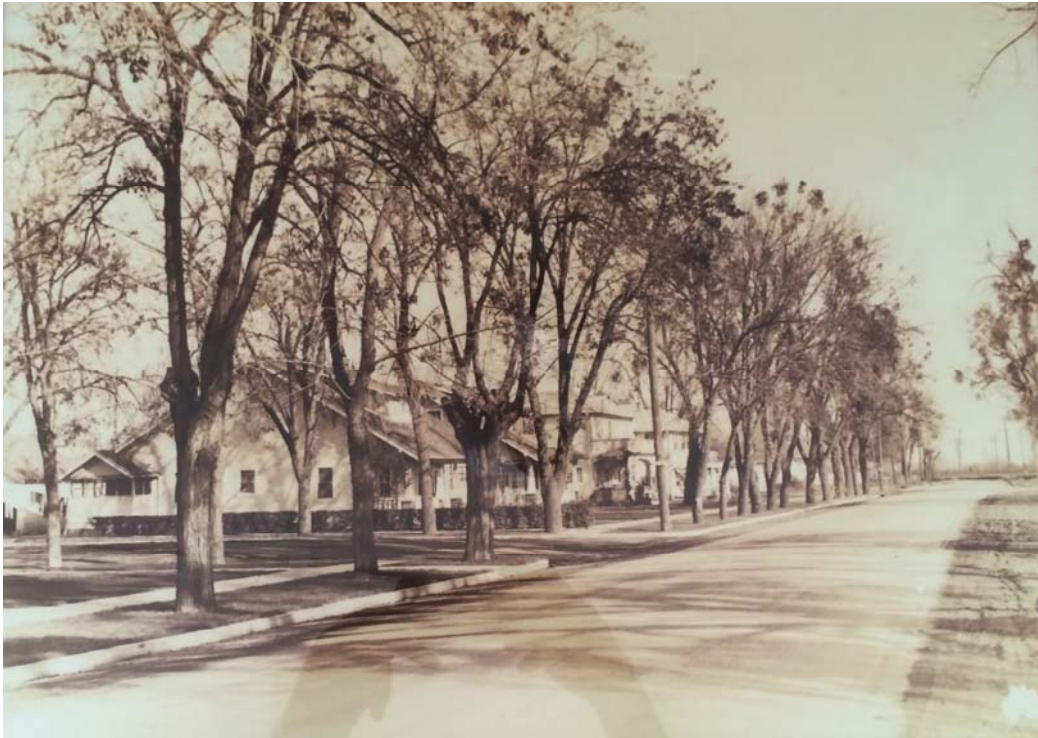
FIGURE 10: View circa 1920s looking east along 1st Street with 503, 509, and 515 1st Street on the left just beyond D Street (courtesy Theta Xi Fraternity).

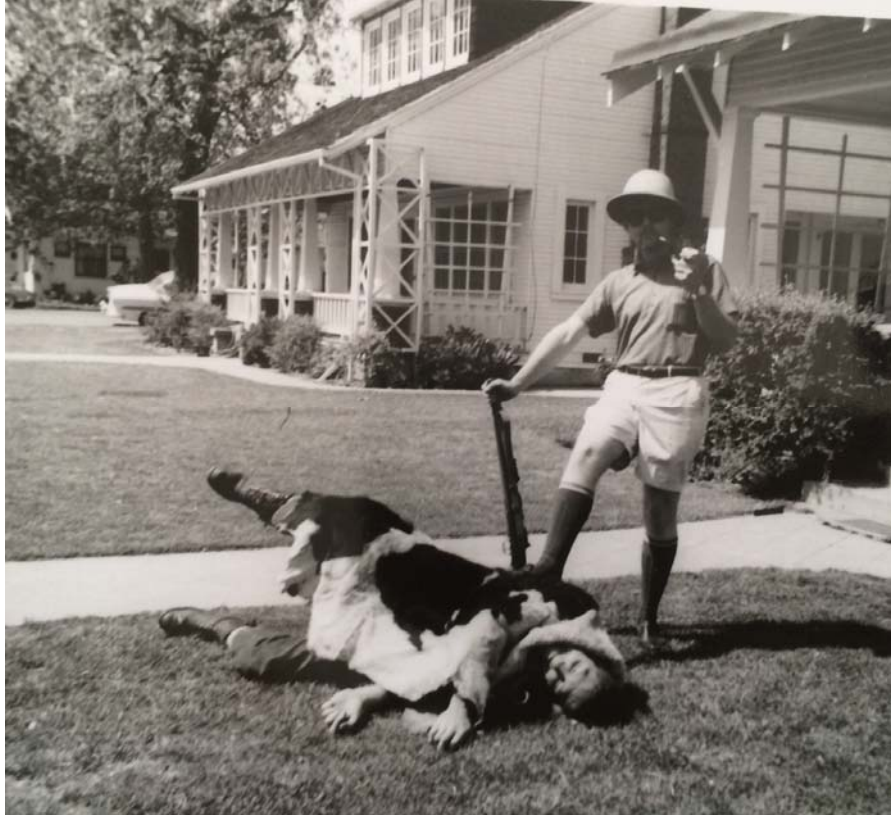
FIGURE 12: View looking west at 503 1st Street in the background and 509 1st Street in the foreground with students performing a safari hunt, circa 1960s (courtesy Theta Xi Fraternity).

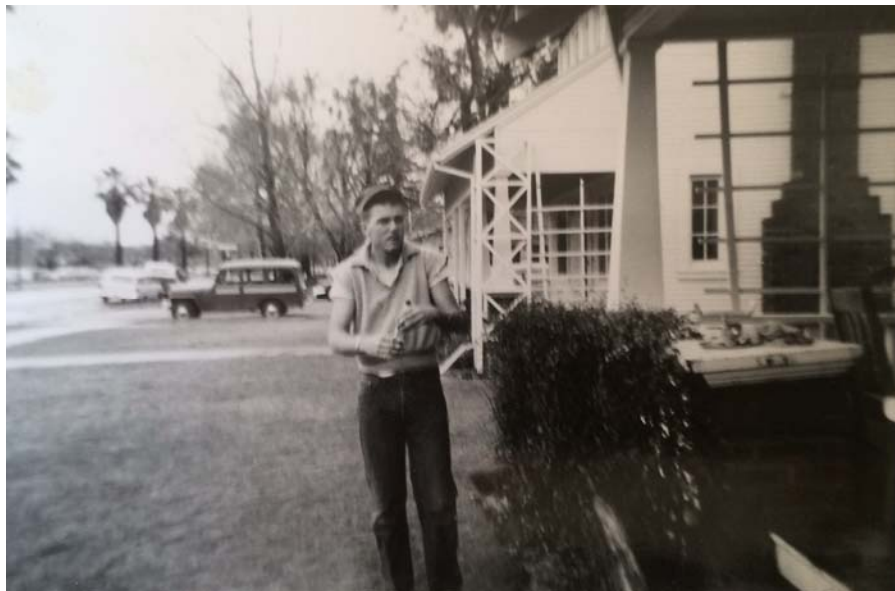
FIGURE 13: View looking west from 509 1st Street towards 503 1st Street, 1958. Note the brick chimney on the right that has since been removed on 503 1st Street (courtesy Theta Xi Fraternity).

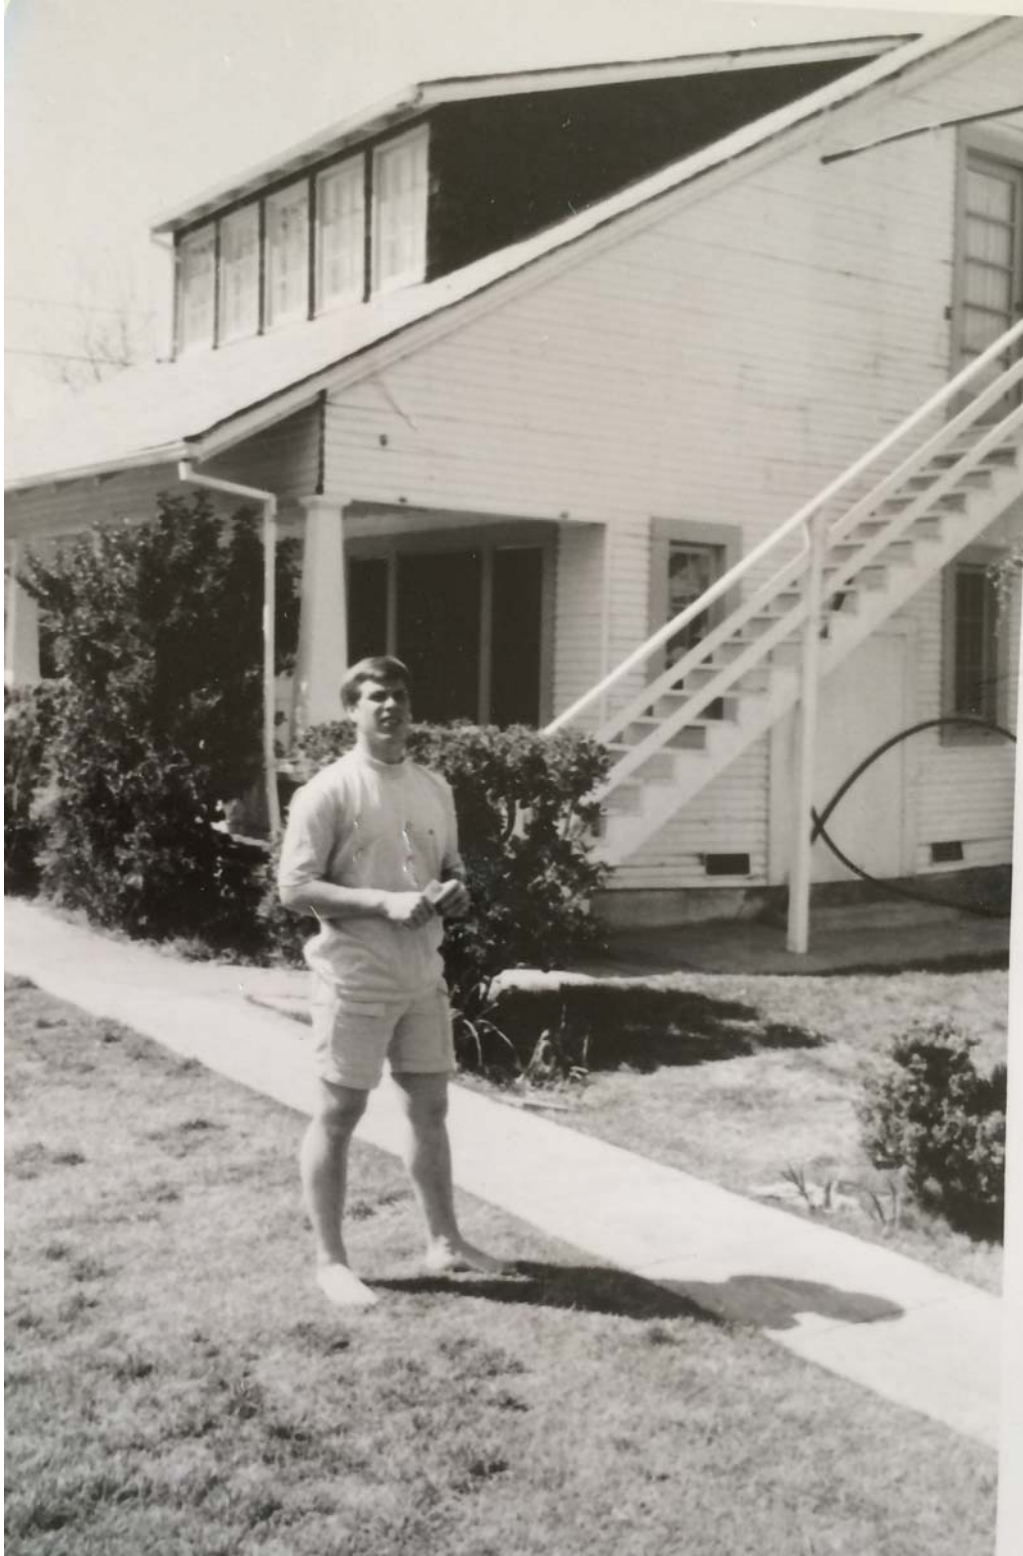
FIGURE 14: View looking west towards 503 1st Street in the 1980s depicting the added side entrance exterior stairway after opening the attic area to create dorm rooms (courtesy Theta Xi Fraternity).

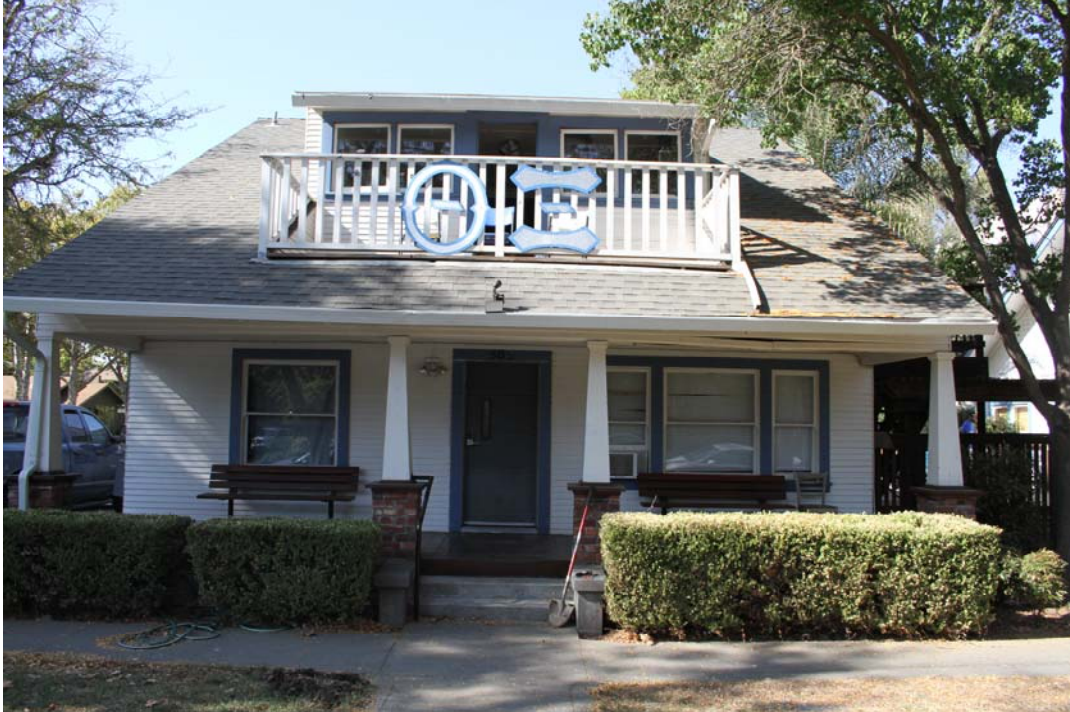
FIGURE 15: Current view of 503 1st Street with the rooftop veranda conversion.

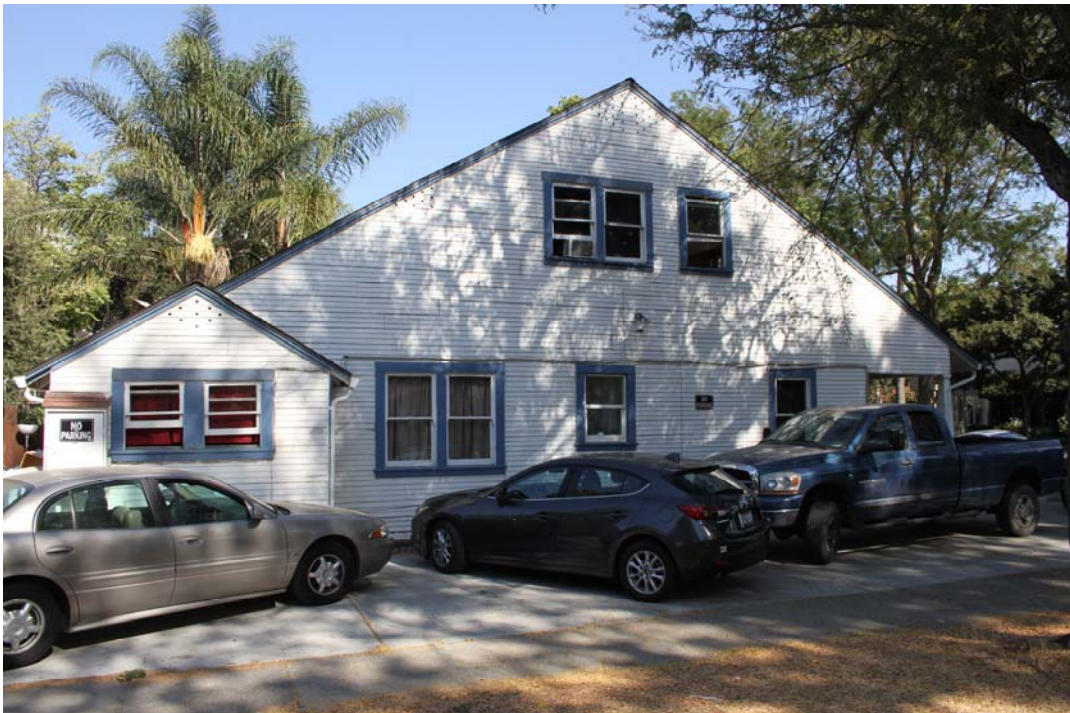
FIGURE 16: View looking east at the west elevation of 503 1st Street with the extended porch enclosure and addition of windows, including adding windows to what was once an attic on the second floor.

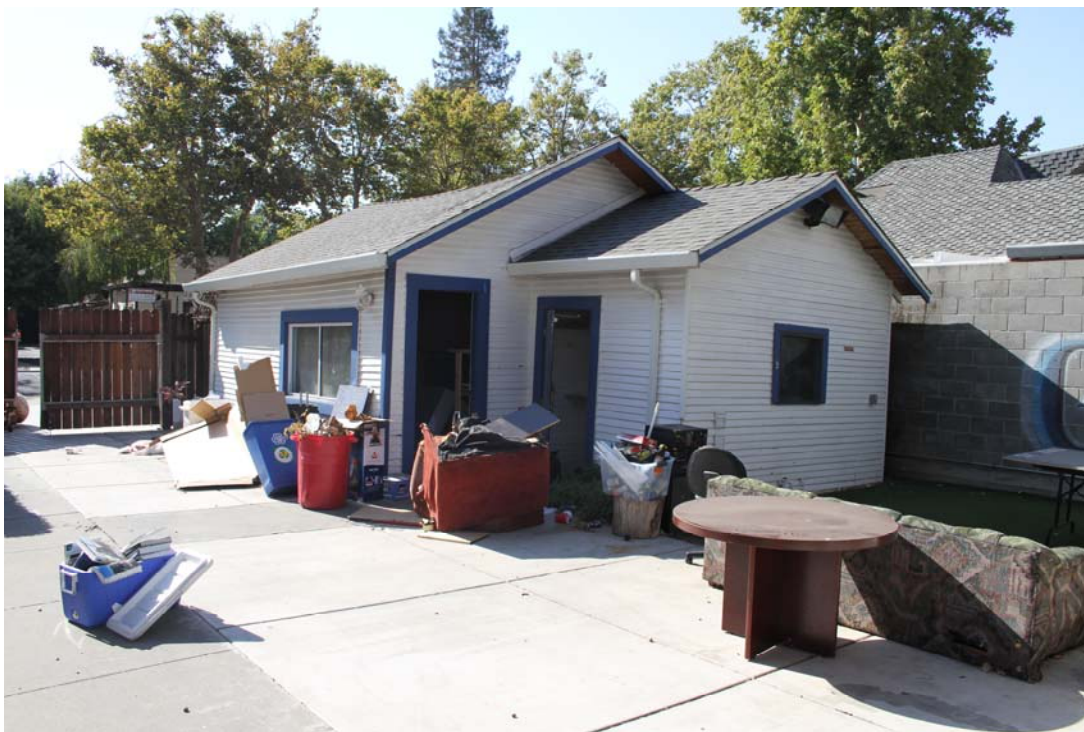
FIGURE 17: View looking west at the shed/garage with the later addition behind 503 1st Street.

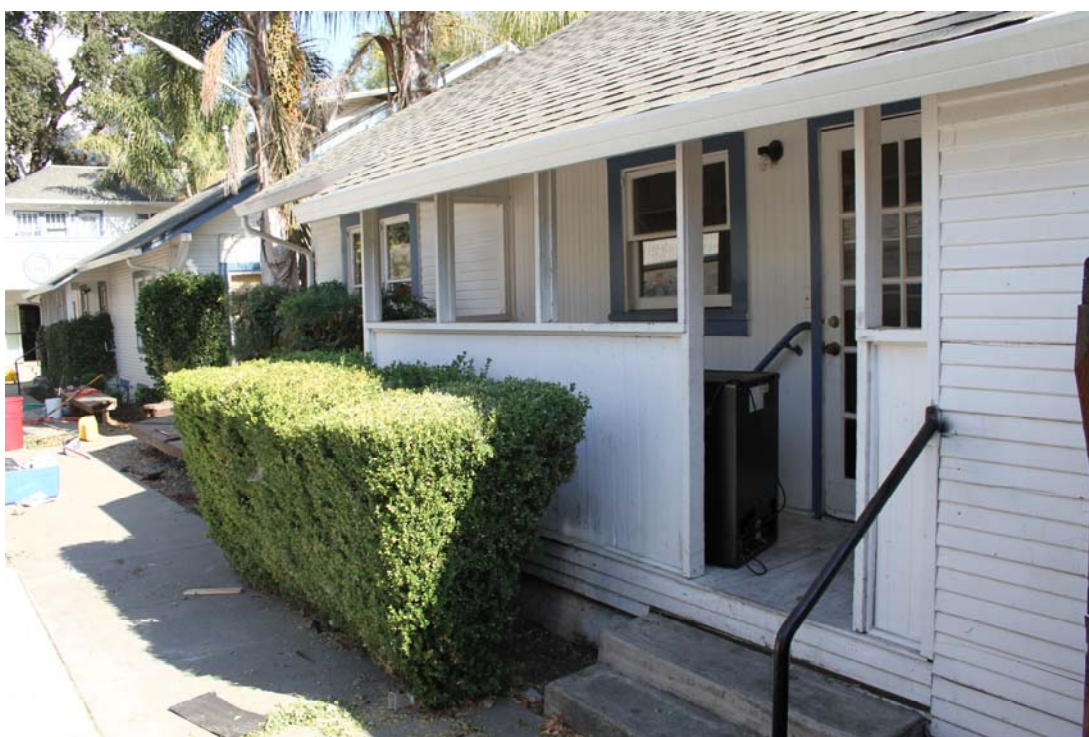
FIGURE 18: View looking east at the rear of 503 1st Street.

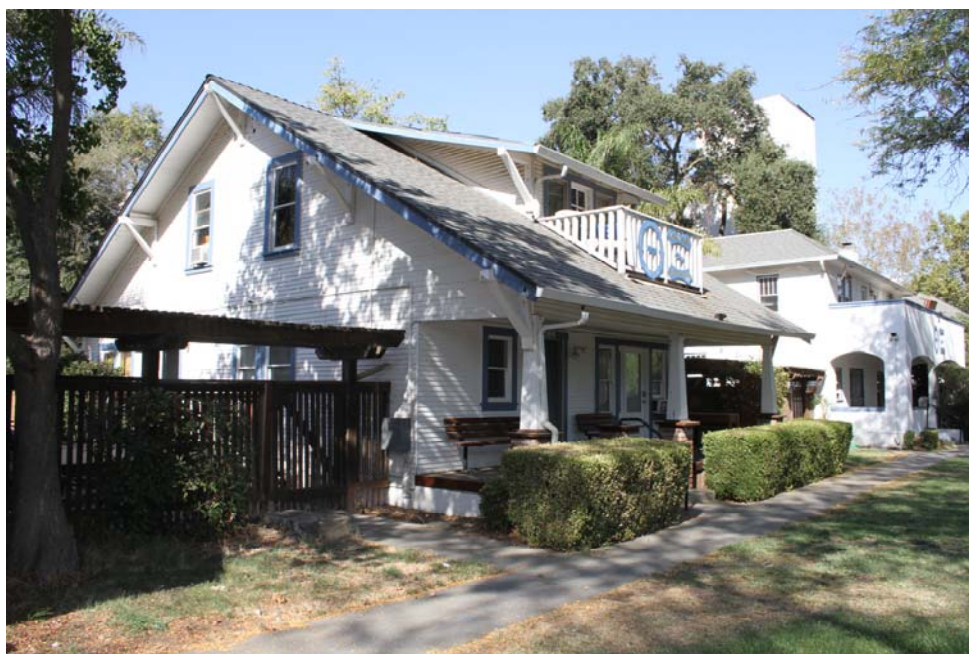
FIGURE 21: Current view of the property compared to a similar view in Figure 20, looking northeast at 509 1st Street with 515 1st Street in the background.

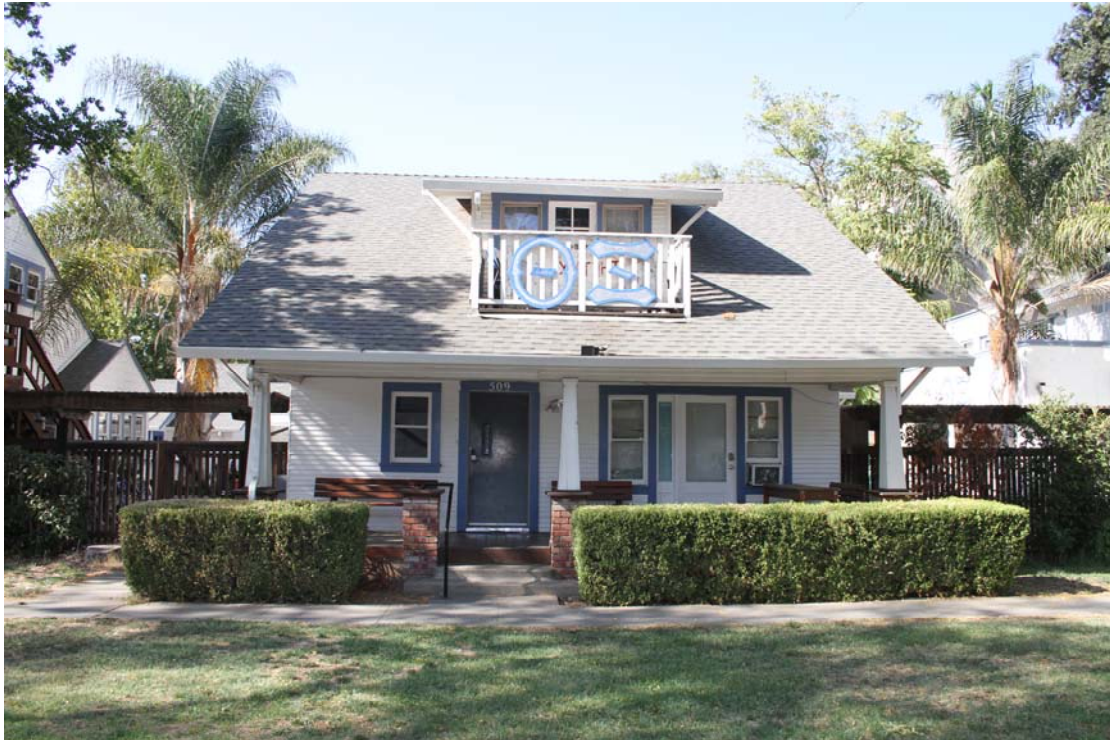
FIGURE 22: Current view looking north at the front elevation of 509 1st Street.

Based upon historic photographs, 509 1st Street, unlike 503 1st Street, appears to have had a rooftop balcony accessed from the central roof-top dormer. This would suggest the home was built with a second-story living area. The current railing (Figures 22 and 23) is a more recent addition, as is the second door to the right of the replaced front door. It should also be noted one of the truncated wood columns is missing, and, like 503 1st Street, the brick fireplace was removed from the east wall. 509 1st Street also features a basement.

509 1st Street retains overall good integrity of design, materials, workmanship, association, setting, feeling, and location. The most serious alterations are the addition of a second door entrance on the front façade and removal of one of the original truncated wood porch columns. Much like 503 1st Street, the entire interior of 509 1st Street has been altered. While condition issues were addressed by Pemberton Engineering, none of those issues have dramatically altered the historic character of the residence. Structural issues, however, are identified throughout the residence, and the living environment for students is consistent with the age of the building.

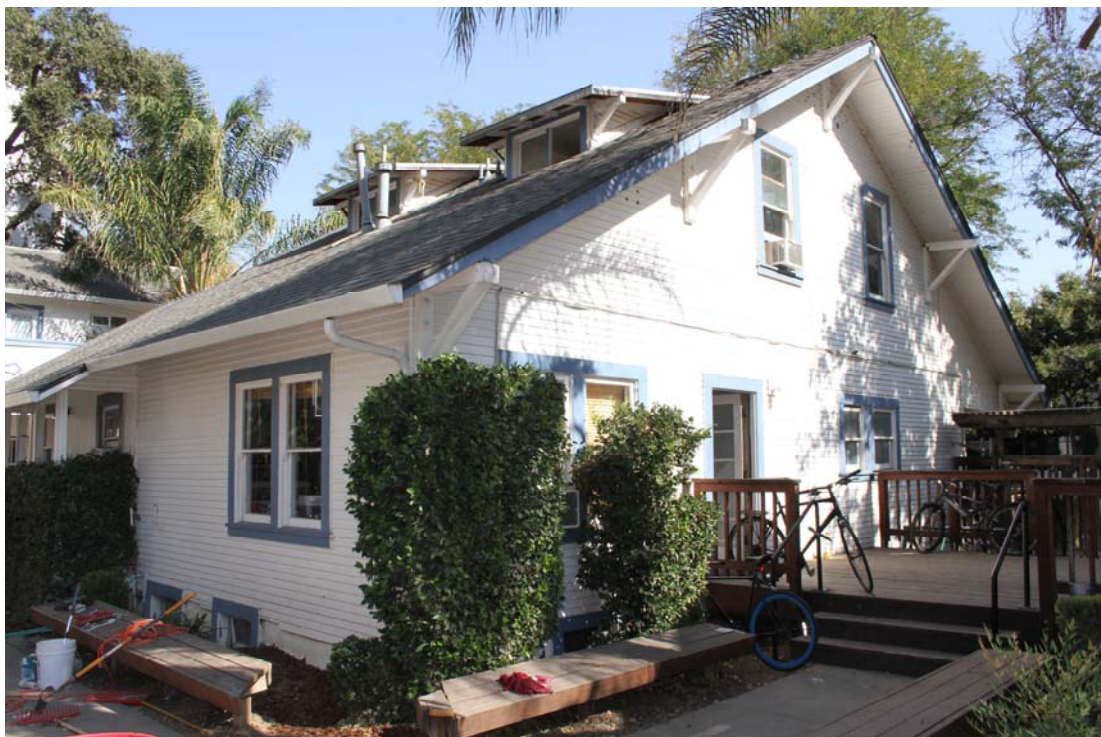
FIGURE 23: Current view looking southeast at the northwest elevation of 509 1st Street. Note the contemporary deck addition between 503 and 509 1st Street.

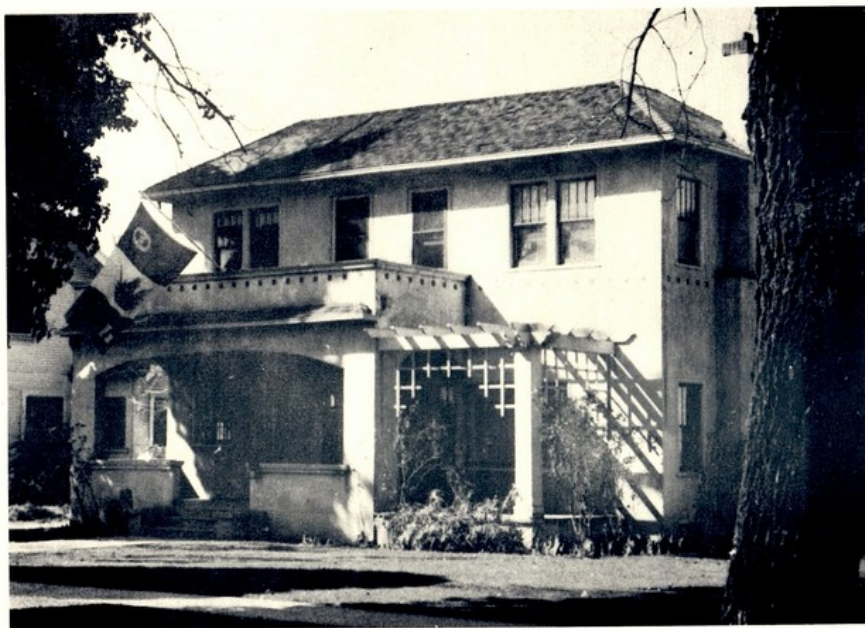
FIGURE 25: Photograph of 515 1st Street not long after its purchase by Theta Xi Fraternity in the 1950s. Note the half porch, clip roof off the porch, and pergola to the right (courtesy Theta Xi Fraternity).

The most dramatic change is to the front veranda, which was altered in the 1950s following acquisition by the Theta Xi Fraternity. The alteration involved demolishing the old porch, which extended half-way across the front of the building, followed by a decorative wood pergola. Instead, the replacement design featured a full front porch or veranda having two arches of unequal size, and a closed veranda wall on the second story that masks the fenestration, namely the doors and windows. A very detailed description of the structural elements of the residence is provided by Pemberton Engineering.¹⁶

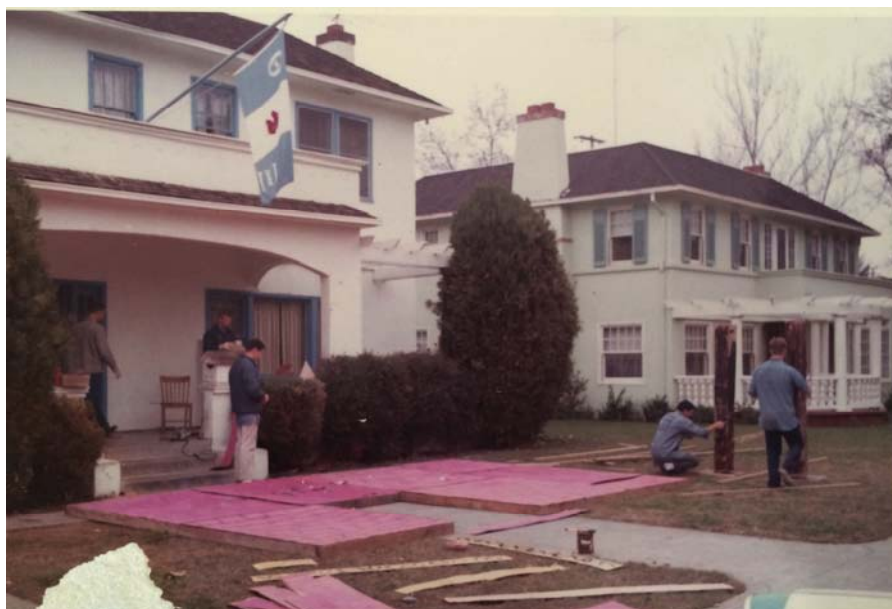
FIGURE 26: Photograph of 515 1st Street in the 1970s. Note that the half porch, clip roof off the porch, and pergola to the right still remain (courtesy Theta Xi Fraternity).

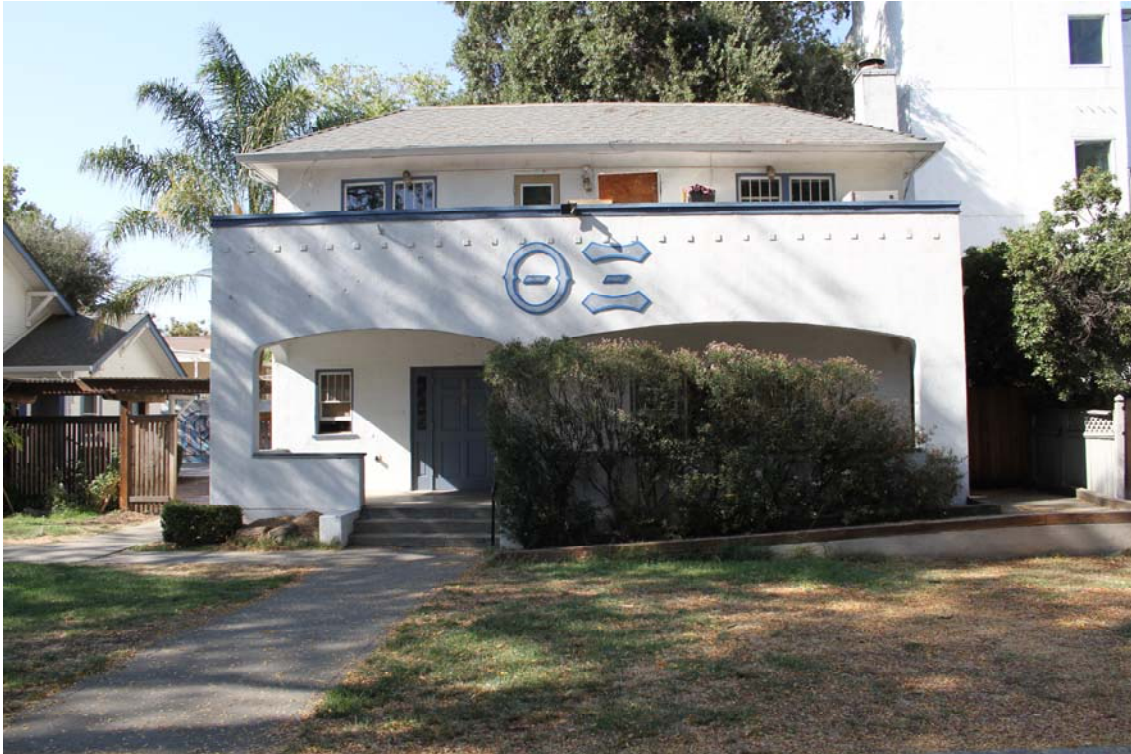
FIGURE 27: *Current view of 515 1st Street with the altered veranda.*

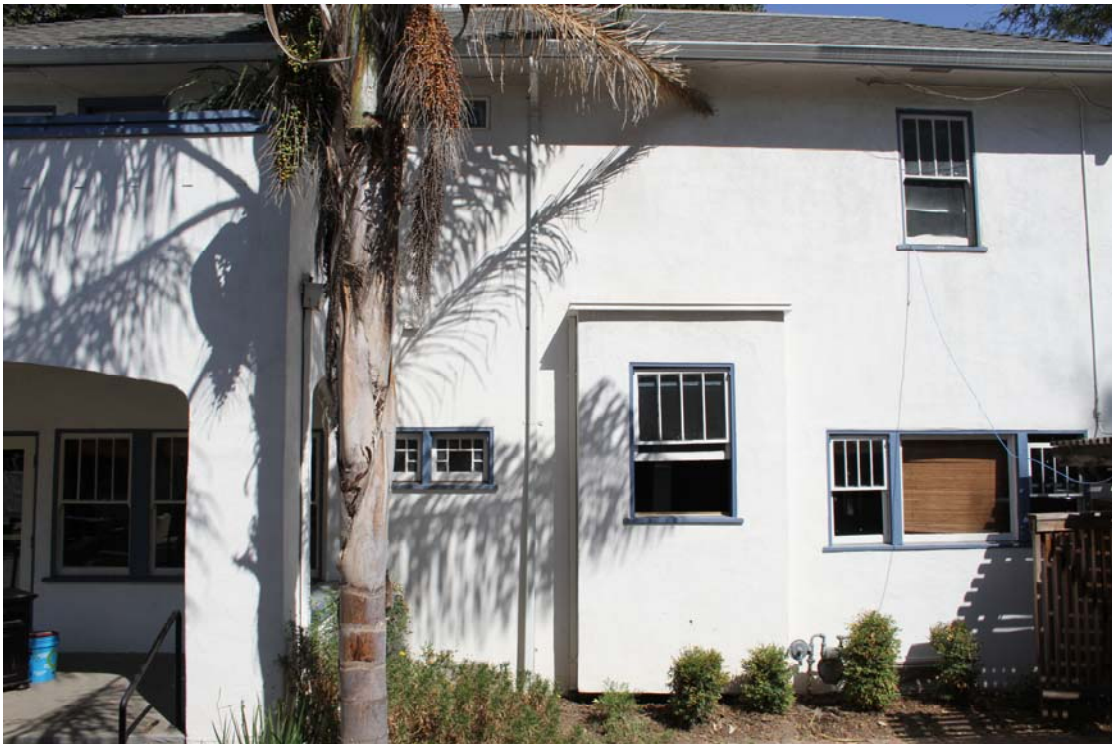
FIGURE 28: *Current view of 515 1st Street, looking east at the west elevation.*

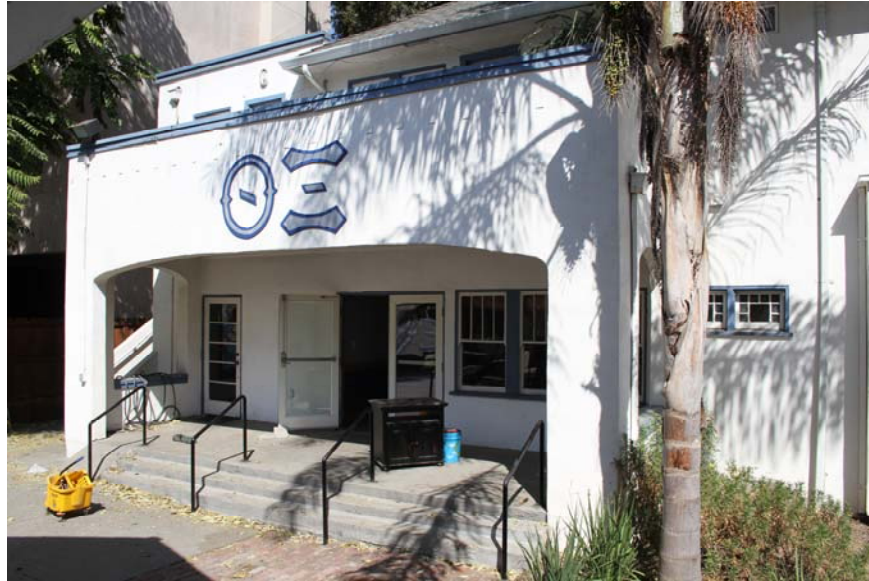
FIGURE 29: Another view of the west elevation of 515 1st Street showing the side veranda, probably remodeled the same time the front porch was reconstructed.

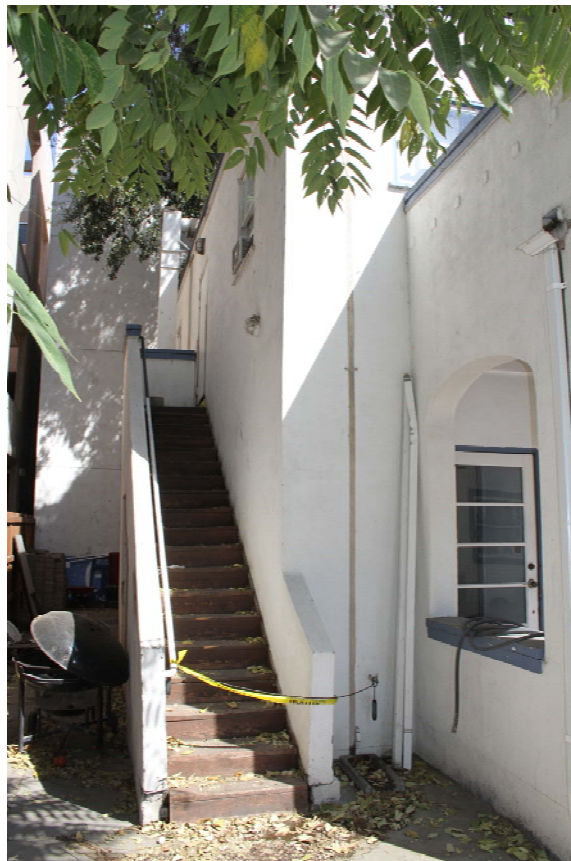
FIGURE 30: View of the north elevation of 515 1st Street. The rear stairway was apparently added when the porches were altered to provide outside access to the second story.

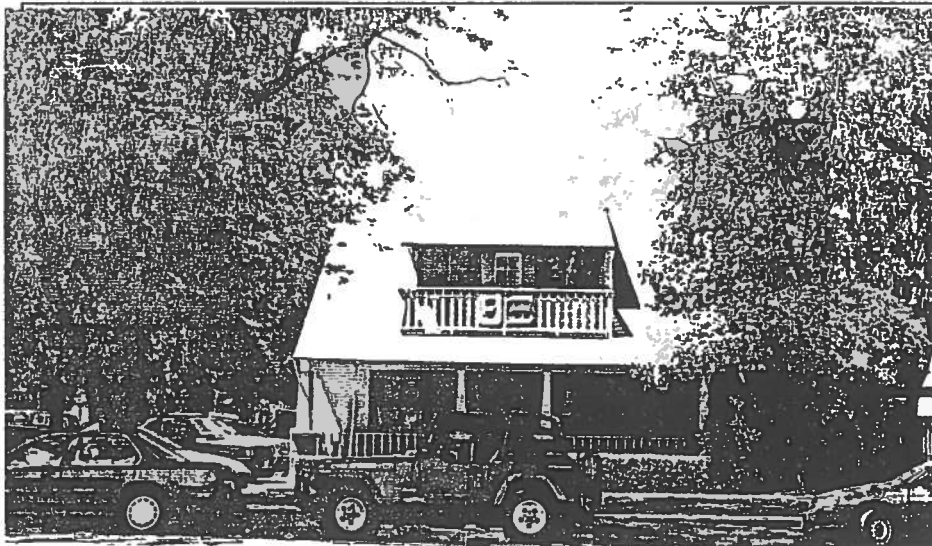
P5b. Description of Photo: (View, date, etc.)
Front elevation
Looking North
