Jurisdictional Delineation Report
for the
Mace Ranch Innovation Center Project

Yolo County, CA

Sycamore Environmental Consultants, Inc.
6355 Riverside Blvd., Suite C
Sacramento, CA 95831
Phone: 916/ 427-0703
Contact: Mike Bower, M.S., PWS #2230

3 February 2015

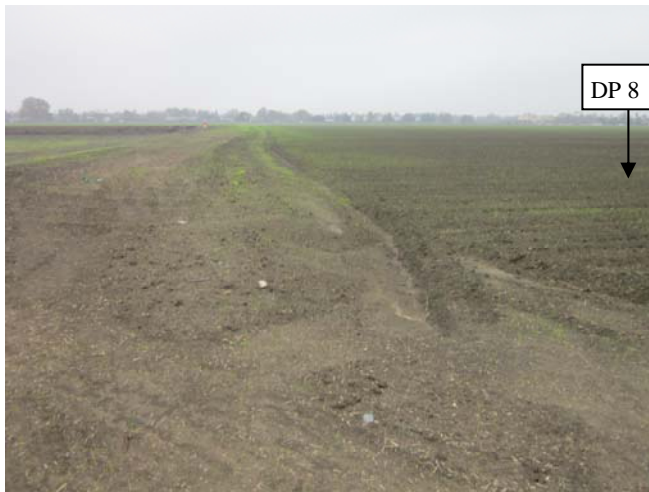
Photo 1. View south from near the center of the PSA. The PSA is dominated by tilled uplands. Arrow indicates approximate location of Data Point 8. 10 December 2014.

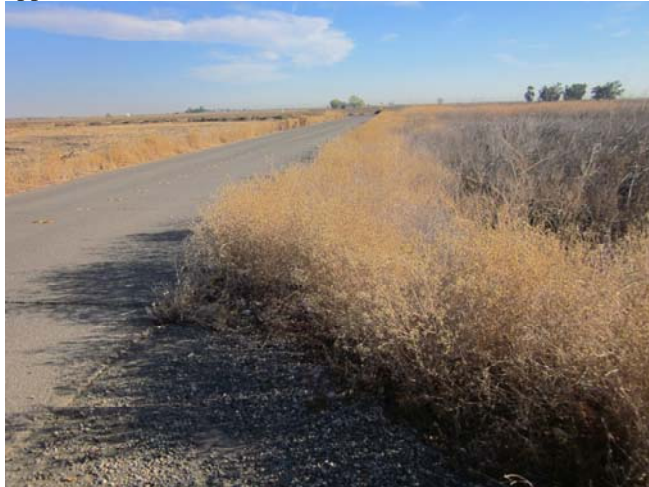
Photo 3. View north along the Davis Park and Ride driveway, in the southern portion of the PSA. Ruderal weeds occur on either side of the driveway. 7 October 2014.

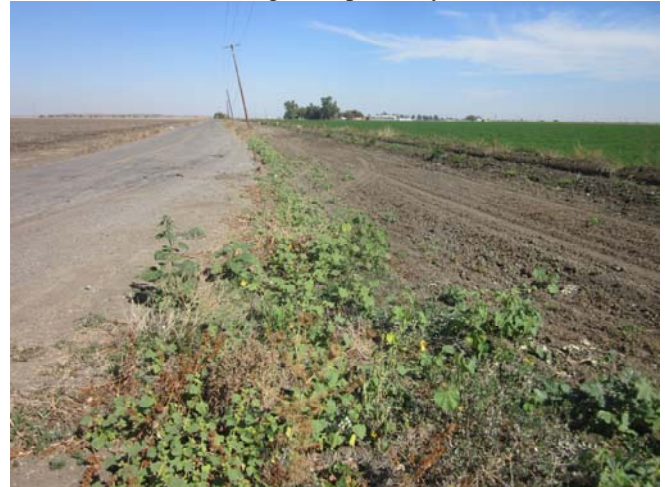
Photo 4. View north along Road 104 along alternative sewer line extension in north part of PSA. Agricultural fields occur along both sides of the road. 7 October 2014.

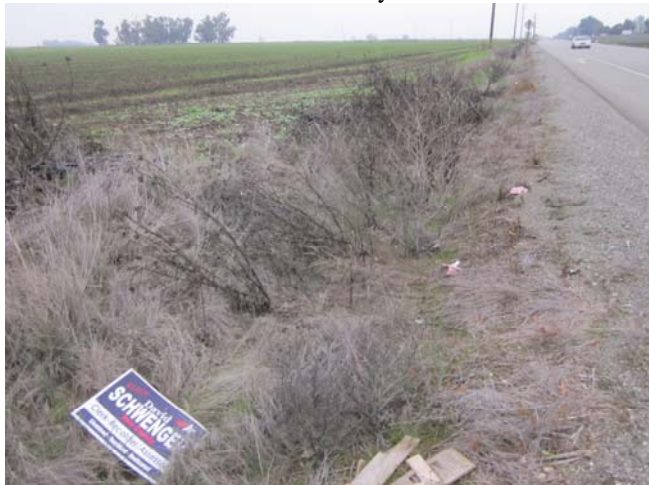
Photo 5. View east along the north side of Road 32A in southern portion of the PSA. 10 December 2014.

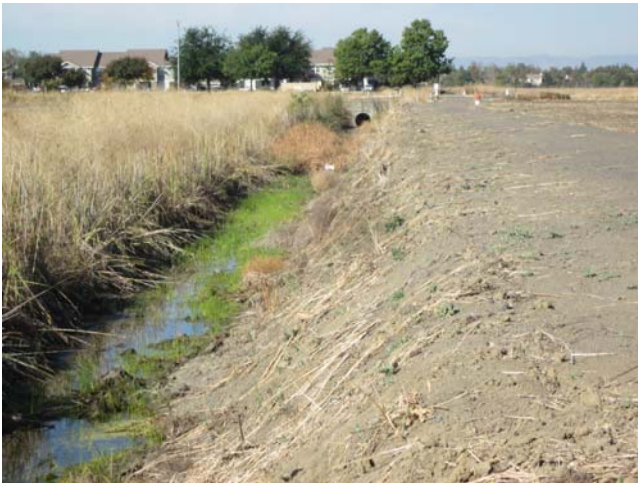
Photo 7. View west toward Mace Drainage Channel in western portion of the PSA. One of two culverts that pass water beneath Mace Blvd visible in distance. 7 October 2014.

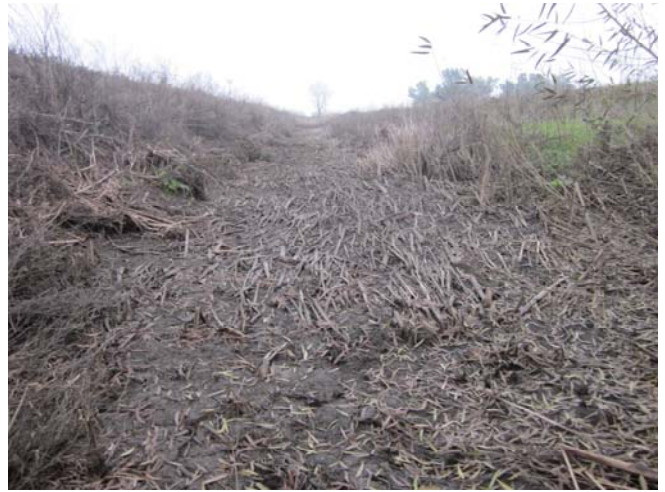
Photo 8. View east (looking downstream) from the bed of Mace Drainage Channel in the central portion of the PSA. 10 December 2014.

- On 10 December 2014, after 3.5 inches of rain in the preceding 12 days, the MDC was dry except for 0-12 inches of standing water in the western half of the MRIC site. The channel was dry in the center of the MRIC site and to the east along the eastern sewer line alternative. Downstream and east of the PSA, the channel was dry in all portions visible from Road 105. The only water observed in the MDC was in the western half of the MRIC site, near Mace Blvd.

- On 23 December 2014, after additional major rain events, the MDC was dry except for 0-16 inches of standing water in the western half of the MRIC site (deeper than on 10 December because some debris was obstructing drainage). The only water observed in the MDC was in the western half of the MRIC site, near Mace Blvd.

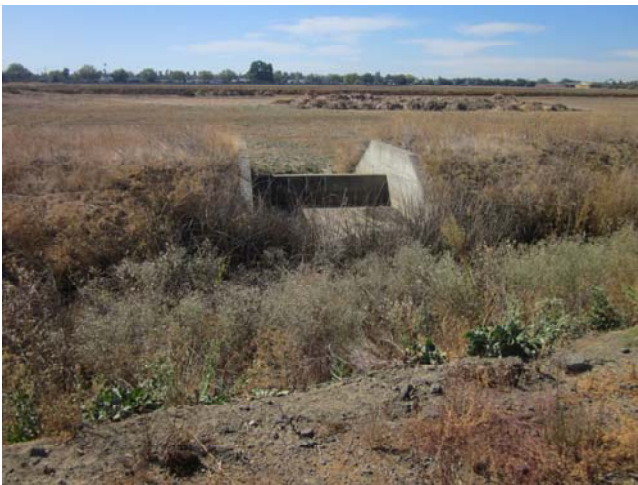
Photo 9. View southwest toward the detention basin. Mace Drainage Channel in foreground. Vegetation recently removed from Mace Channel has been deposited in detention basin in background. 7 October 2014.

Prior to 2014, the detention basin had never been observed with standing water (pers. comm., D. Ramos). None of the aerial photographs available in Google Earth show standing water in this feature. On 10 December 2014, wracking was observed along the northern and eastern sides of the detention basin at an elevation indicating that two to three feet of water had recently inundated the basin. The wracking was not observed along the edge of the basin on 7 October 2014 and most likely originated

from the piles of vegetation that were removed from the MDC and placed in the basin earlier in 2014. A partially blocked culvert just downstream of the spillway in the MDC at the eastern edge of the MRIC site could have caused water levels in the ditch to overtop the spillway, which would have flooded the basin.

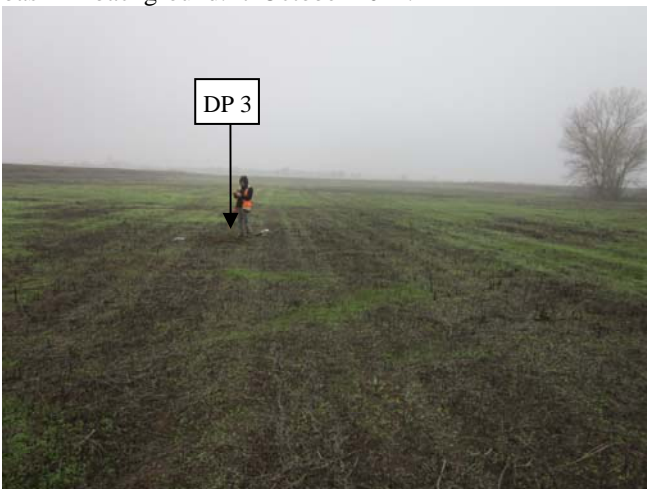
Photo 11. View west from near the center of the detention basin. The arrow shows the location of Data Point 3. 10 December 2014.

No surface water or saturated soils were observed in the detention basin on 10 December 2014 despite over 3.5 inches of rain within the 12 preceding days (NOAA 2014), and evidence of 2-3 ft of inundation. Soil pits excavated throughout the basin showed that much of the basin is underlain by permeable sand and silt. Vegetation in the detention basin was dominated by perennial pepperweed, prickly lettuce (*Lactuca serriola*), milk thistle, poison hemlock, yellow star-thistle, hairy hawkbit (*Leontodon saxatilis*), curly dock (*Rumex crispus*), clover (*Trifolium* sp.), redstem filaree (*Erodium cicutarium*), and immature grass seedlings (most likely nonnative annual grasses). The detention basin does not contain wetlands or waters.

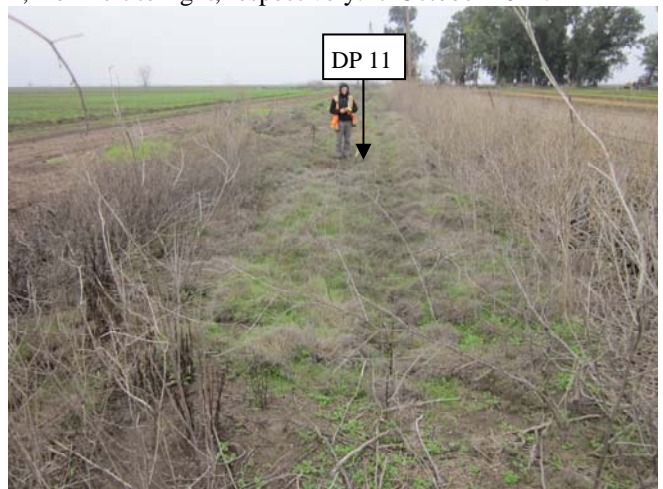
Photo 12. View north along untilled eastern edge of the PSA. The arrow shows the location of Data Point 11. 10 December 2014.

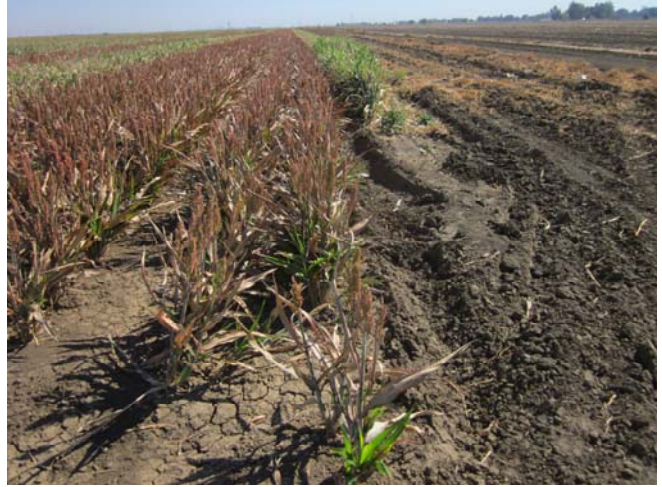
Photo 13. View west toward Data Point 13 in the northeastern portion of the PSA. 10 December 2014.

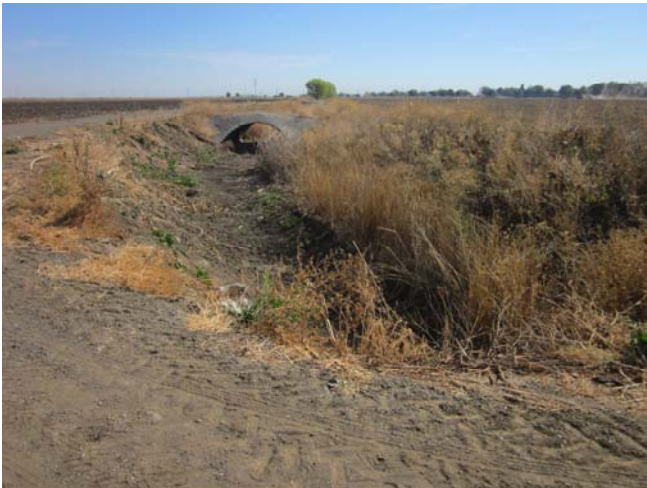
Photo 15. View east from the eastern edge of the MRIC site toward the Mace Drainage Channel (looking downstream) along the sewer line alternative. An open bottom arch crossing visible in distance. 7 October 2014.

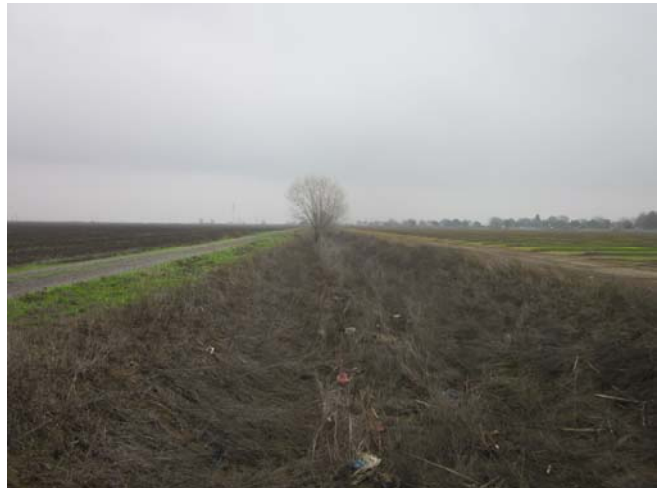
Photo 16. View east toward the Mace Drainage Channel from the eastern arch crossing, in the eastern portion of the PSA along the sewer line alternative. Ruderal weeds dominate the bed and banks of the channel. 10 December 2014.

Bed and Banks: The bed and banks of MDC are earthen and vegetated in the PSA. On the MRIC site, the bed is vegetated with freshwater marsh species (regularly removed as described above) and the banks are vegetated with ruderal species. East of the MRIC site, both the bed and banks are vegetated with ruderal species. The bed is roughly 6-8 ft below the top of the banks. An ordinary high water mark (OHWM) caused by the fluctuations of water is present within the MDC in the PSA. The OHWM was identified by the following indicators (Corps 2005): presence of litter and debris, wracking, vegetation matted down, leaf litter disturbed or washed away, and change in plant community.
