## SYCAMORE ENVIRONMENTAL CONSULTANTS, INC.

22 June 2015

***Subject: Biological Survey of APNs 033-300-011, -015, and Portion of 033-650-088 for Stormwater Capacity for the Mace Ranch Innovation Center Project, Yolo Co., CA.***

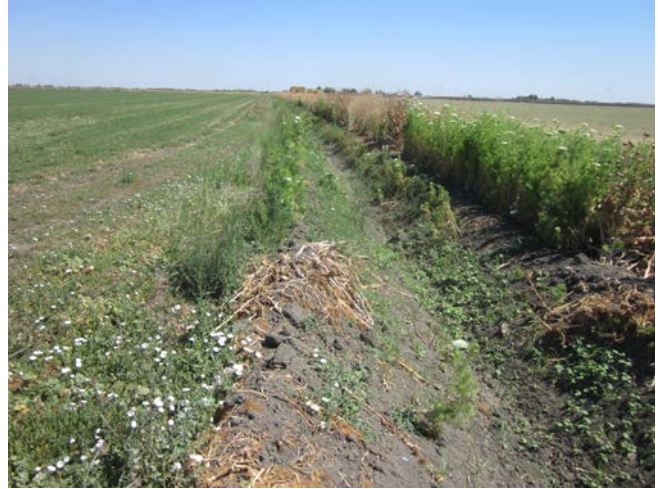
Photo 2. View north along border between APN 033 300 001 and 033 300 015. Typical dry irrigation ditch between fields of alfalfa (left) and wheat (right). 11 June 2015.

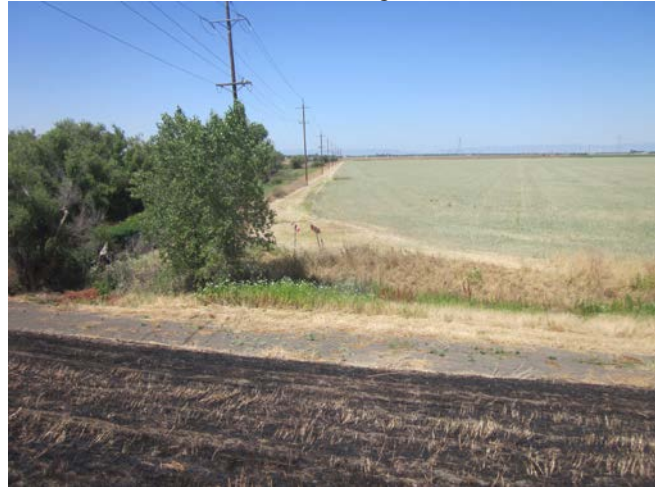
Photo 4. View west from atop the Yolo Bypass levee looking toward southeast corner of BSA with Railroad Channel on left and wheat field on right. 11 June 2015.

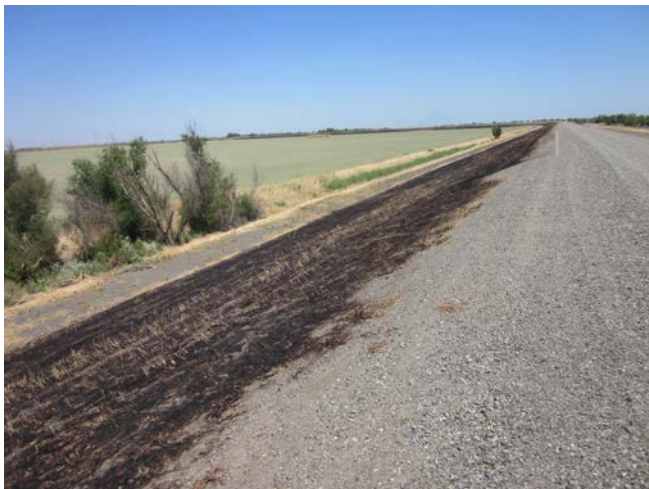
Photo 5. View northwest from atop the Yolo Bypass levee (recently burned). A few willows (*Salix* spp.) occur in a dry ditch on far left. 11 June 2015.

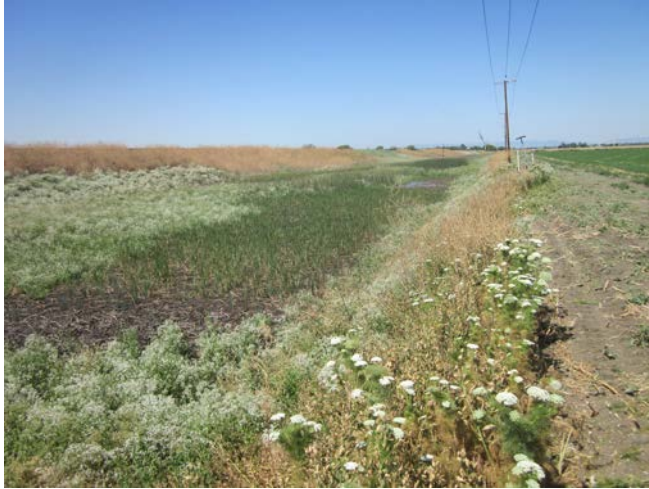
Photo 7. View west toward the Railroad Channel south of the BSA. Alfalfa field in BSA on far right. 11 June 2015.

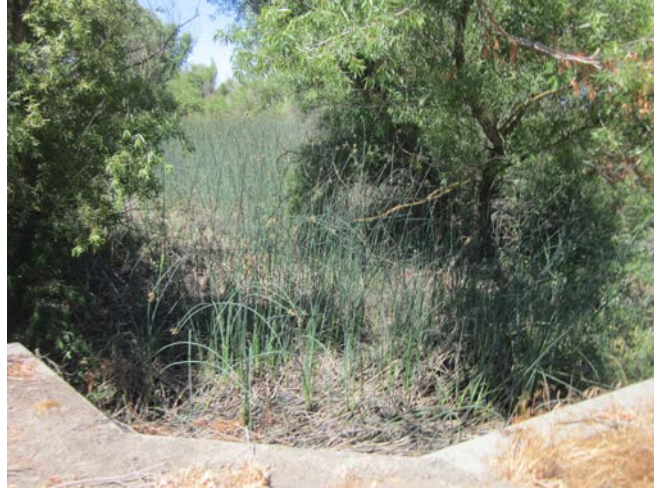
Photo 8. View west toward vegetation in the Railroad Channel near the Yolo Bypass levee. 11 June 2015.

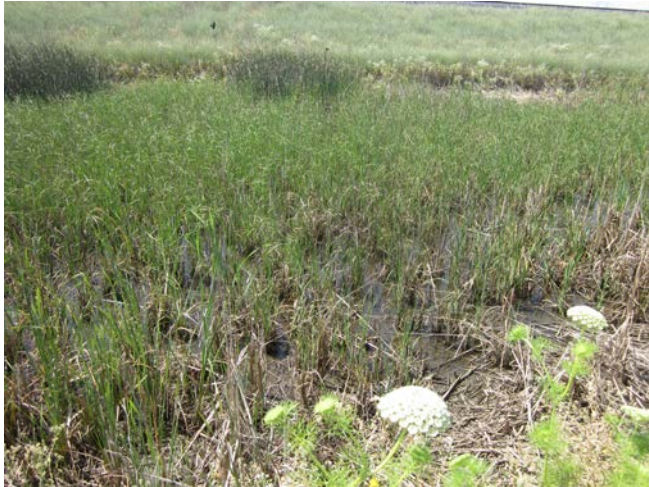
Potential aquatic habitat for federal threatened giant garter snake (GGS; *Thamnophis gigas*) occurs within 200 ft of the BSA in 1) the Railroad Channel to the south; 2) a channel in Willow Slough Bypass north of the levee; 3) a channel on the east side of the Yolo Bypass levee; 4) created wetlands north of Road 30; and 5) an existing detention basin on APN 033 650 006. These features are shown on the map in Attachment A. All of these features contain emergent aquatic vegetation, basking habitat, and water, or at least evidence of frequent inundation during the GGS active season (early spring through mid fall). Minor irrigation ditches occur along field edges in the BSA. These ditches were dry during fieldwork, do not contain emergent aquatic vegetation, and do not provide aquatic habitat for GGS.

Photo 9. View of Railroad Channel south of the BSA with  $\pm 2$  inches standing water, cattails (*Typha* sp.) and bulrush (*Schoenoplectus acutus*) present. 11 June 2015.

- During the active season (May 1 to October 1), the construction monitoring provision of the MRIC GGS mitigation measure should be implemented and a biological monitor should be present during work within 200 ft of aquatic habitat for GGS.
- During the inactive season (Oct 2 to April 30), no work should be conducted in areas within 200 ft of potential aquatic habitat for GGS.
- Temporary stockpiling of topsoil should not occur within 200 ft of potential aquatic habitat for GGS.

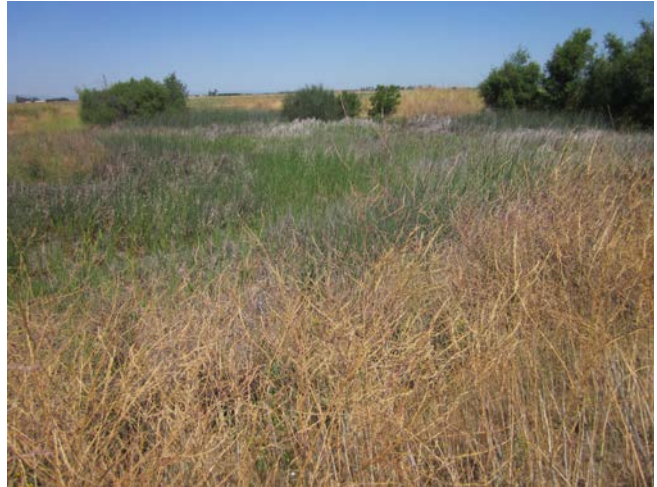
Photo 10. View north toward cattails, bulrush, and scattered willows in the detention basin located west of the BSA. No water present. 11 June 2015.

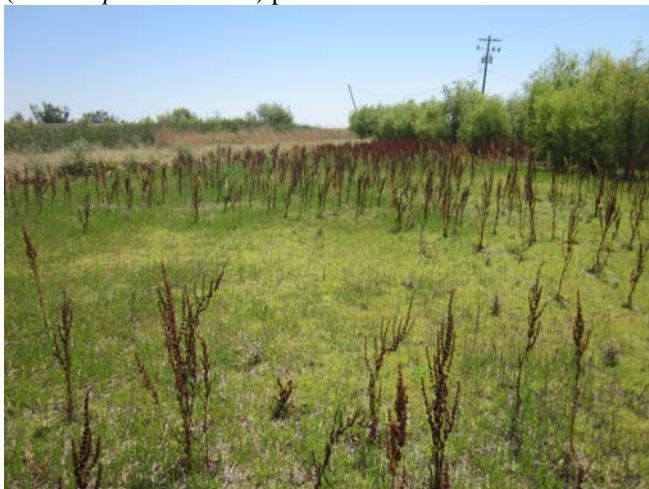
Photo 11. View east toward created wetlands north of the BSA. A row of young willows (*Salix* sp.) occur on right. Most of the created wetland area is dry. 11 June 2015.

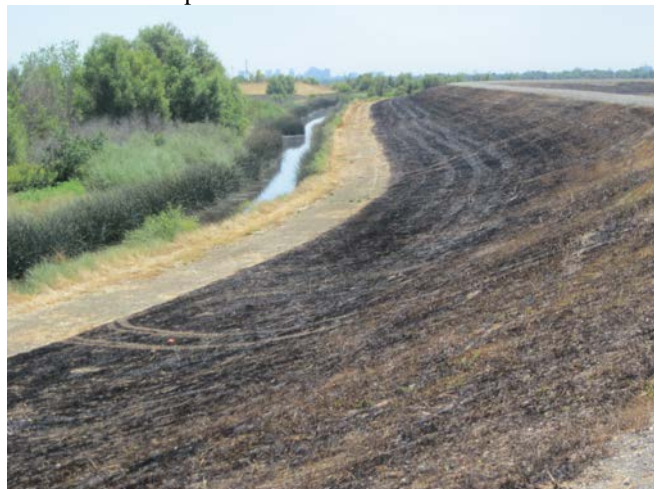
Photo 12. View toward channel in Willow Slough Bypass. The BSA is out of view on right, beyond levee. 11 June 2015.
