Staff Report

September 8, 2016

SUBJECT: Fifth Street Corridor Reconfiguration - Update

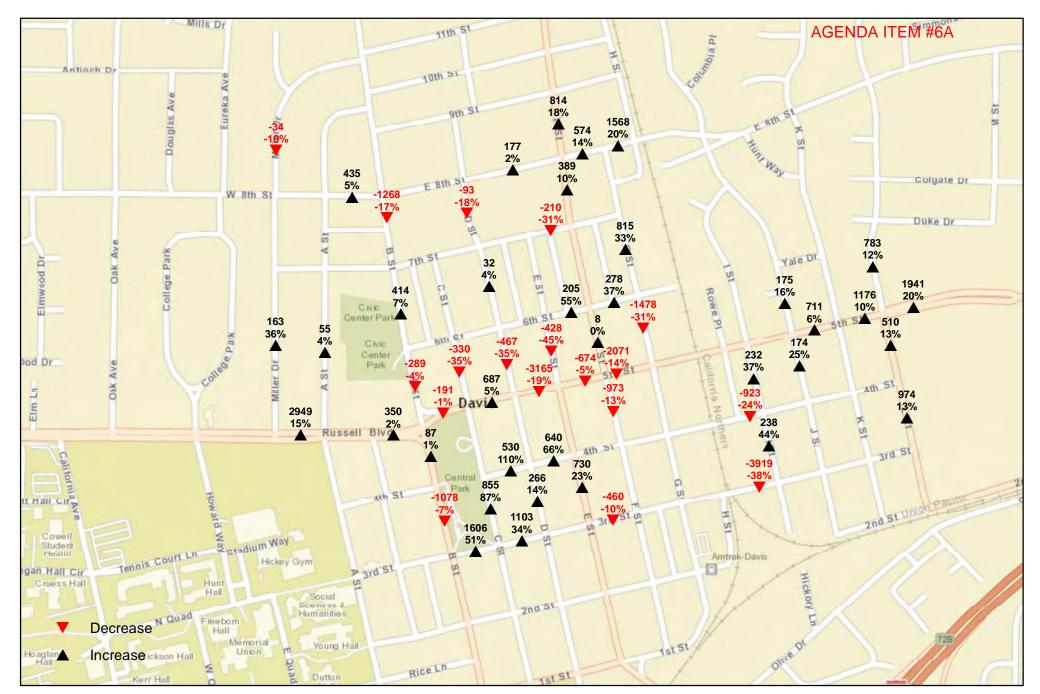
Change in Average Daily Traffic Post Fifth Street "Road Diet"

ADT Summary					
Total Vehicles 2012	315,208				
Total Vehicles 2016	319,801				
Difference	+4,593				
% Change	+1.5%				
	Total Vehicles 2012 Total Vehicles 2016 Difference

- Following is a summary of the traffic volume changes:
 - o Fifth Street decreased up to 19% west of the tracks, and increased up to 20% east of the tracks.
 - o E. Eighth Street east of F Street increased 14 to 20%.
 - o C, D, and E Streets south of Fifth Street increased by 14 to 87%, and decreased 35 to 45% north of Fifth.
 - o Third and Fourth Streets west of the tracks increased 34 to 110%, and decreased by 24 to 38% east of the tracks.
 - o I, J and L Streets increased 13 to 44%.
 - o Sixth Street increased 37 to 55%.
 - o Seventh Street decreased by 31%.
 - o Miller Drive south of E. 8th increased by 36%, and decreased by 10% north of E. 8th Street.

Please see attached Exhibit A for the vehicle volume changes (daily traffic).
