Attachment B

DEPARTMENT OF PARKS AND RECREATION 523 FORMS

Updates produced during current project attached to forms produced during previous studies

*P11. Report Citation: Davis, California: Citywide Survey and Evaluation of Buildings Constructed Prior to 1976

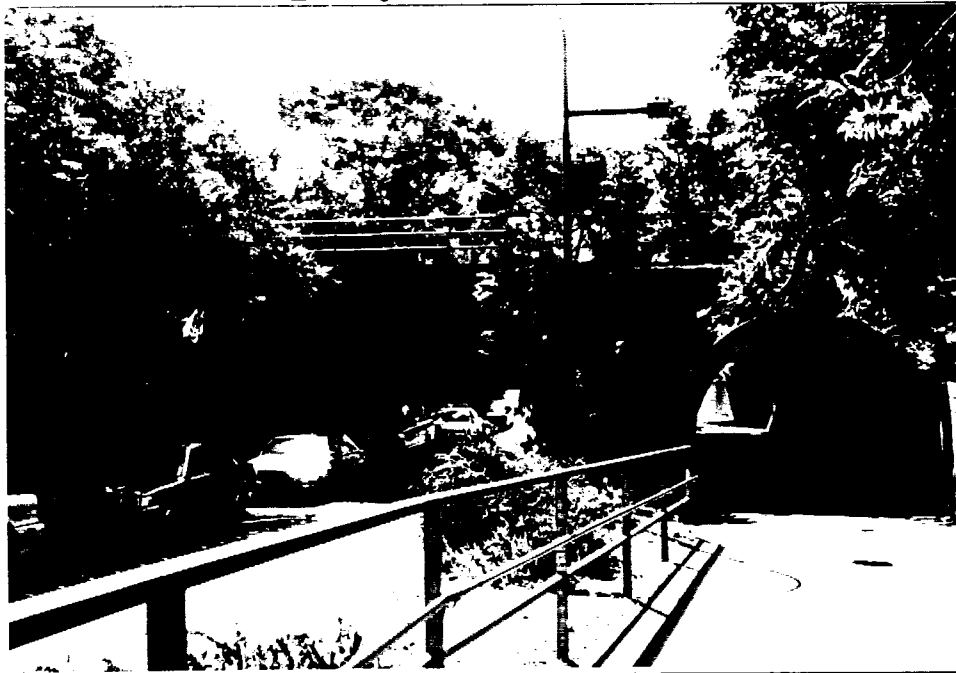
P5b. Description of Photo: (View, date, etc.)
Underpass

Looking Northwest

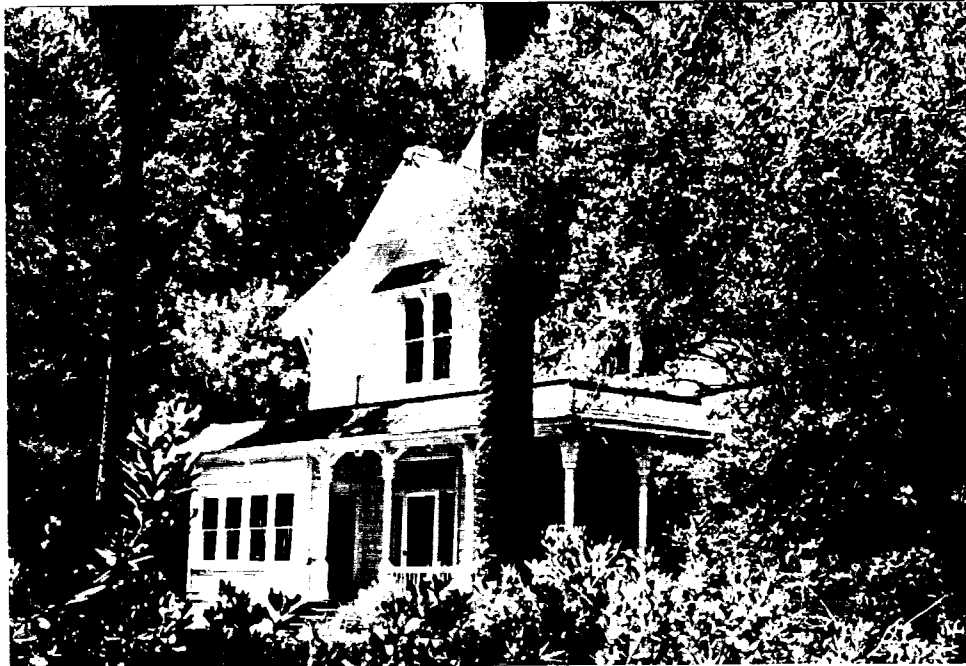
P5b. Description of Photo: (View, date, etc.)

Front facade

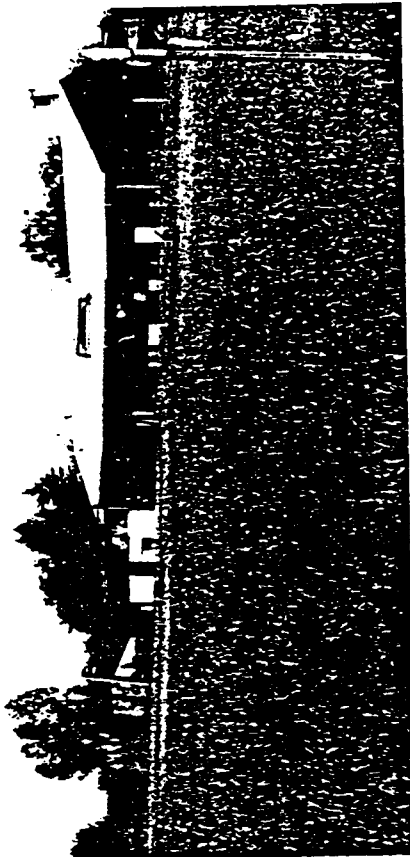
This one story, gabled building is unassuming in its image, and neo-vernacular in style. The wide over hangs reflect solar concerns, and the row of bright blue solar collectors behind the south-facing glass wall provide the primary visual interest.

Designed by Richard Bertaux with Living Systems, this building is a replacement for an earlier Longview School building that was destroyed by fire in 1974. The school building utilizes passive solar heating and cooling concepts. There are large metal culverts containing water which provide a thermal mass element. The use of wide over hangs and concrete slab floor are also elements of the energy conservation system. The parents did much of the construction and installation of the solar system.

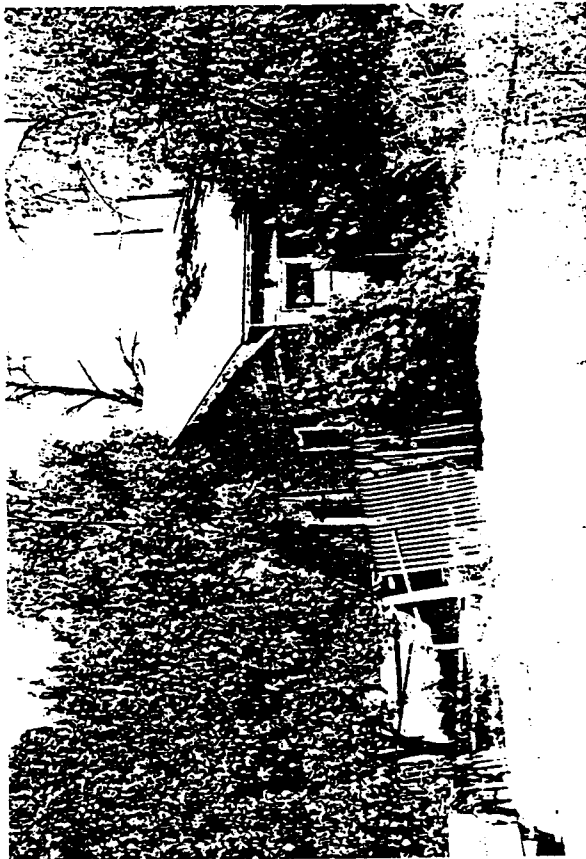
This one story cottage, almost completely obscured by planting, makes early Craftsman and Colonial Revival reverences. The house is quite narrow, and is roofed by a single gable, with the gable ends on the wide, rather than the narrow sides. This creates an unusual form with contrasting massive and tiny aspects.

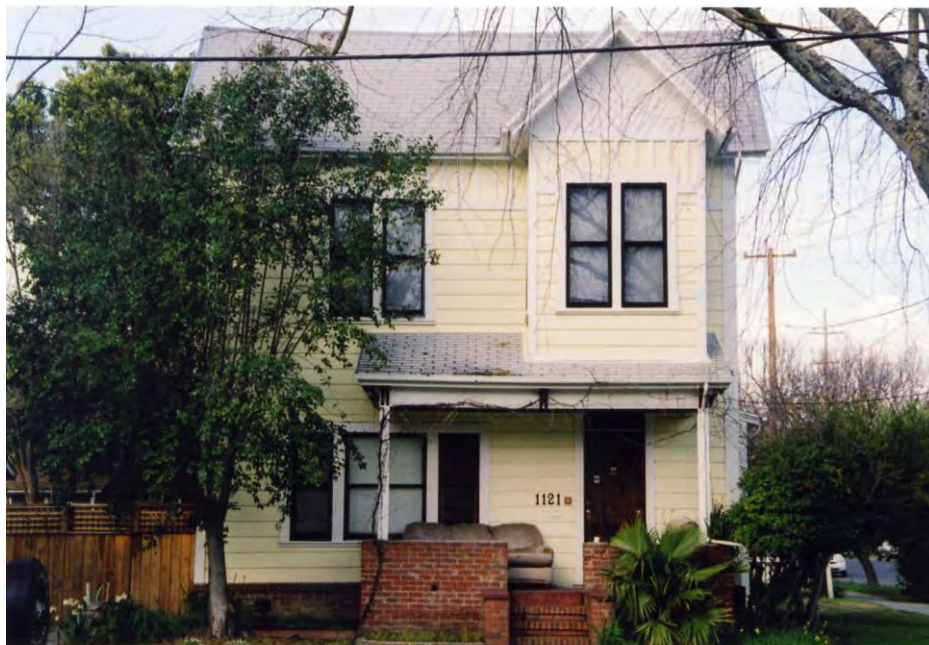
This tall, two-story vernacular farm house has a steeply pitched side gable roof with projecting second story dormer, also with a steeply pitched gable. The gable is trimmed with a plain fascia and the gable end is finished with horizontal stickwork. A shallow, replacement brick porch with a closed brick rail is covered by a projecting shed roof on which the second story projecting dormer rests. The shed porch roof is supported on 4X4 posts. The porch roof appears original in design and form. Windows are strongly vertically emphasized and consist of one-over-one double hung paired and single examples. The lower story front window consists of a large central double hung window flanked by narrow side lights. The house is clad with channel siding. Although there have been some alterations, most notably the replacement of the original porch and porch rail, the house retains its integrity. Although there is no documented construction date, the 1933 assessor record indicate that the house was over 50 years old, which would place it in the 1880s.. It contributes to the character of the neighborhood and may contribute to a multiple property district of Victorian/19th century houses in Davis. .

P5b. Description of Photo:

View north

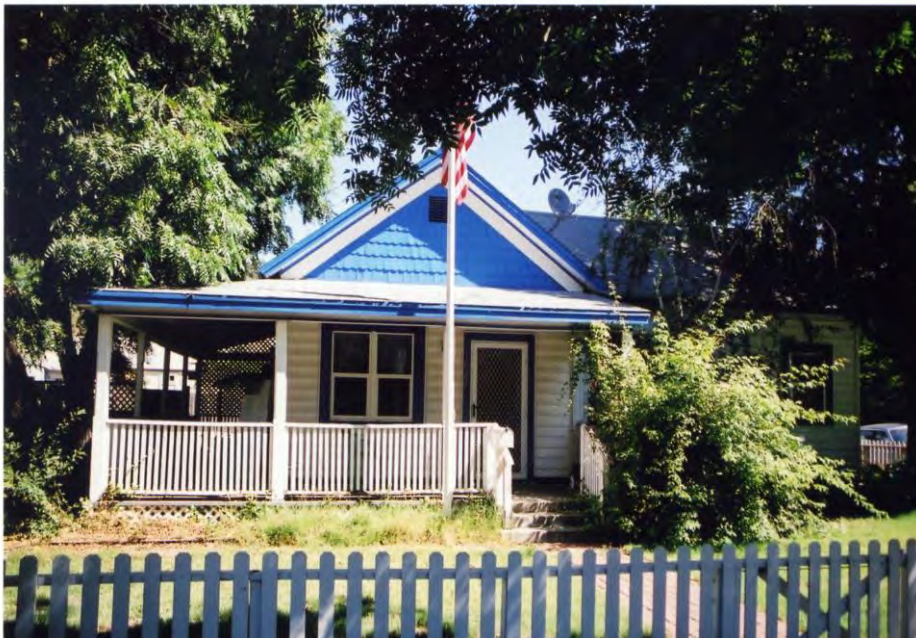
P5b. Description of Photo:

View east

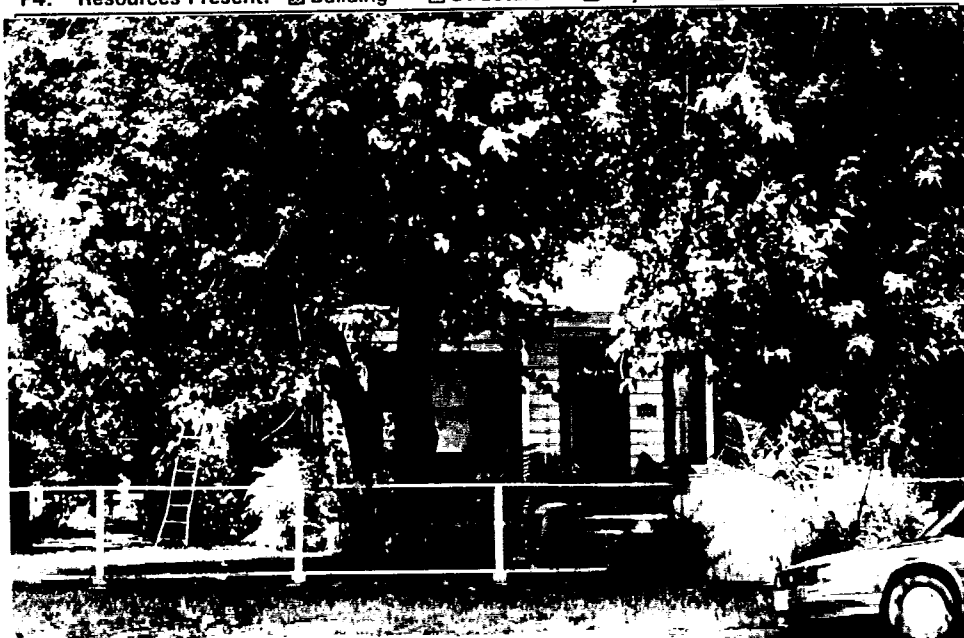
This one story vernacular house has a single gable roof form with the ridge placed parallel to the street. Although apparently vernacular in origin, the building has a collection of elegant details, primarily in its eave and fascia moldings. There is a verandah which covers the entire street facade. The form and details are derived and abstracted from the Greek Revival style. The house is in fair condition and is painted white at the present.

*P5b. Description of Photo: (View, date, etc.)
Front Facade

Looking North

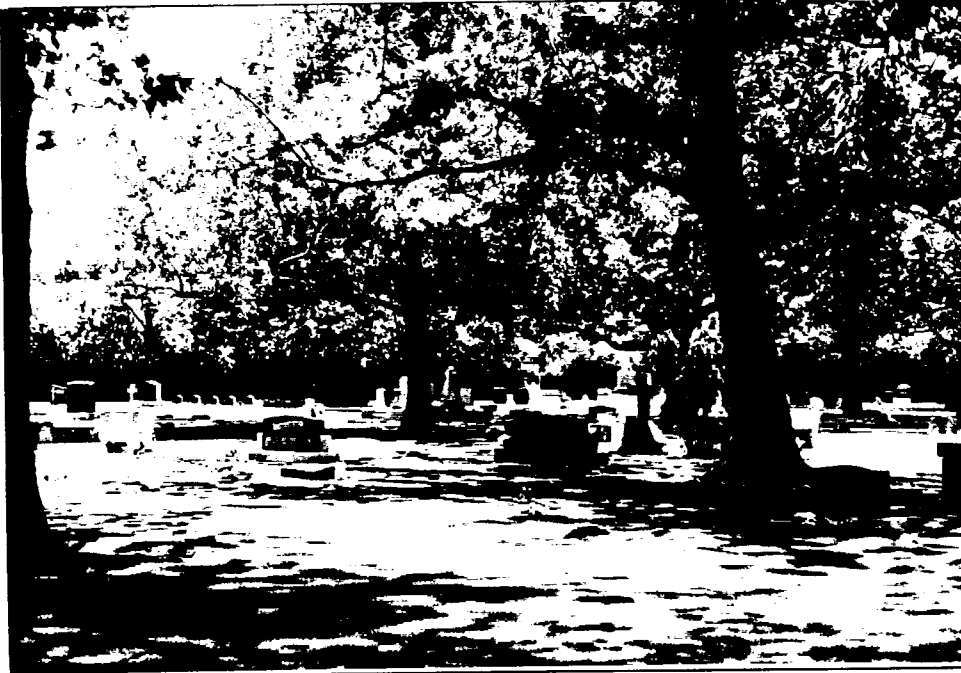
*P3a. Description: (Describe resource and its major elements. Include design, materials, condition, alterations, size, setting, and boundaries.)
The Davis Cemetery District is an important historic landscape within the context of the City of Davis. The cemetery has a park-like atmosphere and is well landscaped. Numerous large family plot markers can be seen from a distance. Several of these are rather elaborately designed.

P5b. Description of Photo: (View, date, etc.)
Cemetery

Looking northwest

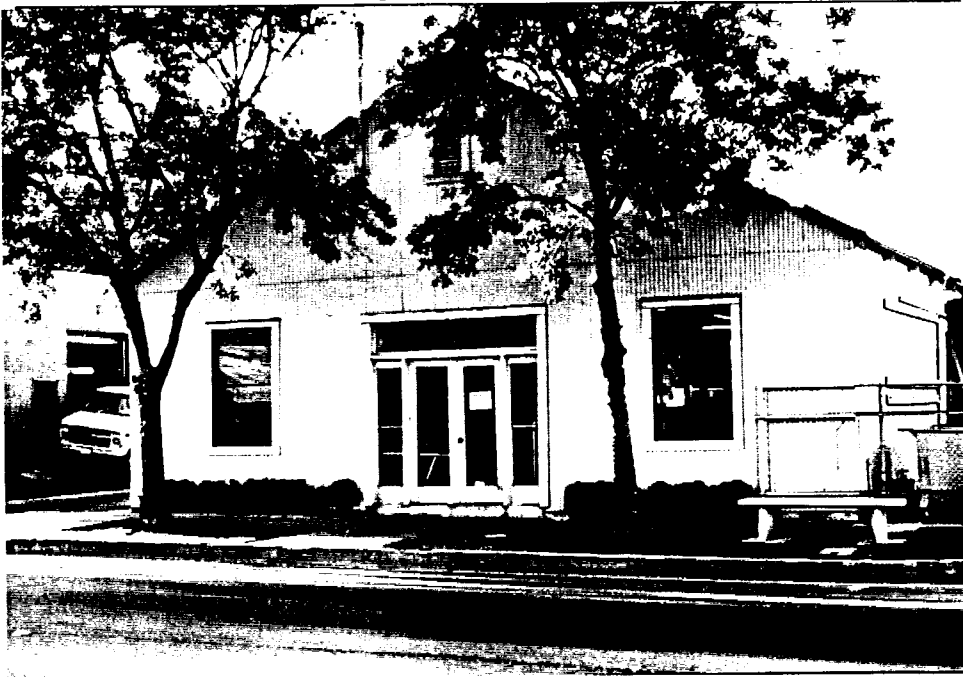
P5b. Description of Photo: (View, date, etc.)

Third St. Elev
Looking North

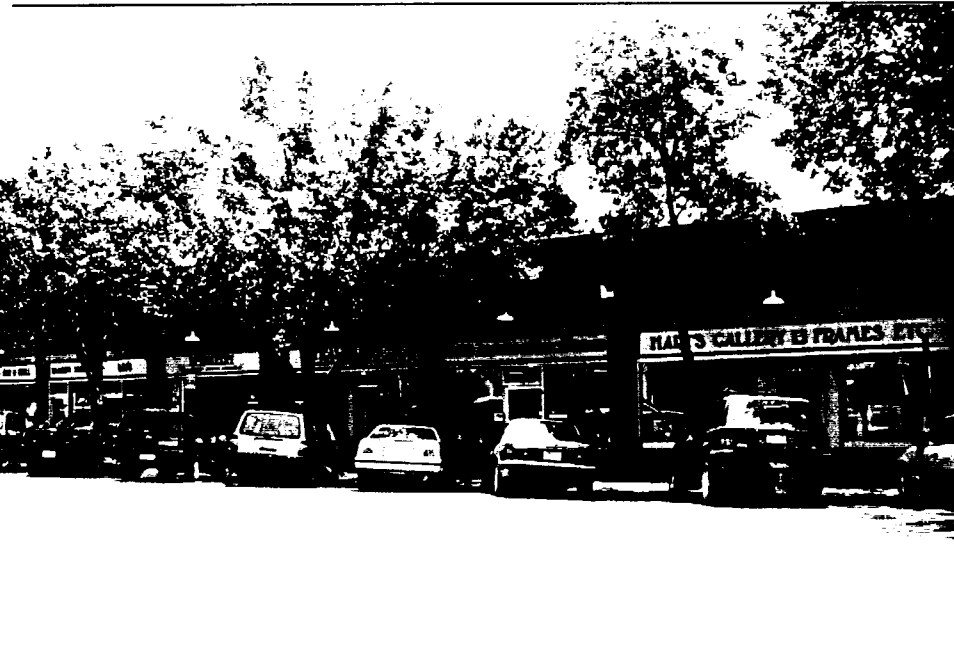
P5b. Description of Photo: (View, date, etc.)
Second St. Elev.

looking south

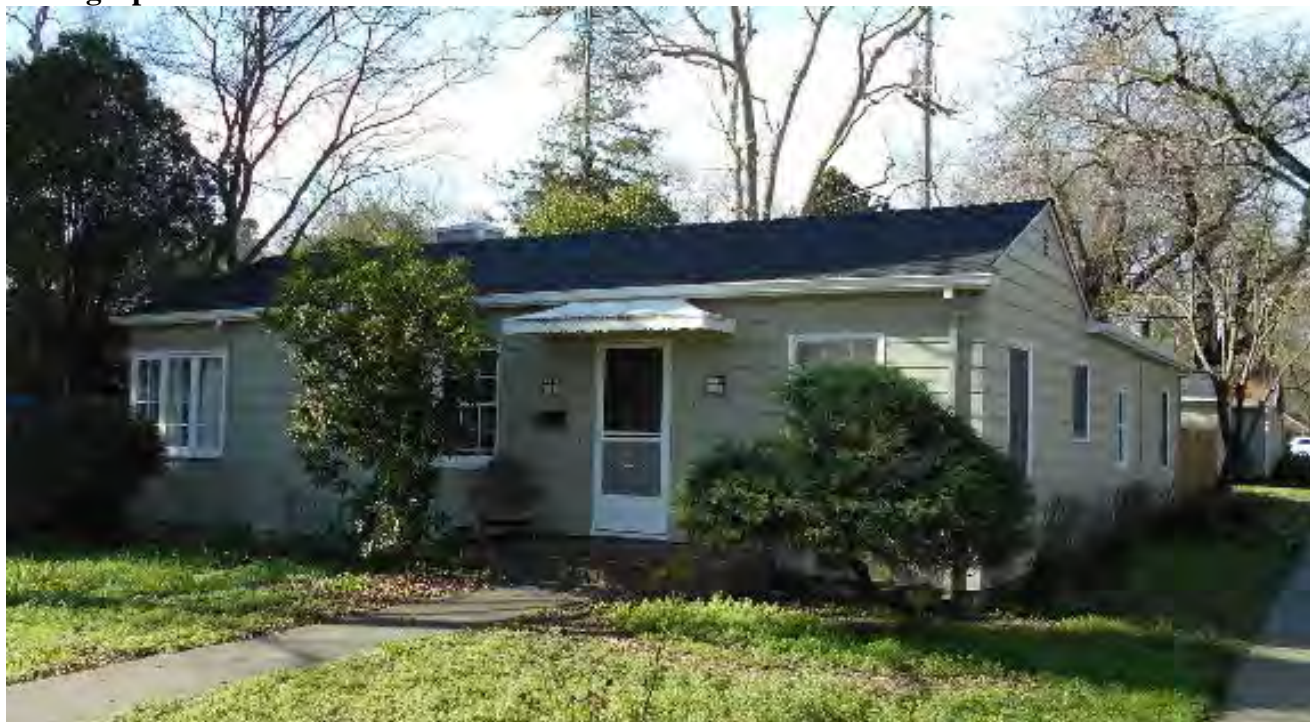
*P3a. **Description:** See original form for architectural style and features. The most visible and significant change to the building since 2003 is the replacement of the windows on the front façade.

See original form; while the replacement of the windows has diminished the property's integrity, this not significant enough to warrant a change in its evaluation.

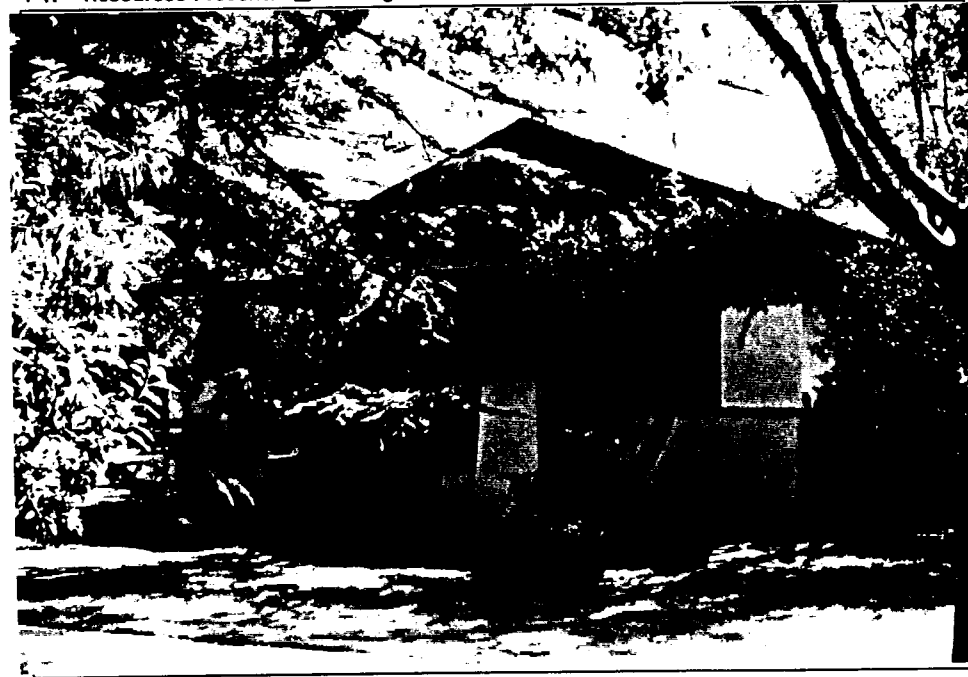
This one story, pattern book bungalow is clad in stucco. A series of gable roofs are perpendicular to the street with the attic gable having a decorative vent. The front porch occupies two thirds of the elevation and is supported by squat piers on masonry pedestals. The porch is accessed via three concrete steps. The front door is centered between two six over one double hung wood sash windows. A large window is present on the south side of the front elevation. The house appears to be in good condition.

*P5b. Description of Photo: (View, date, etc.)

Front Facade

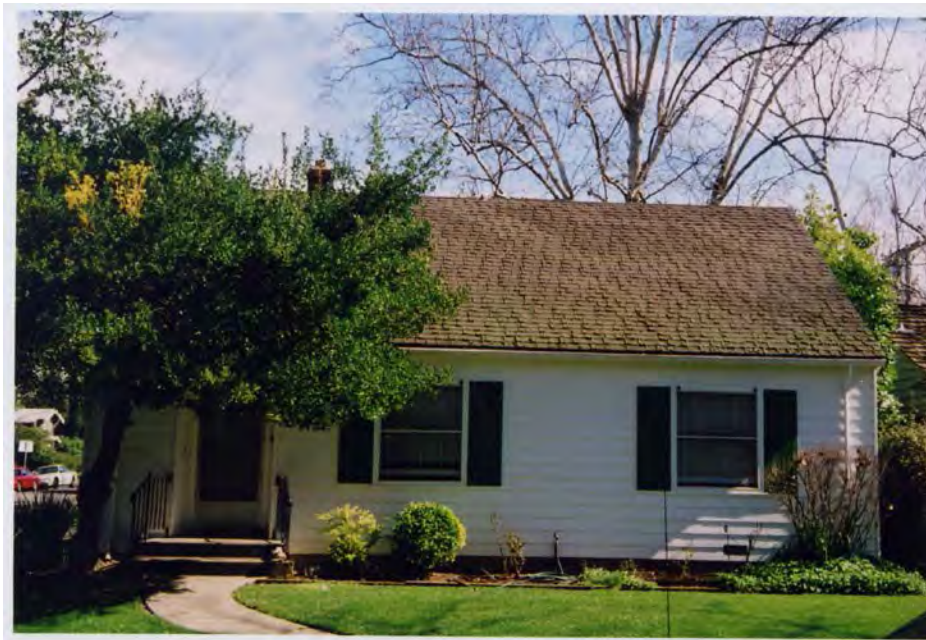
*P3a. Description:
 A rectangular plan building with a moderately pitched, wood shingle side gable roof, this 1938 house is very simple in design. In its form and massing it exhibits the characteristics of a minimalist traditional house, but the treatment of the windows and doors suggest Colonial Revival influences. The roof has closely cropped gables and eaves with a small, brick chimney piercing the roof ridge. Fenestration consists of one-over-one double hung windows with wood casings and sills. Rustic shutters flank the front windows. The entry is located on the north side of the front façade and is cut-in with a small cement stoop and stair. Cladding is clapboard. Although minimal in its design and decorative elements, the house is typical of the simplified small residences, of which there are several examples in Old North Davis, that bridged the period between the revival styles of the 1920s and early '30s and the full emergence of the California Ranch House. It appears to retain its integrity of design, materials, workmanship, setting, feeling and association. It appears to contribute to a district eligible for the California Register.

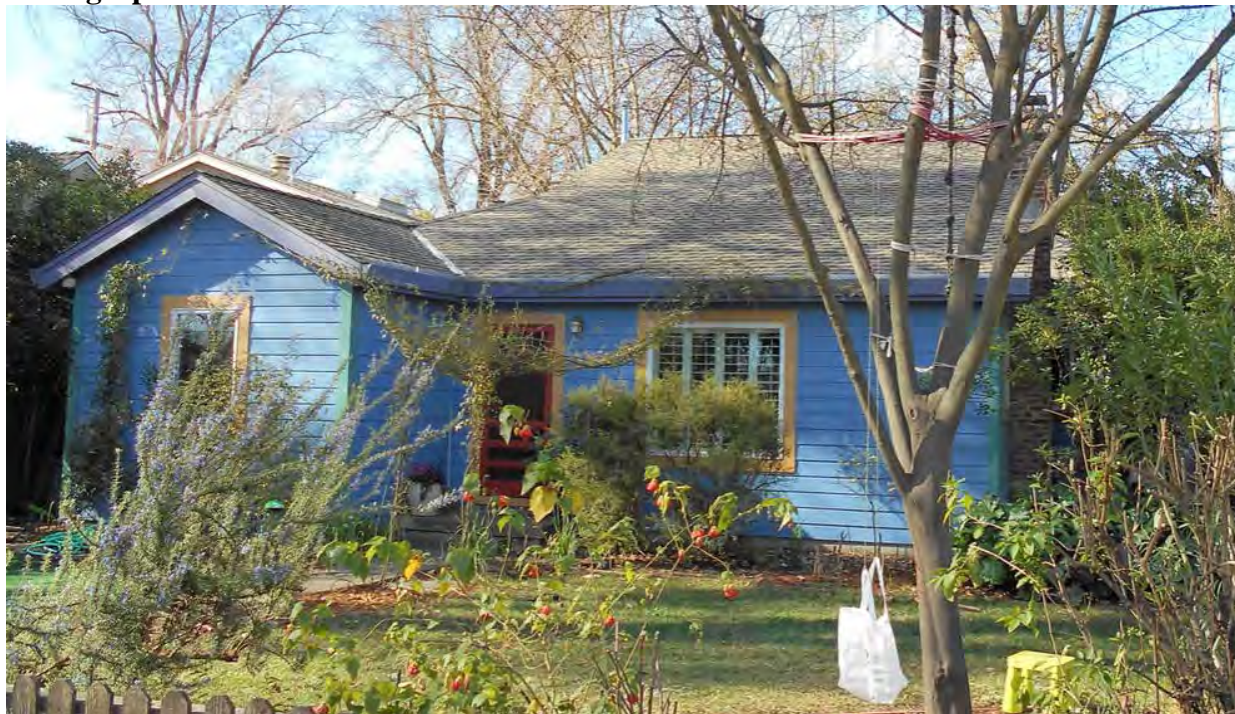
*P3a. **Description:** See original form for architectural style and features. Windows replaced, along with window trim. Main façade window replaced; alterations to roof have increased eave overhang. Shed roof shelter over entry removed. Heavily altered since 2003 inventory.

See original form; further alterations have caused additional loss of integrity since 2003 so that its evaluation should not change.

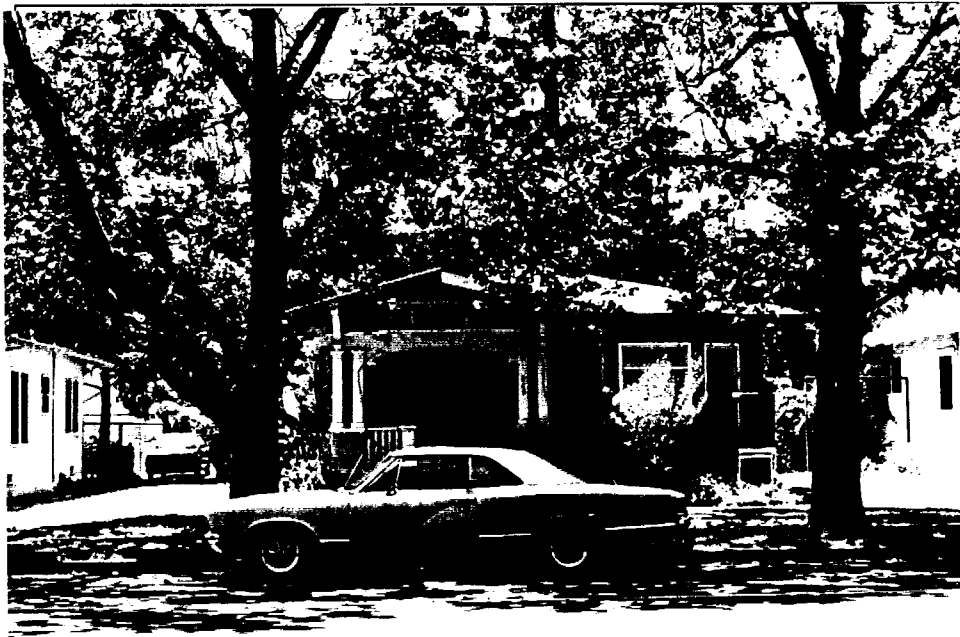
*P3a. Description: (Describe resource and its major elements. Include design, materials, condition, alterations, size, setting, and boundaries.)
The structure is a one story Craftsman style building, surfaced in stucco and trimmed in wood. The shallow hipped roof of the house intersects the low gabled roof of the porch over the entrance. The porch gable contains a decorative window and beam ends. The porch roof is supported by double posts set on stucco piers. The brackets at the eaves add ornament to the roofline. A shallow slanted cantilevered bay extends from the front of the house. The proportions of the house emphasize its horizontality. It appears to be in good condition.

P5b. Description of Photo: (View, date, etc.)
Front Facade
Looking west

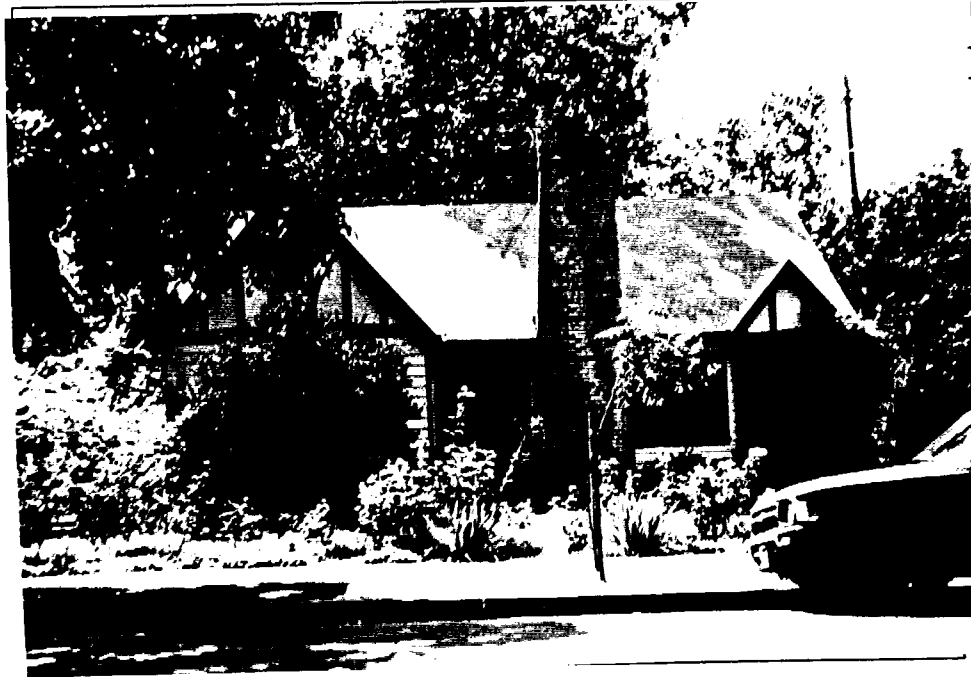
This Tudor Revival Style house has a prominent street facing chimney. Sheathed in horizontal siding, this one story house has a raised slab foundation. The windows are double hung and are in pairs along the front facade. The house is accessed via a recessed porch with a small gable roof. The main roof of the house is gabled with a cross gable on the southern end of the elevation. The house is on a corner lot and is well landscaped.

P5b. Description of Photo: (View, date, etc.)
Front Facade
Looking west

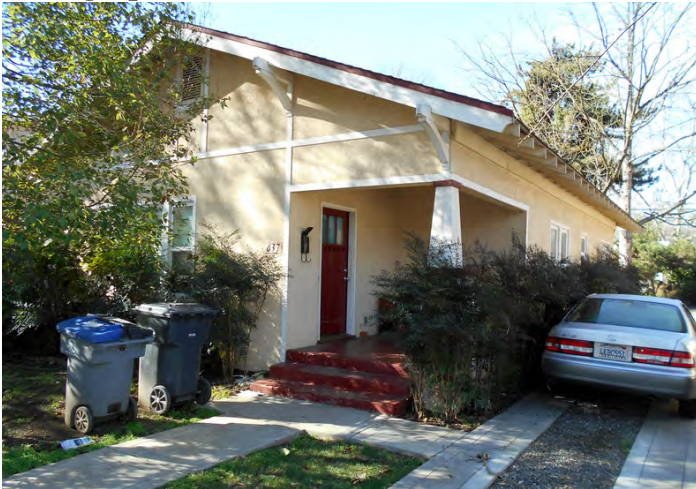
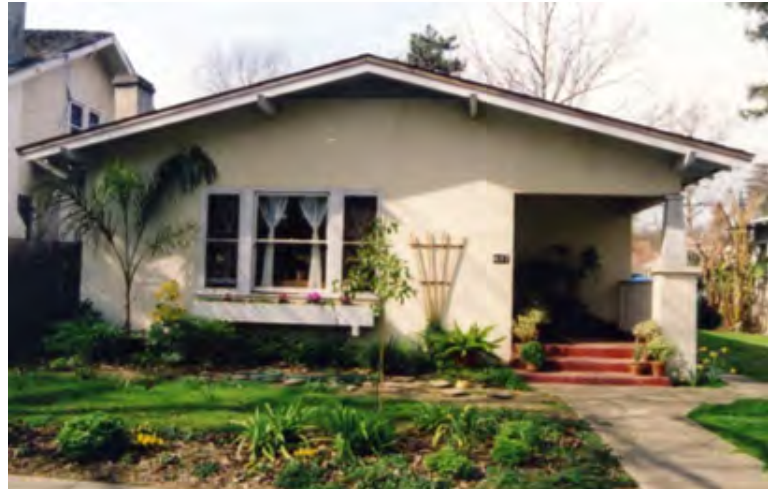
The major alterations to this building since 2003 have caused it to lose integrity and it may no longer contribute to the historic character of Old North Davis.

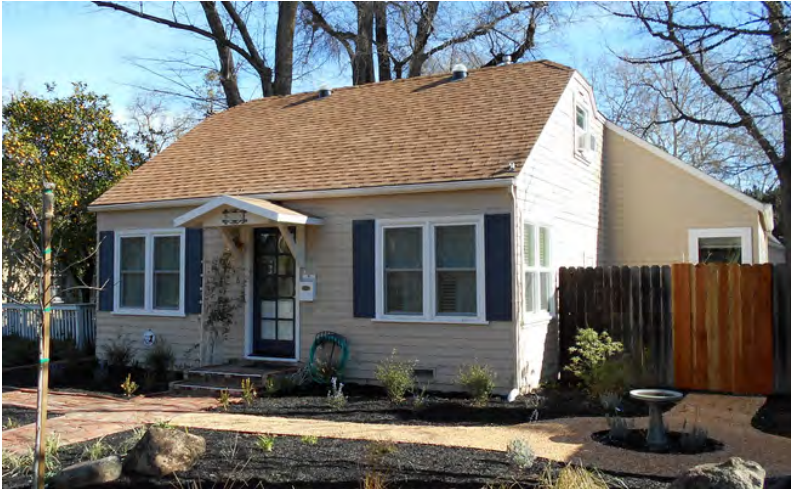
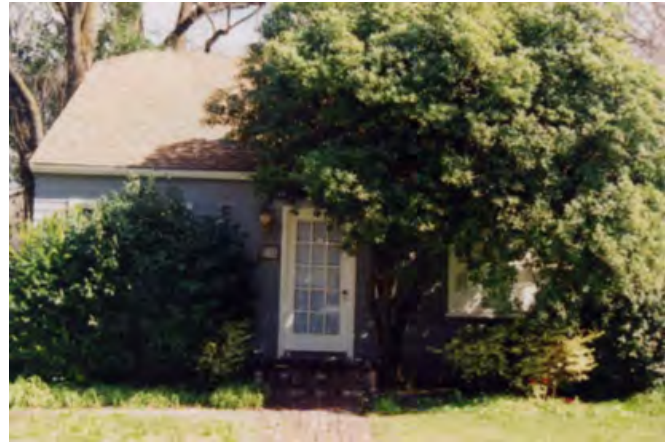
*P3a. **Description:** This building has been renovated and significantly expanded since 2003. The new rear addition is wider than the original house and projects outwards on both the north and south, altering the massing and appearance of the building. Other changes are principally decorative. A bracketed gabled cover for the front entry has been added. The front door has been replaced. Decorative shutters have been added to the front windows. These changes are significant enough that the building's integrity of design is substantially diminished.

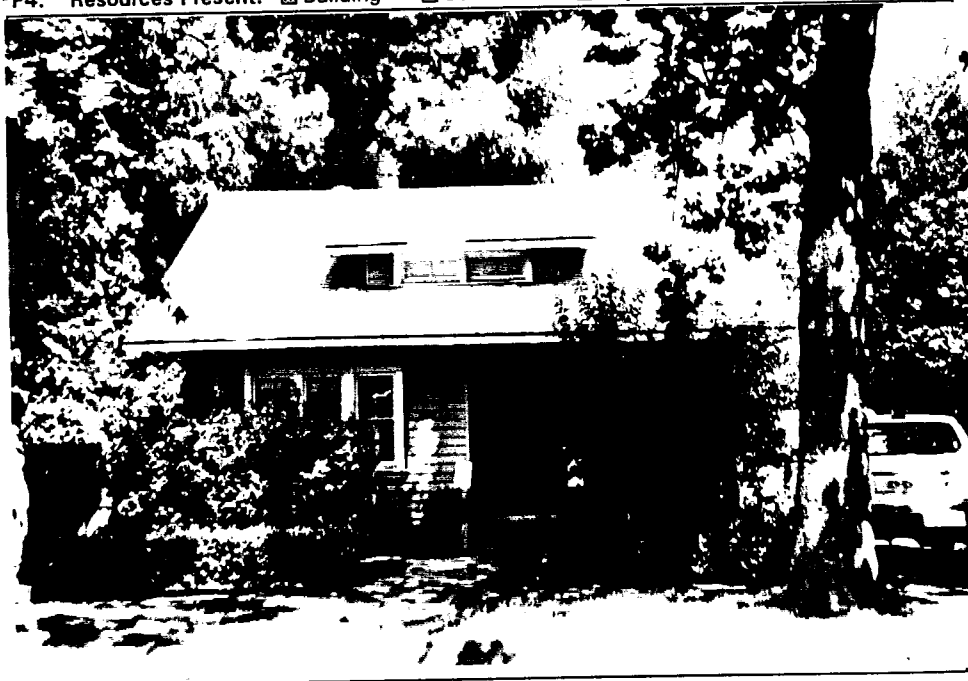
*P3a. Description: (Describe resource and its major elements. Include design, materials, condition, alterations, size, setting, and boundaries.)
This small, one story bungalow has a prominent attic dormer. A recessed porch is accessed via several steps. A tripartite window is found on the south side of the front elevation. The house has a gable roof running parallel to the street. The house is sheathed in horizontal wood siding.

P5b. Description of Photo: (View, date, etc.)
Front Elevation

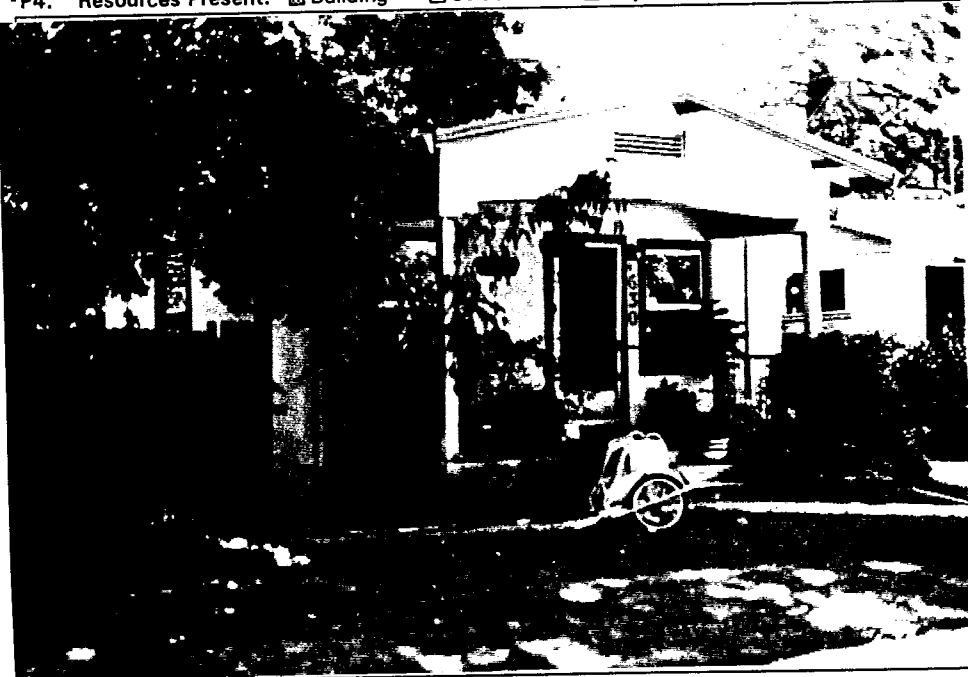
Front Facade

This one story, Craftsman style bungalow has a gable roof perpendicular to the street. The porch gable echoes the line of the main gable. The porch gable has a centered vent. Thin posts support the slight arch of the porch. The porch floor is concrete and is on the same level as the raised foundation of the house. The front door is slightly off center and is flanked by a double hung window on either side. The house is clad in cream painted stucco. The wood trim is painted a light brown or tan.

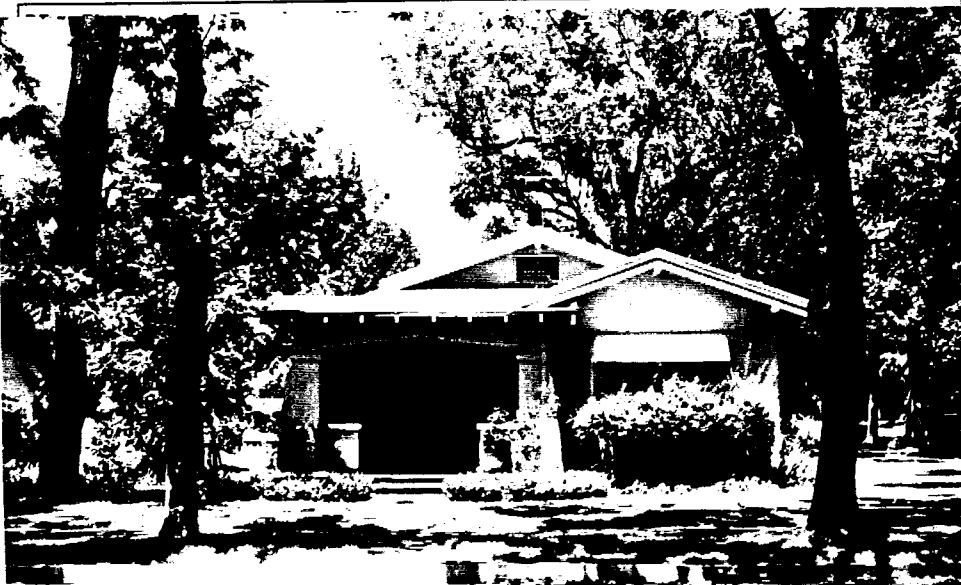
Front facade
Looking north

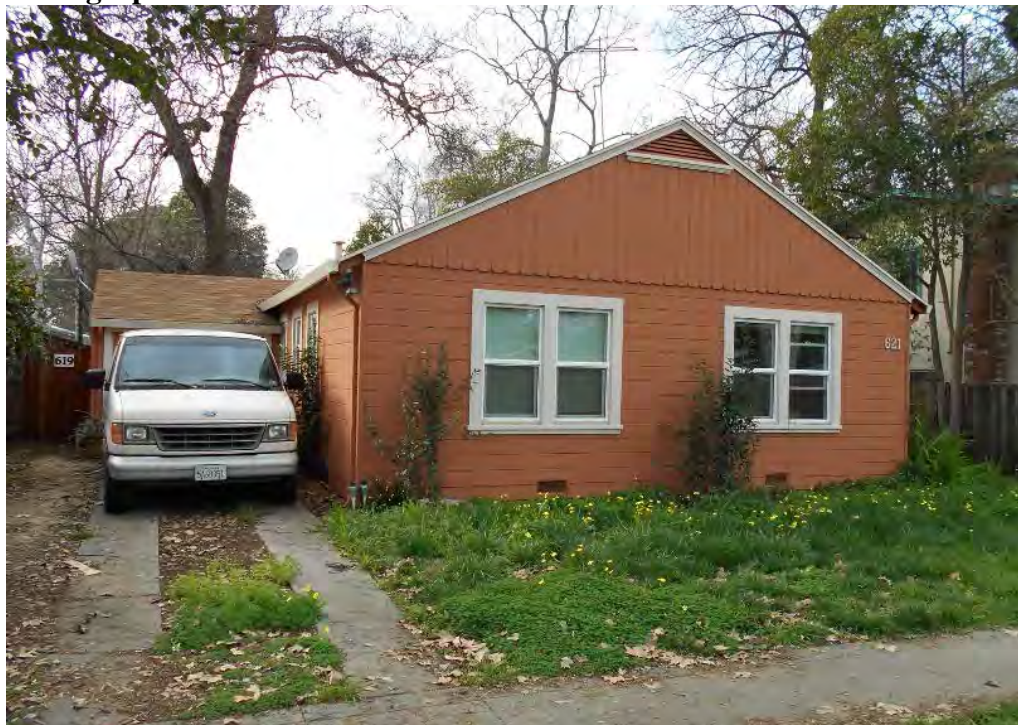
*P3a. **Description:** See original form for architectural style and features. Since 2003, the most visible and significant change for this building was the replacement of the windows and the removal of the ornamental shutters that flanked the windows on the front façade.

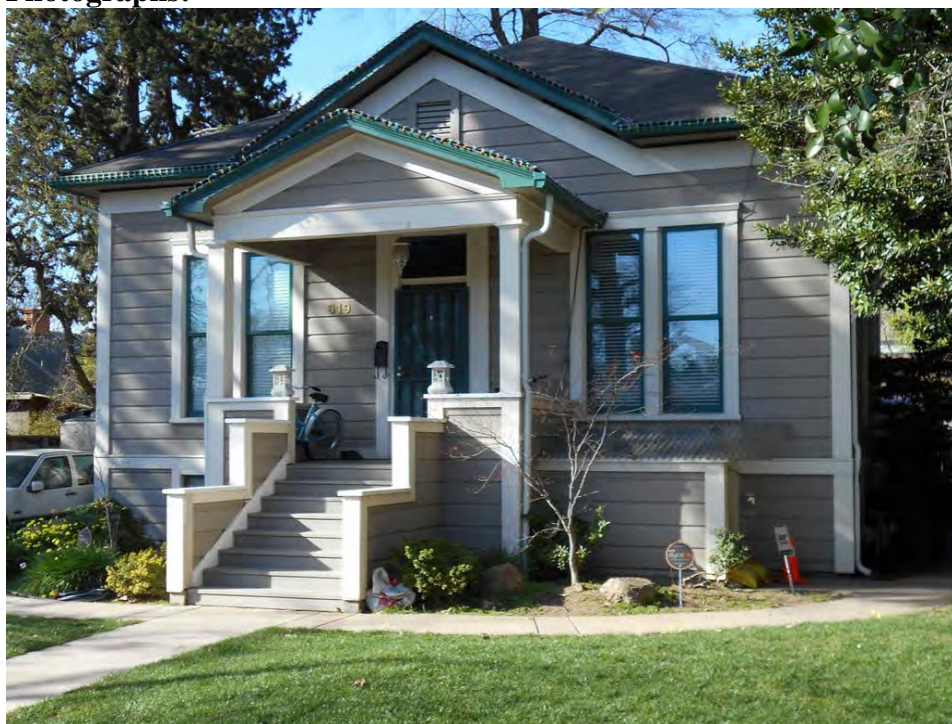
*P3a. **Description:** See original forms; alterations include complete interior remodel; replacement windows with reflective panes.

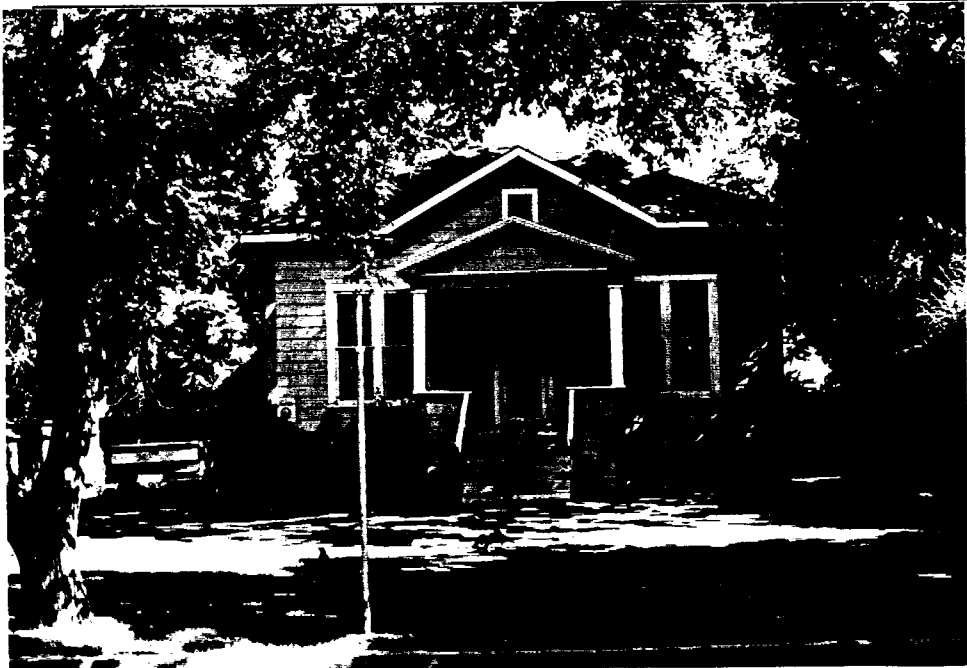
This vernacular Classical Revival, compact one story house has a pyramidally hipped roof. The roof is broken by a centrally placed gable facing the street which is echoed by the roof of the porch. The composition is symmetrical with a central transomed entry and flanking pairs of rather large double-hung windows. There are brackets at the soffited eave. The house is currently painted grey with blue and white trim.

Front elevation

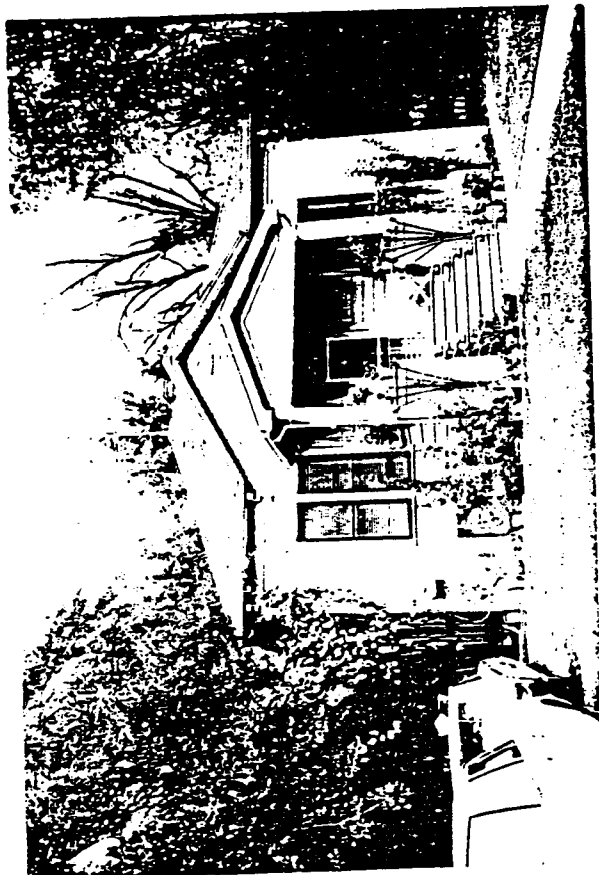
13. Date(s) of enclosed photograph(s): 1978

This compact one story house has a pyramidally hipped roof which is broken by a centrally placed gable facing the street. This gable is echoed by the roof of the porch. The composition is symmetrical, with a central, transomed, entry and flanking pairs of rather large double-hung windows. There are brackets at the soffited eave. The style is a vernacularized Classical Revival.

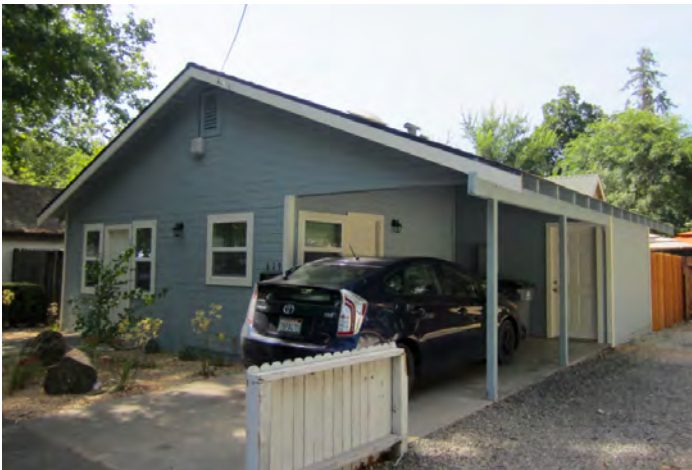
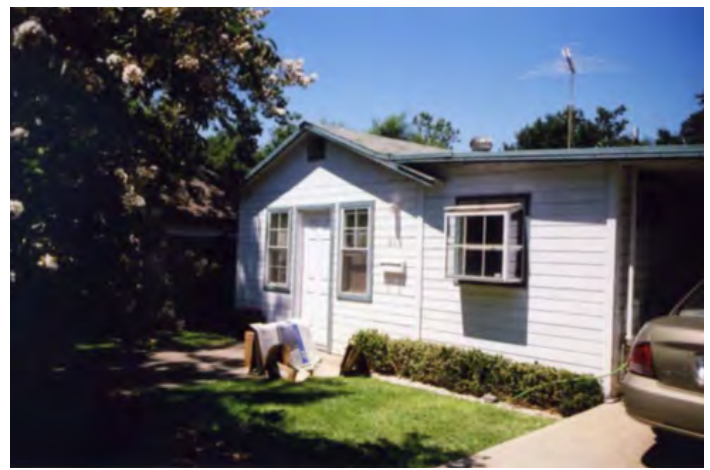
*P3a. **Description:** This building, originally a converted garage, has been extensively altered since 2003. The roof has been raised so that a single front gable now extends over the building and covered carport on the building's east, replacing the series of gable and shed roofs that had been added incrementally to the structure. The fenestration remains the same but all of the windows have been replaced, including removing a garden window box in favor of a double-hung window.

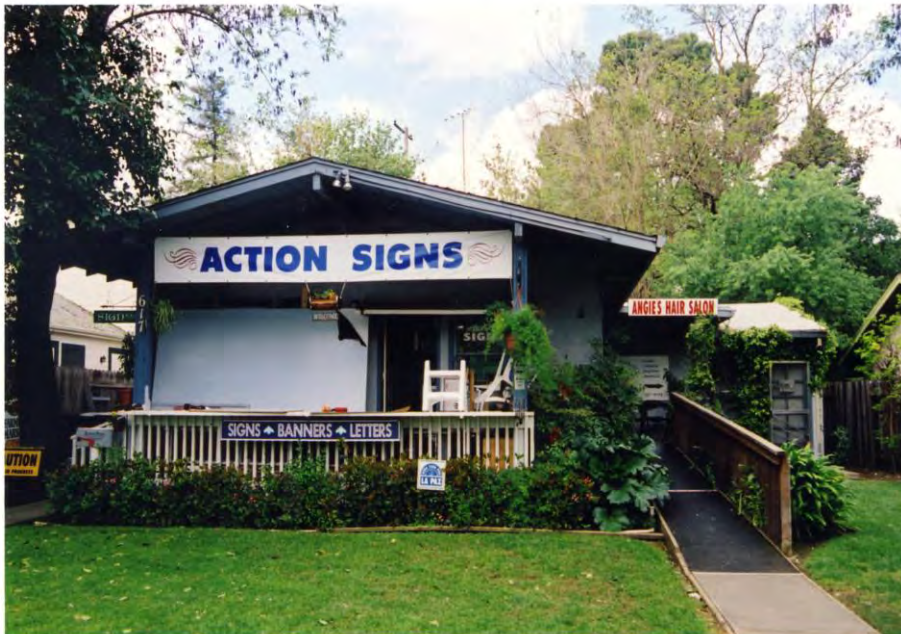
This 1919 residence was originally a Craftsman Bungalow with a low pitched front gable roof with wide overhangs. It has been extensively remodeled and converted to commercial use. Changes include the removal of front façade windows and their replacement with a blank wall, insertion of a commercial door and window, construction of a front deck and handicap ramp. The house no longer retains its integrity of design, materials, workmanship, setting, location, feeling and association. It does not contribute to a district eligible for the California Register.

*P3b. Resource Attributes: HP2
 *P4. Resources Present: Building Structure Object Site District Element of District
 P5b. Description of Photo:
 View west
 *P6. Date Constructed/Age:
 1919 84 years old documented
 Prehistoric Historic
 Both

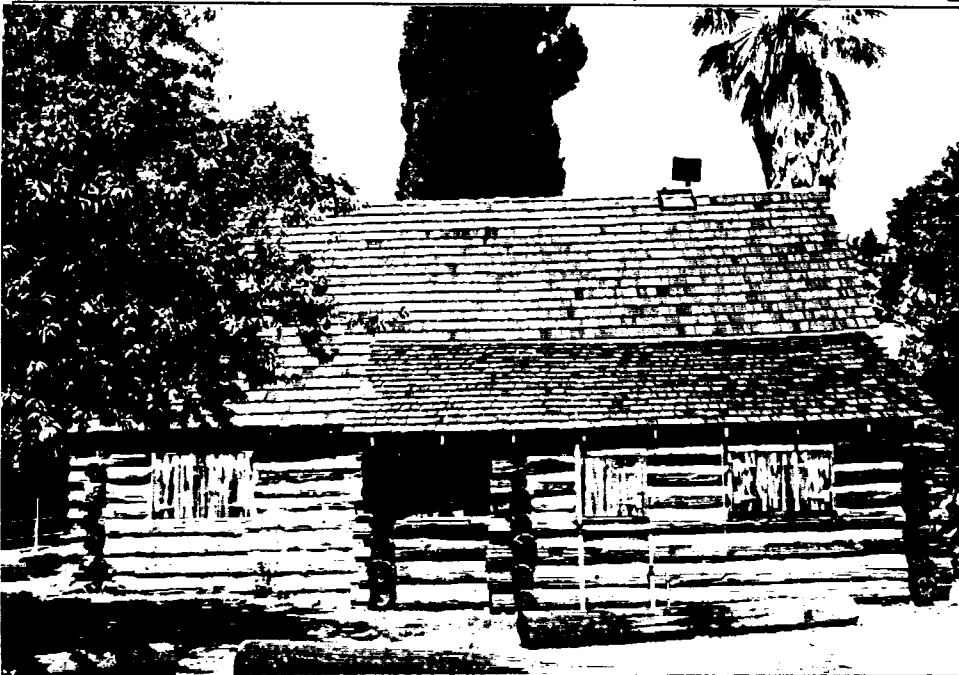
*P3a. Description: (Describe resource and its major elements. Include design, materials, condition, alterations, size, setting, and boundaries.)
This one story gabled cabin is constructed of logs. The overlaps of the logs at the corners are strongly emphasized and there is a rustic stone chimney present at the rear. The logs are of varying diameter, stacked eight high, they make up the structure of the walls and have been filled with cement. The gabled roof and the pediments it forms are shingled. Operable wood shutters with decorative metal hinges are found at the windows. Along the top ridge of each wall runs an additional log, slightly larger in diameter. This feature acts as a header above all the windows and doors as well as a beam upon which the rafters and roof rests. The structure is approximately 33 x 45. The small addition to the side appears to be a slightly later in date. The building appears to be in excellent condition.

P5b. Description of Photo: (View, date, etc.)
West Elevation
Looking east

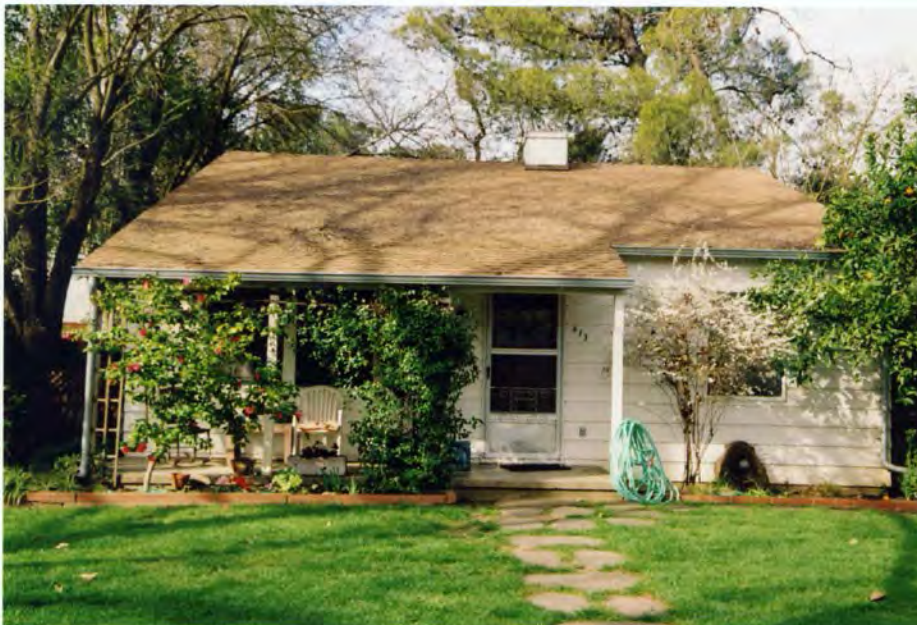
P5. Photograph or Drawing (Photograph required for buildings, structures, and objects.)

*P3a. Description:
 This simple rectangular plan house is an early example of the ranch house vernacular. Its low, side gable roof gives the house, which is small, a horizontal emphasis. This horizontality is enhanced by the extension of the front roof slope to cover the three-quarter length porch. The porch is set on a low concrete slab with its roof supported on 4X4 posts. Fenestration is symmetrical and consists of double hung windows. The house is clad with asbestos siding. A rectangular, brick chimney pierces the ridge of the roof. The replacement of the original siding compromises the integrity of materials, but otherwise the house remains unaltered and possess integrity of design, workmanship, setting, feeling and association. It appears to contribute to a district eligible for the California Register.
