Attachment B

DEPARTMENT OF PARKS AND RECREATION 523 FORMS

Updates produced during current project attached to forms produced during previous studies

*P11. Report Citation: Davis, California: Citywide Survey and Evaluation of Buildings Constructed Prior to 1976

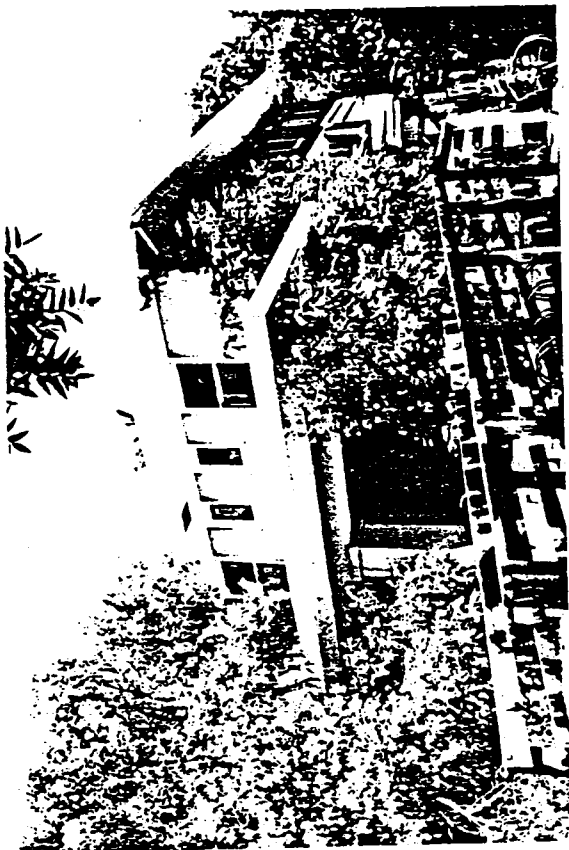
6. Briefly describe the present physical appearance of the site or structure and describe any major alterations from its original condition:
 This two story stucco prairie school building has a shallow hipped roof both on the porch and the the house itself. There are wide soffited eaves with a pattern of narrow boards in the soffit. There is a side entrance with heavily proportioned brackets. The garage is of similar design. The handicap acces ramp and the garage additions are recent alterations.

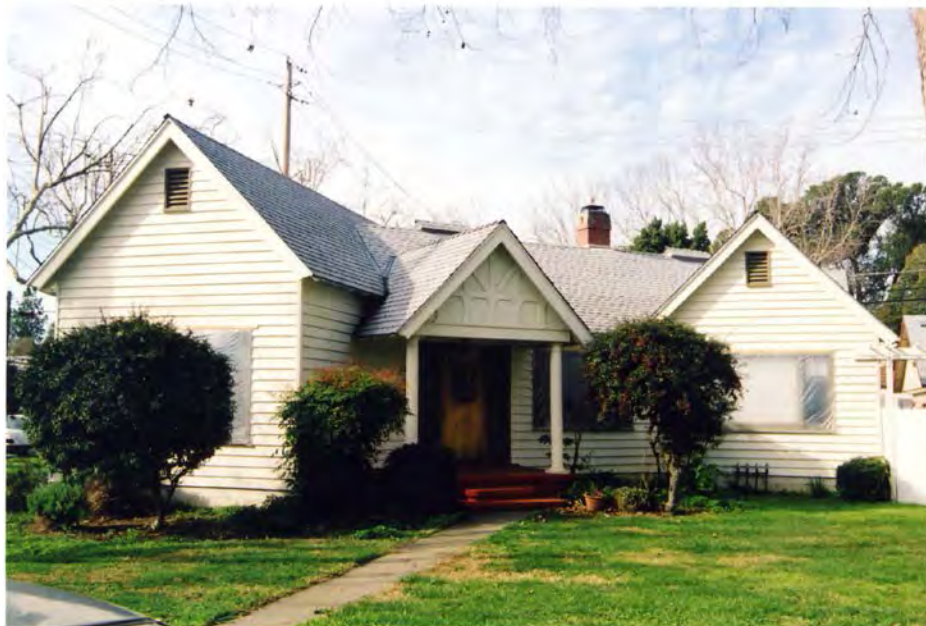
P5. Photograph or Drawing (Photograph required for buildings, structures, and objects.)

This unusual house is sited at an angle on its large corner lot. A central rectangular block connects two cross-gabled wings on either side. A prominent gable roofed porch is set at an angle to the intersection of the south gable wing and the central block of the house, The roof is moderately pitched, with slight gable overhangs finished with a fascia and a decorative attic vent. Eaves are also short, with exposed rafter tails. Front fenestration consists of cottage style windows, with a broad, central fixed panel and narrow sidelights. These cottage windows also occur on the north cross wings rear gable wall and on the eave wall of the south cross wing. Both of these "rear" facades are exposed to 5th Street where they are connected by a long screened-in , shed roof porch that backs on the central block. Other fenestration consists of paired casements. A brick chimney is located on the south cross wing eave wall. The house is eclectic in style. The projecting porch gable is finished with faux half-timbering frequent on Tudor Revivals, but the porch roof is supported on slim, cylindrical pillars which suggest a Colonial Revival influence. The house is clad with clapboard. Plastic weatherproofing material applied over all the windows distracts from the house's historic appearance, but is easily reversible. The house retains its integrity of design, materials, workmanship, setting, feeling and association. It appears to contribute to a district eligible for the California Register.

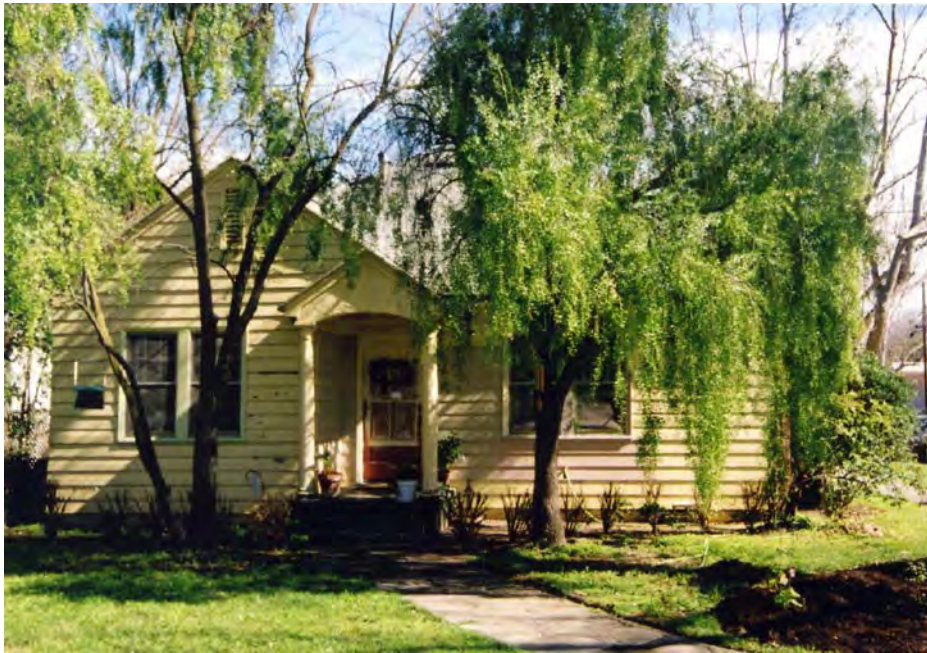
An L-shape plan house with a moderately sloped gable roof, the cottage was constructed in 1936. The roof is covered with composition shingle, has clipped eaves and gables and exhibits a vertically emphasized, decorative attic vent at the apex of the front facing gable. Fenestration consists of double hung, multi-light cottage style windows, which are paired on the front façade. Some of the windows have recently been replaced in kind. The building is clad with clapboard. The porch entry is a small concrete stoop covered by a projecting gable roofed pediment supported on cylindrical columns. The porch roof is finished with a plain fascia with a return. Although minimally embellished, the few decorative details which including the porch pediment and columns, the cottage style windows, and the roof elevation are suggestive of a Colonial Revival. The house retains its integrity of design, materials, workmanship, setting, feeling and association. It appears to contribute to a district eligible for the California Register.

*P3b. Resource Attributes: HP2
 *P4. Resources Present: Building Structure Object Site District Element of District
 P5b. Description of Photo:
 View east

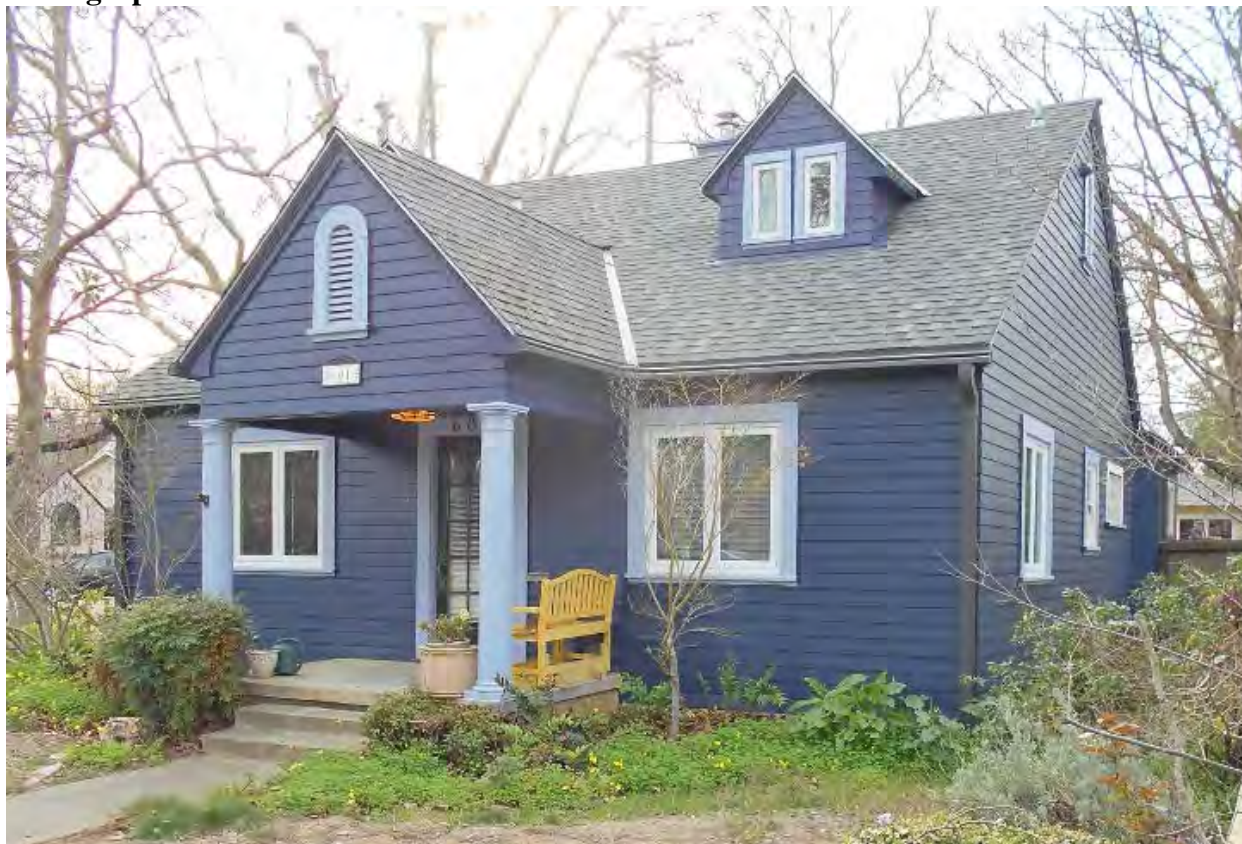
*P3a. **Description:** See original form for architectural style and features; since 2003, the most visible change to this building (repainting aside) is the replacement of the windows on the front façade. .

See original form; further alterations since 2003 have caused additional loss of integrity so its evaluation as a non-contributor to a proposed Old North Davis Historic District should not change.

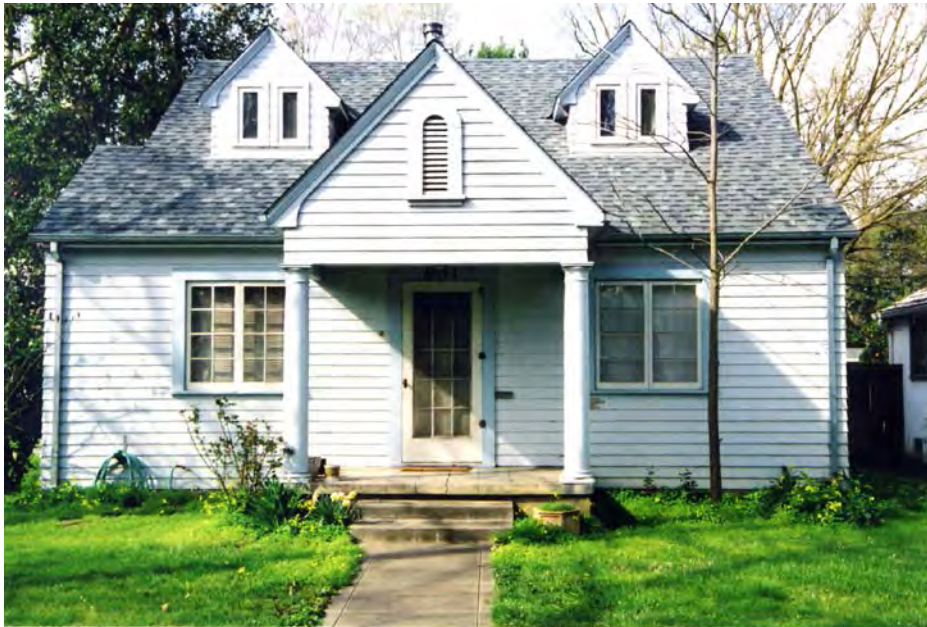
This Colonial Revival house was constructed in 1930. It is rectangular in plan with a steeply pitched side gable roof covered in composition shingle. Two symmetrically arranged dormers project from the front roof slope. These have steep gables and paired, vertically emphasized windows. Multi-light paired casement windows flank the centrally located, multi-light entry door. A centered, raised cement porch is covered by a portico supported on Tuscan columns. The porch gable roof has a return which is located above the gable end. Although the house retains its original form and style, it appears to have been modified to accommodate a second story addition. The 1933 assessment record indicates that the house was originally one story. The dormers appear to have been added to allow light into the upper story. The portico is oddly proportioned and appears to have been extended at the lower edge in an attempt to adjust its proportions to accord with the raised roof. Like most of the Colonial Revivals in this area the house is clad with clapboard. The house retains its integrity of, setting, location, and feeling. Clearly recognizable as a period revival, the addition of dormers and the alterations to the porch compromise the integrity of the original design and workmanship. While the house contributes to the character of the neighborhood, it has been too extensively altered to contribute to a district eligible for the California Register.

*P3b. Resource Attributes: HP2
 *P4. Resources Present: Building
 Structure Object Site
 District Element of District
 P5b. Description of Photo:
 View west
 *P6. Date Constructed/Age:
 1930 72 years old documented
 Prehistoric Historic
 Both
 *P7. Owner and Address:
 John Meeks
 601 E Street
 Davis, CA 95616
 *P8. Recorded by:
 Carol Roland
 Roland-Nawi Associates
 4829 Crestwood Way
 Sacramento, CA 95822
 *P9. Date Recorded: 04/07-10/2003
 *P10. Type of Survey: Intensive
 Reconnaissance Other
 Describe: Determination of
 Local District Eligibility
 *P11. Report Citation: none
 *Attachments: NONE Map
 Sheet Continuation Sheet

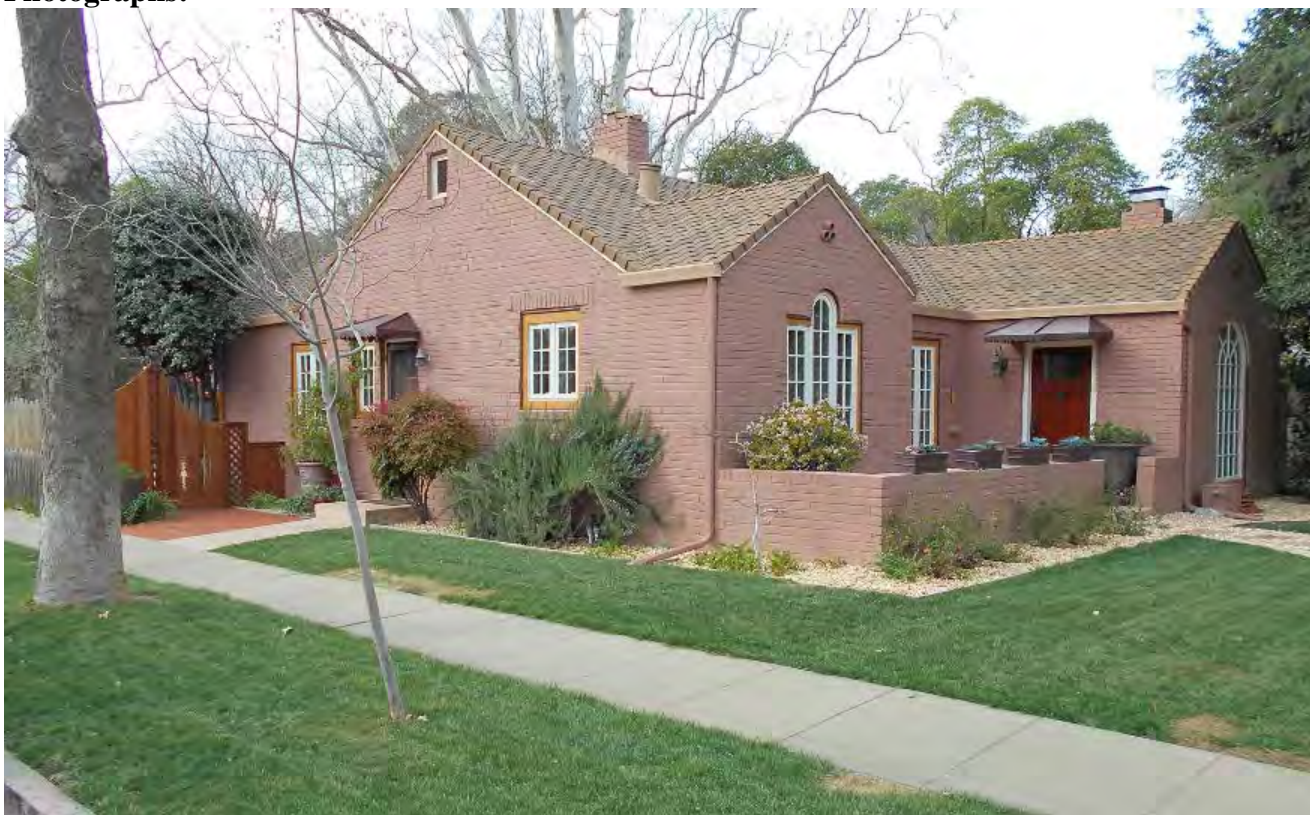
*P3a. **Description:** See original form for architectural style and features. The most visible and significant alteration to the house since 2003 is the replacement of its windows with more modern vinyl windows.

See original form; the window replacement has not undermined the building's integrity sufficiently to warrant reconsideration of its proposed inclusion in a district eligible for the California Register.

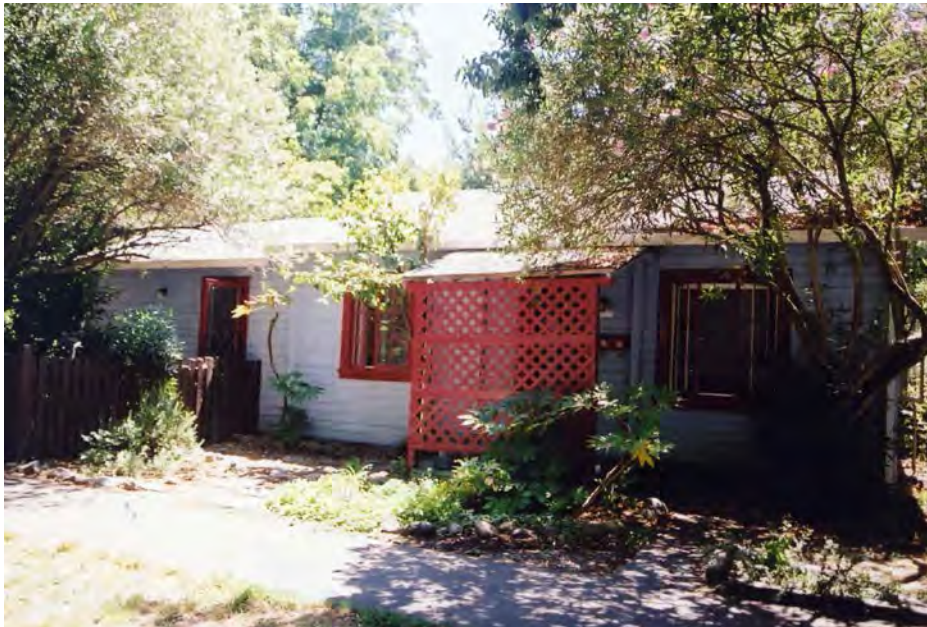
This rectangular plan house was constructed in 1932. It is very simple in concept, almost vernacular. It has a low side gable roof, with small eave and gable overhangs. Fenestration consists of wooden casements. A stoop porch leads to an entry which is covered by a shed porch roof, supported on brackets. The entry is partially obscured by a lattice work screen that is loosely connected to the building. Cladding is clapboard. The house retains its integrity of design, workmanship, setting, location, feeling and association. It contributes to a district eligible for the California Register, but further alteration could easily render it non-contributing.

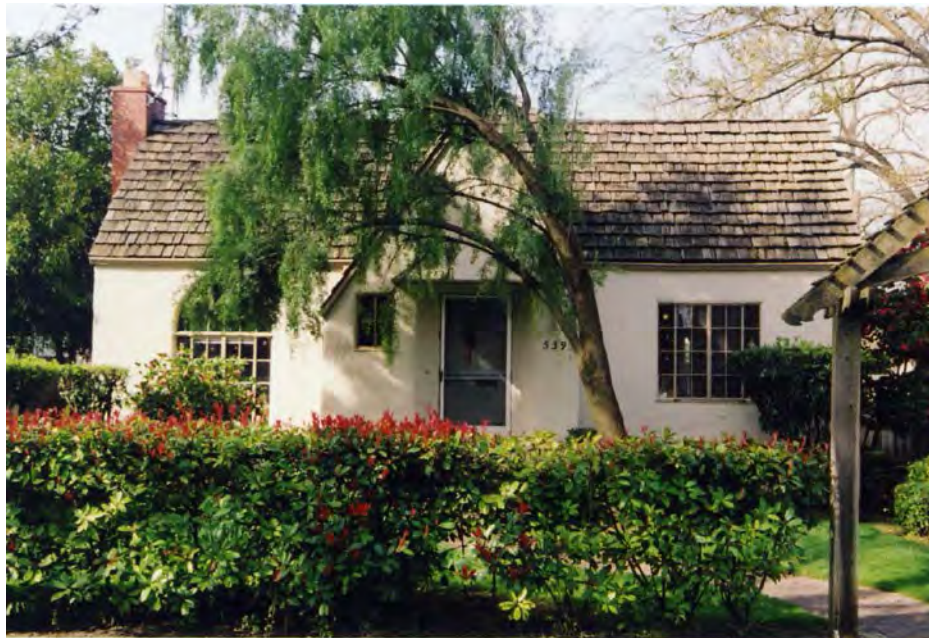
This small rectangular plan English Cottage Revival is similar in plan and appearance to one of the popular small house plans of the 1930's which was widely circulated and is found in a number of Revival Style developments. There are several houses of this design in the Curtis Park area of Sacramento. Constructed with a moderately pitched side gable roof, the focal point of the building is the steeply gabled, projecting front entry centered on the front façade. This entry features a recessed doorway, an asymmetrical exaggerated gable, sometimes known as a "cat slide," with a small, decorative vestibule window set to one side. The door is paneled Fenestration is arranged on either side of the door and is metal casement. The window on the south side of the façade is arched and has a transom in the arch. An exterior brick chimney rises on the south façade. The roof is clad with wood shingle that add to the house's rustic appearance. The walls are stucco. The house retains its integrity of design, materials, workmanship, setting, location, feeling and association. It appears to be unaltered and it contributes to a district eligible for the California Register.

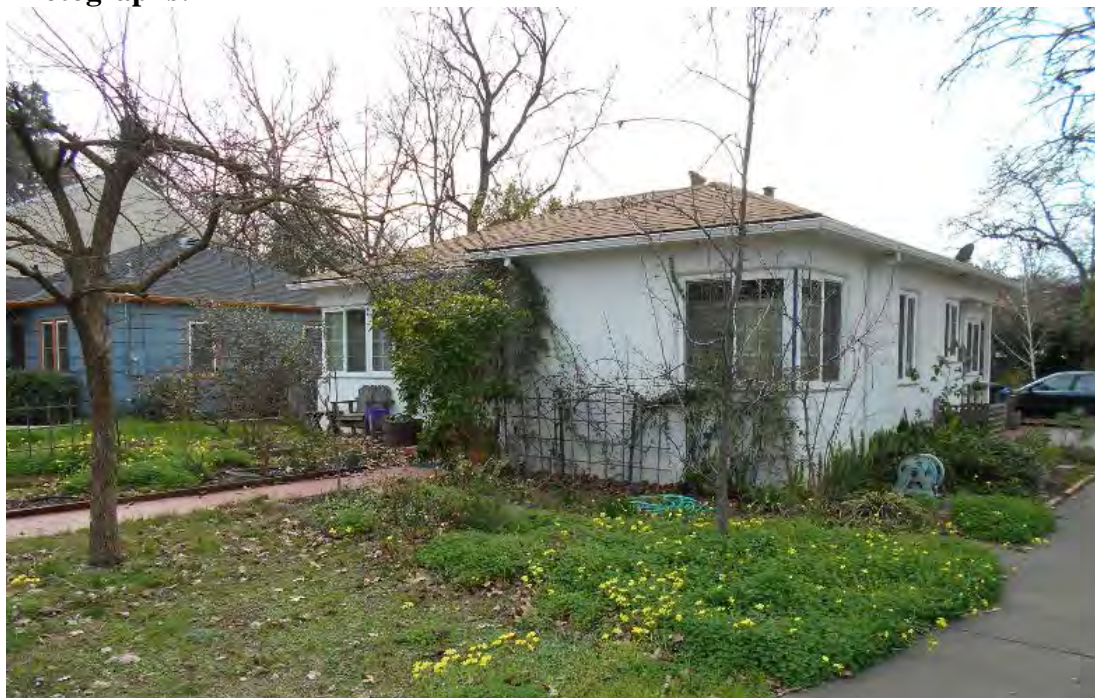
*P3a. **Description:** See original form for architectural style and features. The most visible and significant alteration to the house since 2003 is the replacement of both sets of windows at the two corners of the front façade with vinyl, double-hung windows.

See original form; the replacement of the windows has not sufficiently diminished the integrity of the building as a potential contributor to an historic district eligible for the California Register.

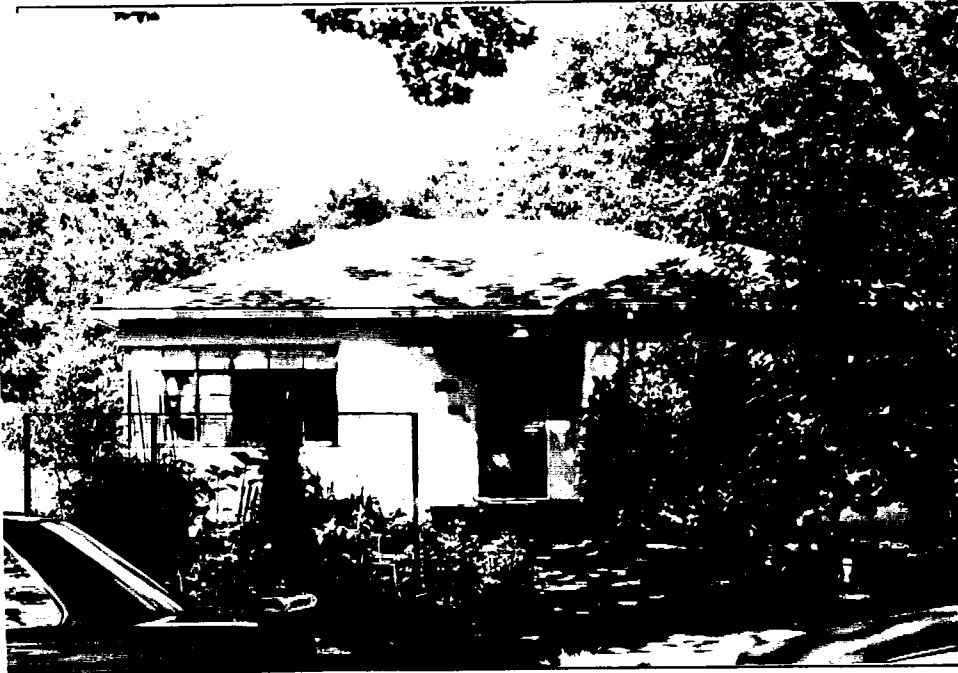
*P3a. Description: (Describe resource and its major elements. Include design, materials, condition, alterations, size, setting, and boundaries.)
This one story, stucco house has a hip roof. The house has nicely crafted, fixed, wrap around windows in the International Style. L-shaped in plan, the entry is to the south of the projecting portion of the L. A flat, cantilevered roof covers the entry. The house has a raised foundation and an attached garage. The house appears to be in good condition, including the landscaping.

P5b. Description of Photo: (View, date, etc.)
Front Elevation

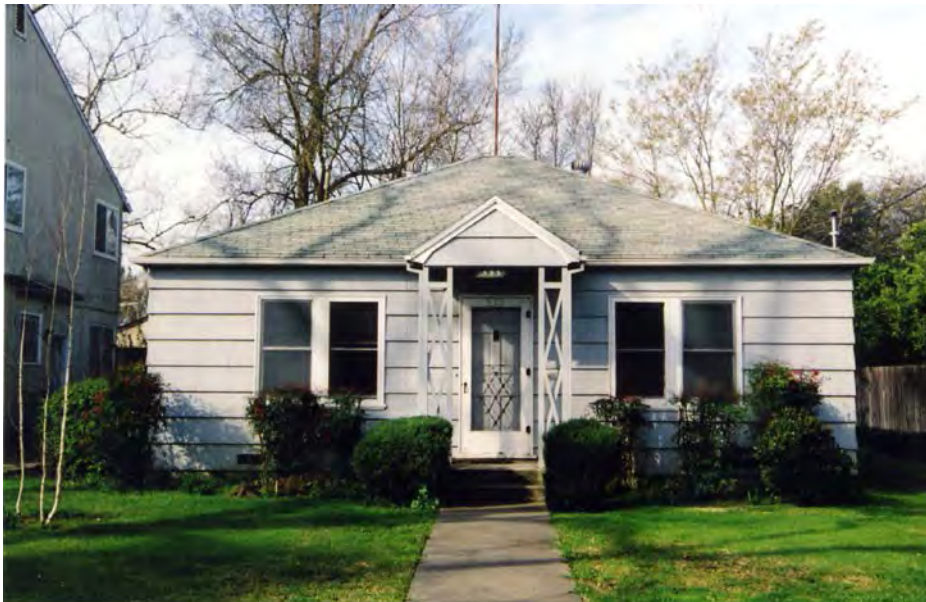
A late example of Colonial Revival, this house was constructed in 1942. Rectangular in plan, it is surmounted by a moderately pitched hip roof. The front façade is symmetrically arranged with a central entry flanked by paired one-over-one double hung windows. A small porch pediment projects over the porch stoop and is supported on latticed posts. The gabled pediment is finished with a fascia with returns. The entry door is paneled. The house has been clad with vinyl siding. The use of composition shingle on the roof and the replacement of the original siding have compromised the integrity of materials. In all other aspects the house remains unaltered and is a good example of its design type. It retains integrity of design, workmanship, location, setting, feeling and association. It appears to contribute to a district eligible for the California Register.

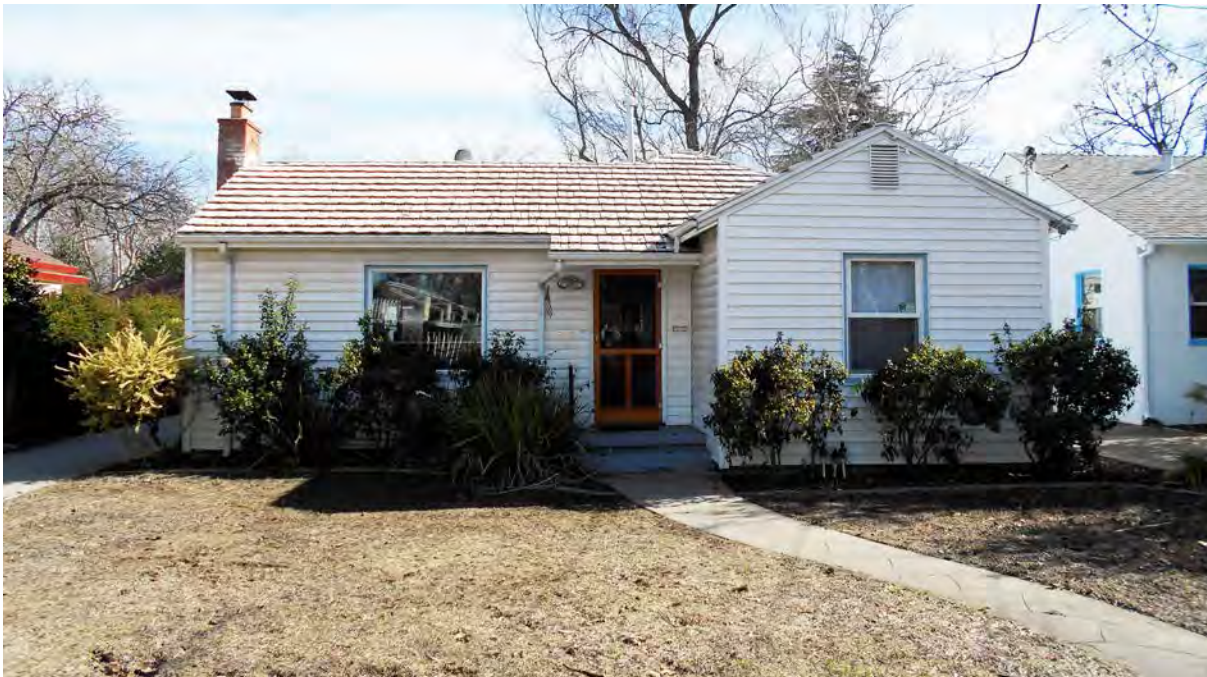
*P3a. **Description:** See original form for architectural style and features. 2015: siding noted in 2003 is vinyl, not original. Windows are compatible style Aluminum double-glazed. 1970 awnings removed. Original house is now 84 years old. Roofing material appears to date to 2003; may be vinyl and has a style that is not true to the likely original shakes.

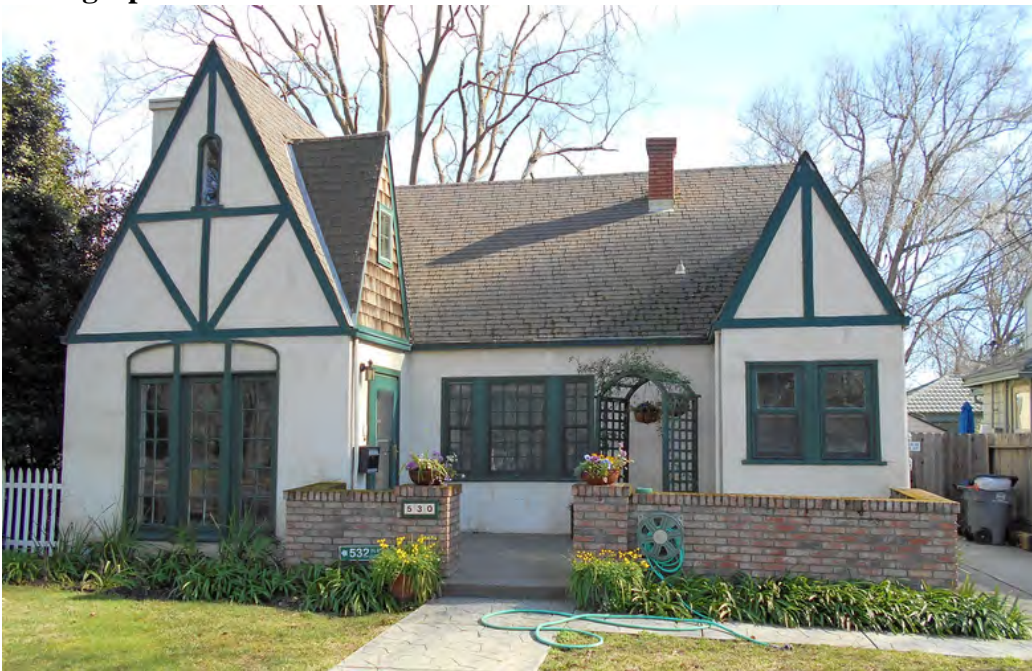
*P3a. **Description:** See original form for architectural style and features. The center front windows, between the two wings, has been replaced since 2003. The prior windows featured a fixed single-pane in the center with multi-paned sidelights. These have been replaced with double-hung multi-paned windows that more closely match the other windows on the gable walls. This change enhances the overall integrity and appeal of the building.

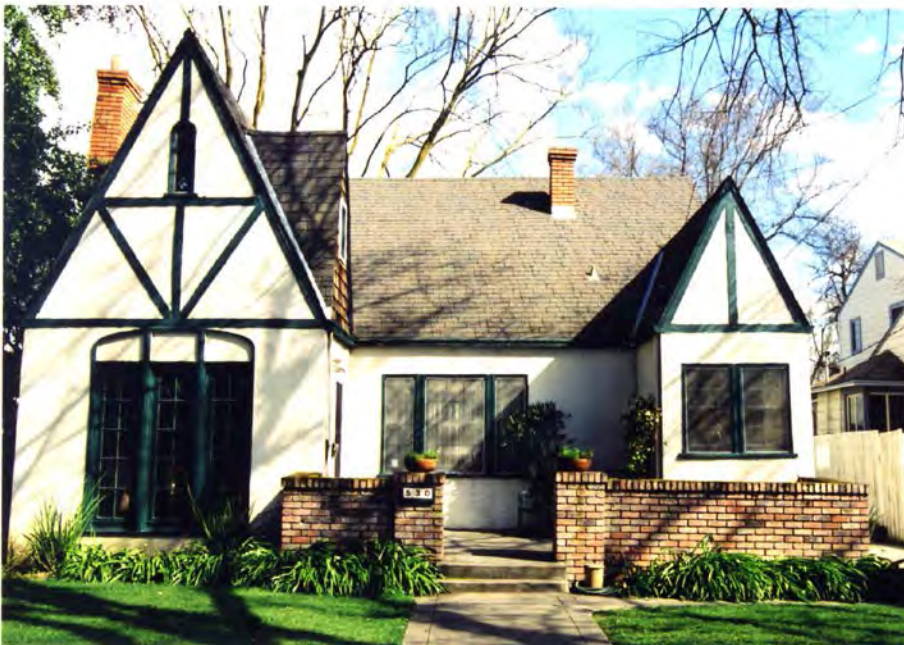
This charming Tudor Revival Cottage was constructed in 1925. It is an excellent example of its style type. The house is roughly U-shape in plan, with two cross wings projecting toward the street. The wings are of similar design, but differing size, a factor that enhances the rustic, vernacular quality of the building. The multiple cross gable roof is steeply pitched. The front facing gable ends are trimmed with faux half timbering in a diamond pattern. The wing on the north side is the larger of the two and has a gabled side dormer which is finished with shingles. Gable ends and eaves are clipped. Fenestration is mixed. The north gable wall window consists of three tall, fixed, multi-light panels which are trimmed at the top with an elliptical wooden frame in-filled with stucco. A horizontally emphasized window is found on the center wall, between the two wings. This is a fixed center panel with narrow, multi-light sidelights. The smaller south projecting wing has paired, double hung cottage windows. Other fenestration consists primarily of double cottage windows. A concrete porch fills the area between the projecting wings and extends along the front south wing wall. The porch is enclosed by a low brick wall which is capped with a header row. The house has both an exterior brick chimney, located on the north façade, and an internal brick chimney which pierces the front slope of the principal roof. The house is clad with stucco. It retains its integrity of materials, workmanship, setting, location, feeling and association and contributes to a district eligible for the

California Register.
 *P3b. Resource Attributes: HP2
 *P4. Resources Present: Building
 Structure Object Site District
 Element of District
 P5b. Description of Photo:
 View east
 *P6. Date Constructed/Age:
 1925 78years old documented
 Prehistoric Historic
 Both
 *P7. Owner and Address:
 Lynne Journey
 530 F Street
 Davis, CA 95616
 *P8. Recorded by:
 Carol Roland
 Roland-Nawi Associates
 4829 Crestwood Way
 Sacramento, CA 95822
 *P9. Date Recorded: 04/07-10/2003
 *P10. Type of Survey: Intensive
 Reconnaissance Other
 Describe: Determination of
 Local District Eligibility
 *P11. Report Citation: none
 *Attachments: NONE Map
 Sheet Continuation Sheet

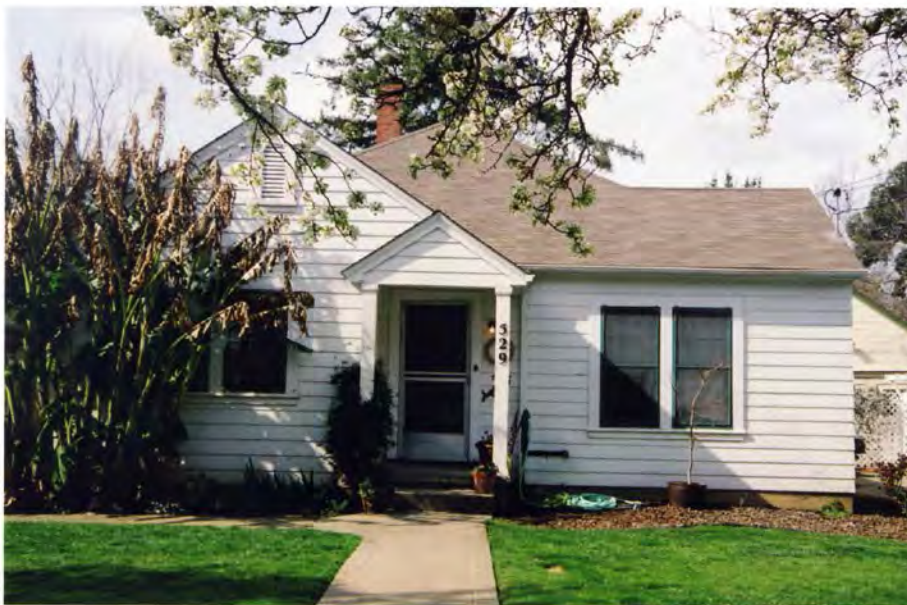
P5. Photograph or Drawing (Photograph required for buildings, structures, and objects.)

This L-plan cottage has a hip on gable principal roof, with a front projecting cross gable on the south side. This multiplicity of roof heights and intersections provides visual interest to the otherwise simple house. Unfortunately the varied roof line is played down by the untextured composition shingle replacement covering. Gables and eaves are clipped. The front projecting gable is finished with a half circle vent and a molded fascia; this latter also found on the projecting porch gable. Both fascia feature returns. This treatment suggests a Colonial Revival influence in a house that otherwise models the form and footprint of the Minimalist Traditional houses popular at the time of its construction. Windows are double hung, multi-light cottage types of varying sizes. Those on the front façade are strongly vertically emphasized and are arranged in pairs. The entry is set back into the L formed by the intersection of the south wing and the principal block of the house. This recession is emphasized by the addition of a slightly projecting porch gable, supported on wooden posts. Cladding is clapboard which also contributes to the Colonial feeling of the house. The integrity of design, materials, workmanship, setting, location, feeling and association are retained. The house contributes to a district eligible for the California Register.

***P5b. Description of Photo:**
 View west

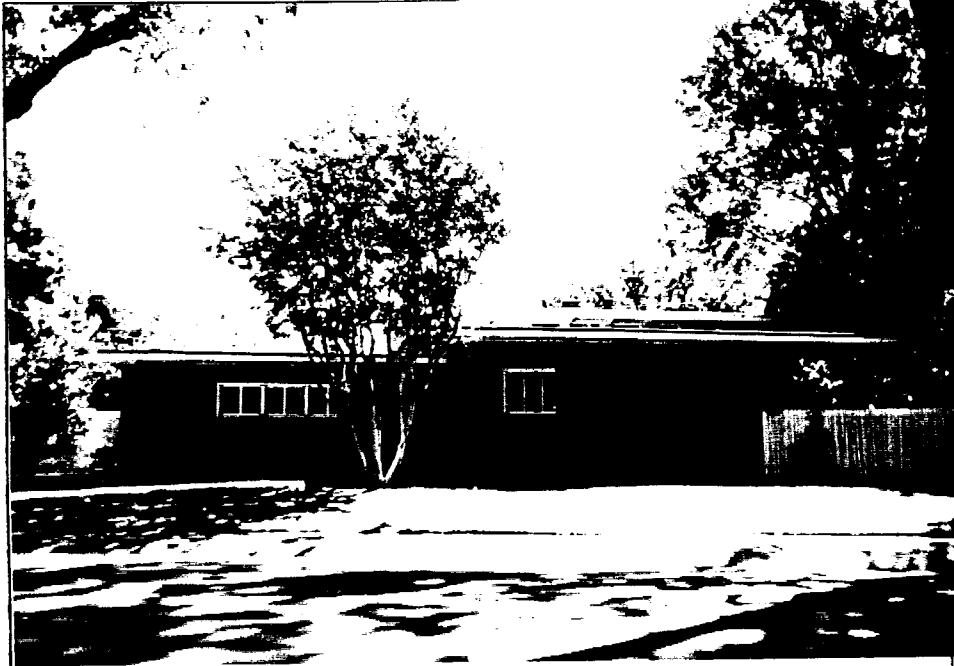
*P5b. Description of Photo: (View, date, etc.)

Front Facade

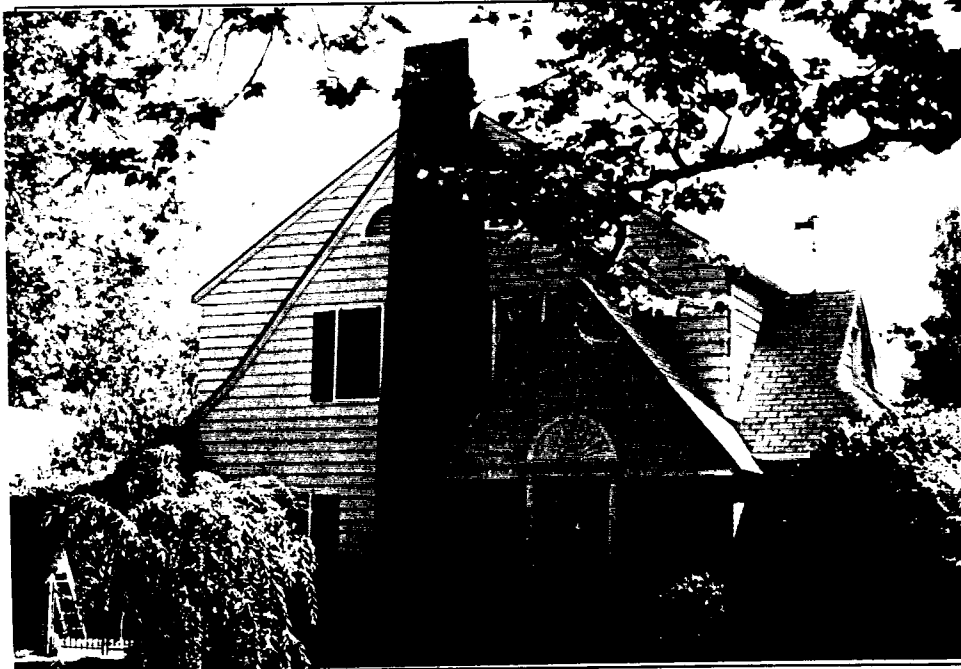
P5b. Description of Photo: (View, date, etc.)
Front Facade

This two story Colonial Revival house presents an interesting facade to the street. The main facade is a collage of shallow gabled forms of various pitches. The primary gable sweeps low on the left side to provide a wing wall pierced with an arch. There is a fan motif in wood relief over the entrance. The brick of the chimney continues as a veneer on the entry portion. A set of semi-circular steps leads to the front door. The house is one of the strongest Colonial Revival facades in this part of Davis. It appears to be in excellent condition.

looking east

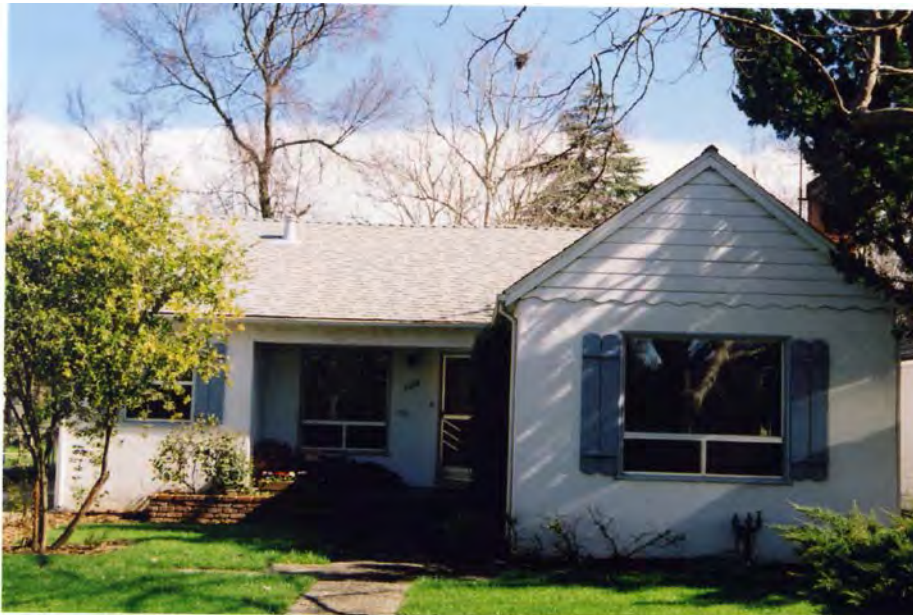
P5. Photograph or Drawing (Photograph required for buildings, structures, and objects.)

This asymmetrical, U-shape plan house is very similar in design to its neighbor at 522 C Street. The house has a moderately pitched cross gable roof with a central porch cut in under the eaves. There is a prominent front projecting, gabled wing on the south side of the façade. It is trimmed with decorative clapboard siding, finished at the bottom with a scalloped pattern. Gable and eaves are clipped. The porch is constructed of replacement brick with a built in planter extending partially across the front façade. The original fenestration has been replaced in the original openings and are flanked by rustic, vertical plank shutters which appear original. The building is clad in stucco. The replacement of the porch and the fenestration has had a significant effect on the integrity of this very simply designed house. While it retains its original form and some elements of detailing (particularly the gable end trim and shutters) it has lost integrity of design, materials, and to some degree workmanship. It appears not to contribute to a district eligible for the California Register.

View east
 *P6. Date Constructed/Age: 1941 66 years old documented
 Prehistoric Historic
 Both
 *P7. Owner and Address: Birgit Puschner
 528 C Street
 Davis, CA 956616
 *P8. Recorded by: Carol Roland
 Roland-Nawi Associates
 4829 Crestwood Way
 Sacramento, CA 95822
 *P9. Date Recorded: 04/07-10/2003
 *P10. Type of Survey: Intensive
 Reconnaissance Other
 Describe: Determination of Local District Eligibility
 *P11. Report Citation: none
 *Attachments: NONE Map Sheet Continuation Sheet Building, Structure, and Object Record Linear Resource Record Archaeological Record District Record Milling Station Record Rock Art Record Artifact Record Photograph Record

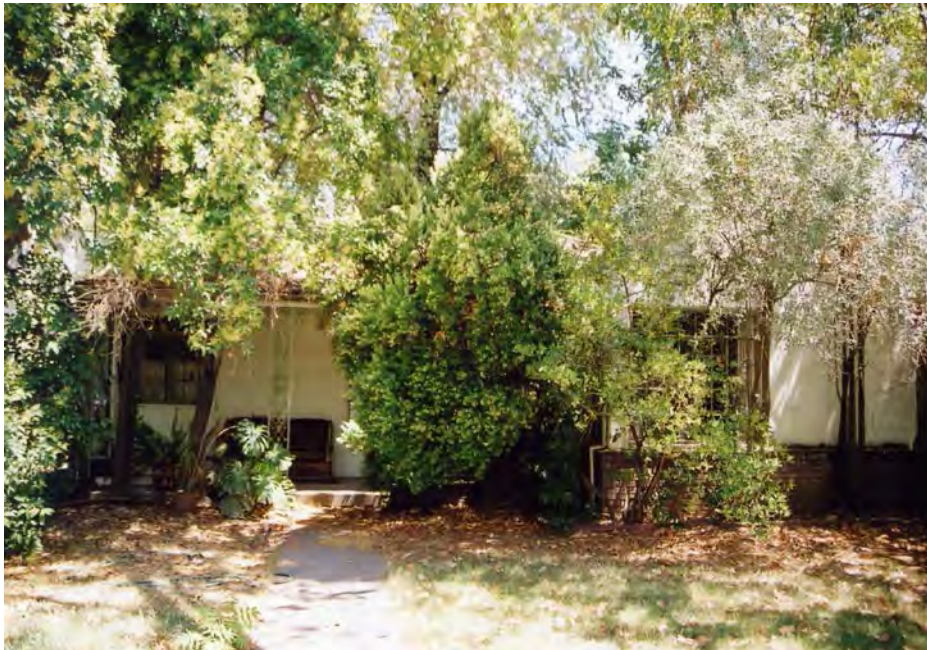
P5. Photograph or Drawing (Photograph required for buildings, structures, and objects.)

This Minimalist Traditional house has been allowed to deteriorate. The porch posts have been replaced by wrought iron garden frames and the original door has been replaced. On a simple house without much original architectural embellishment, these changes have had a significant effect on the character of the house. It is heavily obscured from view of the street by vegetation. The house no longer retains its architectural character or integrity. It does not contribute to the historic character of Old North Davis or to a historic district eligible for listing on the California Register.

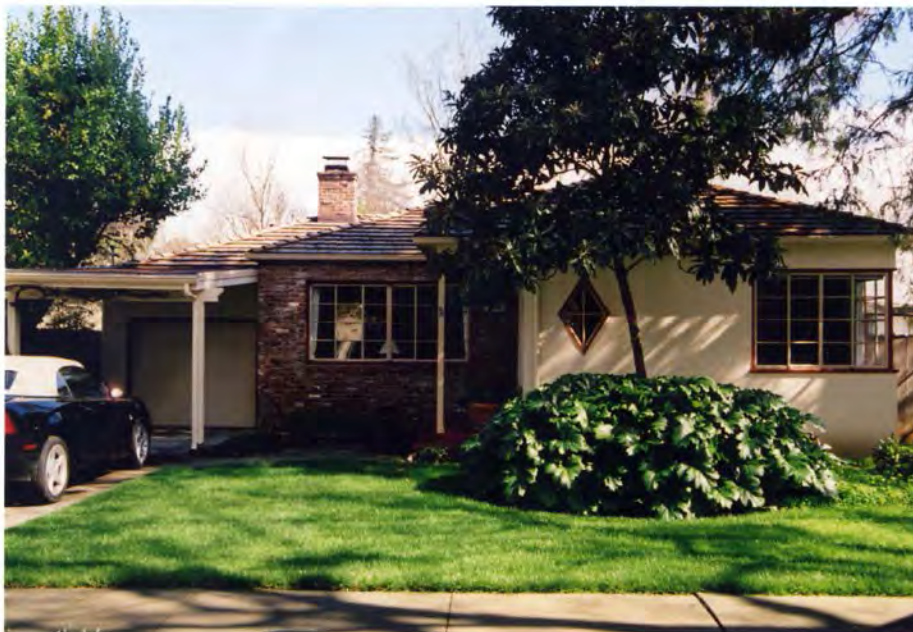
P5. Photograph or Drawing (Photograph required for buildings, structures, and objects.)

A Minimalist Traditional house constructed in the early 40's, this residence is a single-story, cross hip roofed structure with an L-shape plan. Like its neighbor at 517 D Street, it is an example of early attempts to integrate the garage into the envelope of the house. Unlike its "snout-house" neighbor, the garage is stepped back from the façade on the north side of the house. Of wood frame construction, the house is predominantly clad with stucco, with one wall of the front façade faced with used brick. Fenestration consists of metal casement, multi-light windows. A wrap-around corner window, of the type that became popular in the early 1940s is found on the south corner of the front facade. A decorative, multi-light triangular window is placed to illuminate the entry vestibule. A porch runs along the north wall of the front façade. It consists of a low concrete stoop covered by an extension of the hip roof supported on one end by a 2X4 post. The entry is oriented toward the driveway, another indication of the growing importance of the car in domestic design. A rectangular, brick chimney pierces the ridge of the rear hip roof. A carport projects from the front of the garage and is a later addition. This nicely maintained home is a good example of its style type and retains its integrity of design, materials, workmanship, setting, feeling and association. It appears to contribute to a district eligible for the California Register.

*P3b. Resource Attributes: HP2
 *P4. Resources Present: Building
 Structure Object Site
 District Element of District
 P5b. Description of Photo:
 View east
 *P6. Date Constructed/Age:
 1941 62 years old documented
 Prehistoric Historic
 Both
 *P7. Owner and Address:
 Eric roe
 522 D Street
 Davis, CA 95616
 *P8. Recorded by:
 Carol Roland
 Roland-Nawi Associates
 4829 Crestwood Way
 Sacramento, CA 95822
 *P9. Date Recorded: 04/07-10/2003
 *P10. Type of Survey: Intensive
 Reconnaissance Other
 Describe: Determination of
 Local District Eligibility
 *P11. Report Citation: none
 *Attachments: NONE Map
 Sheet Continuation Sheet

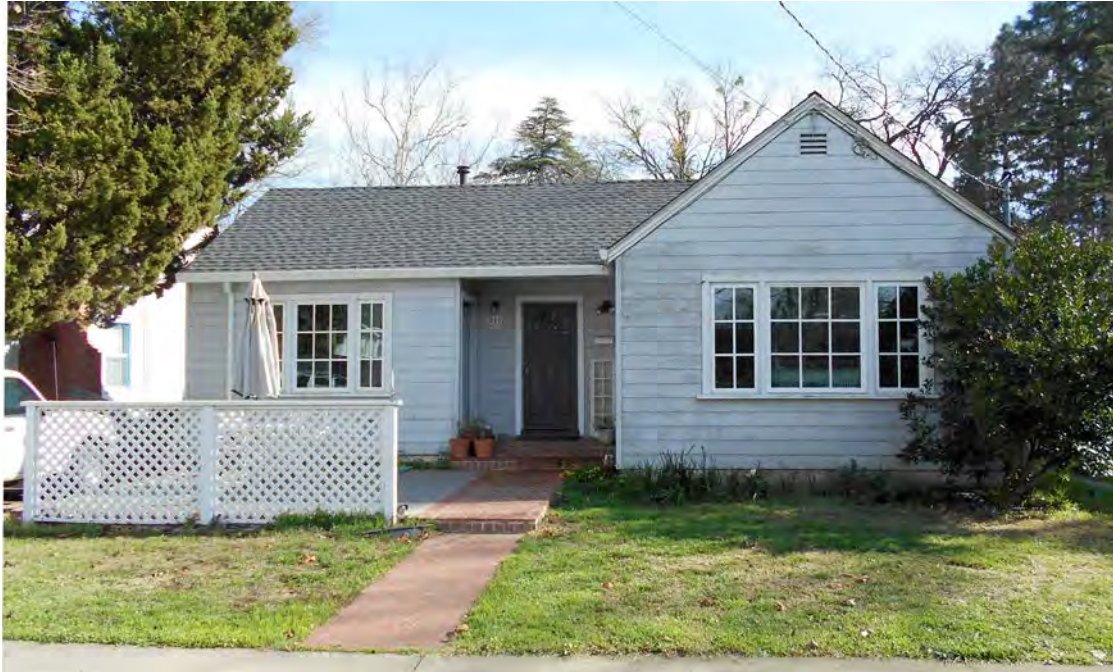
*P3a. **Description:** See original form for architectural style. 2015: Original windows removed. New windows are Aluminum double glazed, compatible style. 2013 wooden deck and railing (not original) now replaced by concrete slab with brick trim, sensitive in design. Original 8” wood bevel siding remains. Original house is now 76 years old.

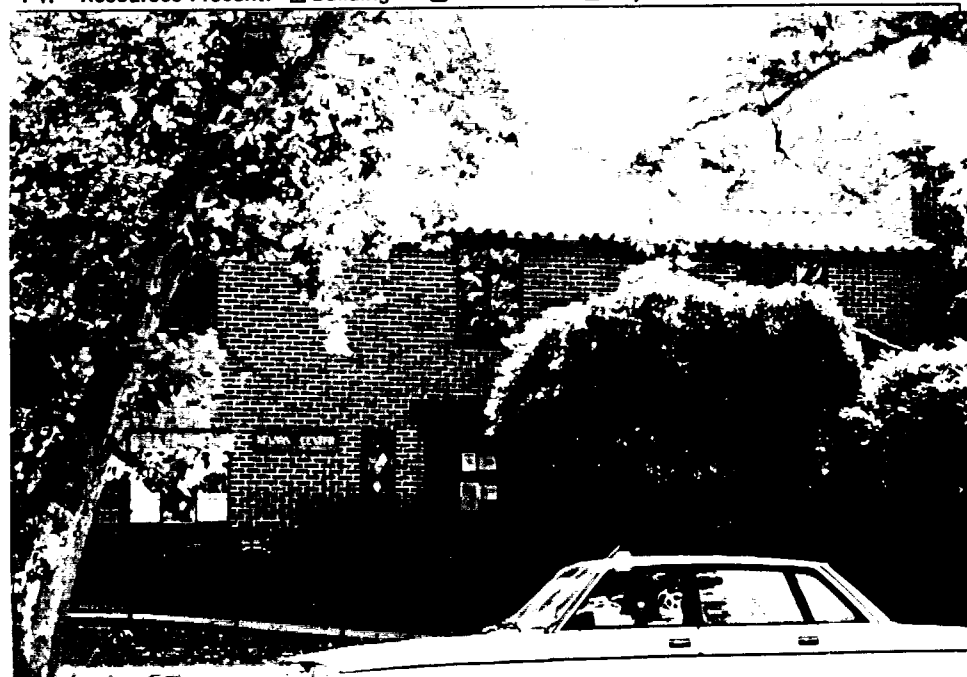
Front Facade

6. Briefly describe the present physical appearance of the site or structure and describe any major alterations from its original condition:
 This two story gabled brick rectory relates to the adjacent church because of its brick construction and red tile roof. Stylistically however, it is closer to the Spanish Colonial Revival than to the Romanesque imagery of its next door neighbor. The wall surface is animated by a pattern of darker bricks. There is a recessed entry with a heavy wooden lintel. The windows are metal casements, and there is a small window near the entrance which is composed of small, diamond-shaped panes.

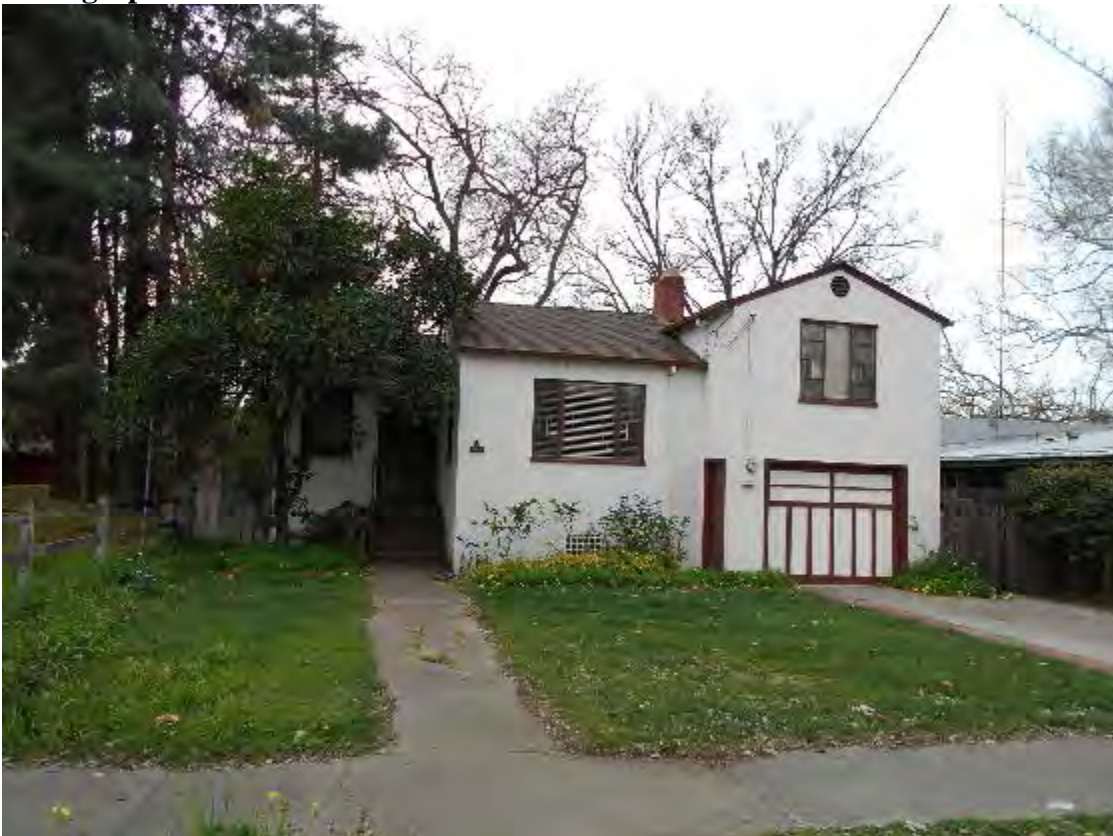
*P3a. **Description:** See original form for architectural style and features. Since 2003, the building has been minimal altered. The most apparent change has been made to the garage door, which has either been repainted or replaced (yet again, as noted in the original form).

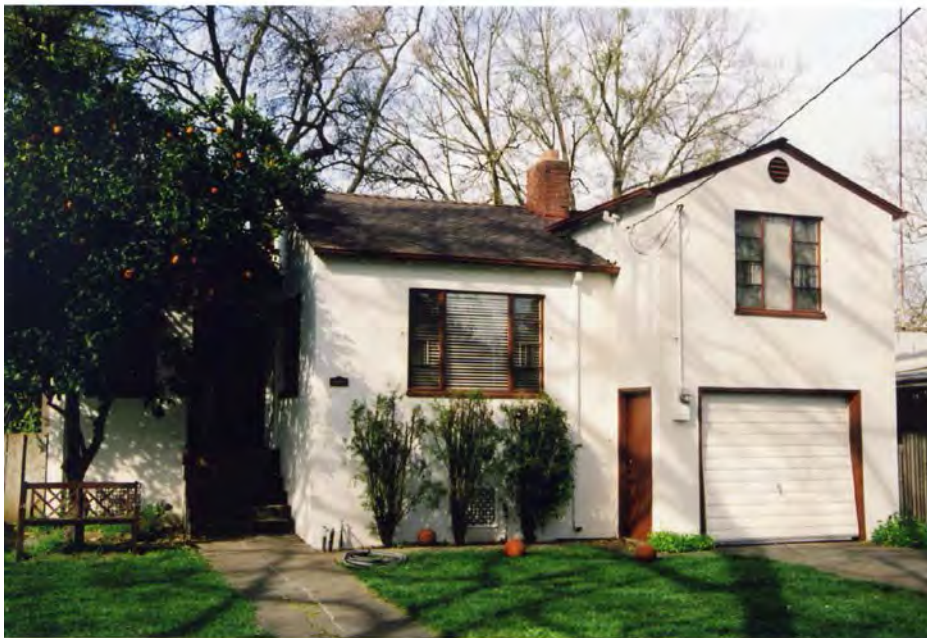
This complex plan house is a one and one-half-story, stucco clad building with a moderately pitched cross gable roof. A unique feature of the house is its attached garage, an example of early attempts to integrate the garage into the principal structure, and an indication of the growing prominence of the automobile in suburban life. The placement of the garage in the projecting north façade, with living space above, foreshadows later “snout-house” designs where the garage becomes a principal focus of the front façade. The original garage doors, probably wooden, have been replaced with an aluminum tilt-up. The original doors, by virtue of their placement, were a prominent decorative element and their removal diminishes the integrity of a visually important façade. The cross gable roof is shingle with closely cropped gable ends and eaves. Fenestration consists of metal casement windows with single light central panels and multi-light sidelights. The front façade steps back in three parts, creating three distinct bays with a cut in entry located between the center and south bay. The house is relatively unembellished by decorative detail and might be categorized as either highly simplified Mediterranean Revival or Minimal Traditional in style. Although the garage door replacement diminishes the integrity of design and materials to some degree, the house is otherwise unaltered and appears to retain sufficient integrity of design, materials, workmanship, setting, feeling and association to contribute to a district eligible for the California Register.
