Attachment B

DEPARTMENT OF PARKS AND RECREATION 523 FORMS

Updates produced during current project attached to forms produced during previous studies

*P11. Report Citation: Davis, California: Citywide Survey and Evaluation of Buildings Constructed Prior to 1976

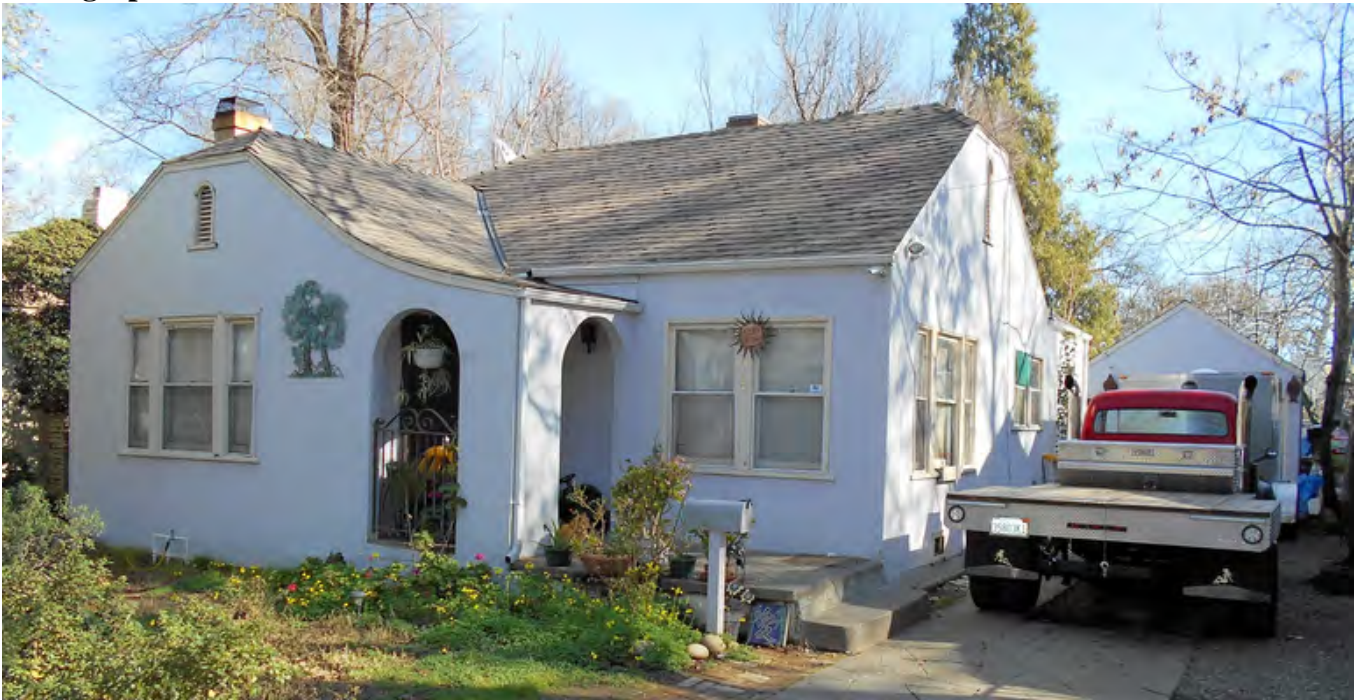
*P3a. **Description:** See original form for architectural style and features. The 2003 form should have noted that the front and side gables were clipped. A wooden awning over the front window has been removed since 2003.

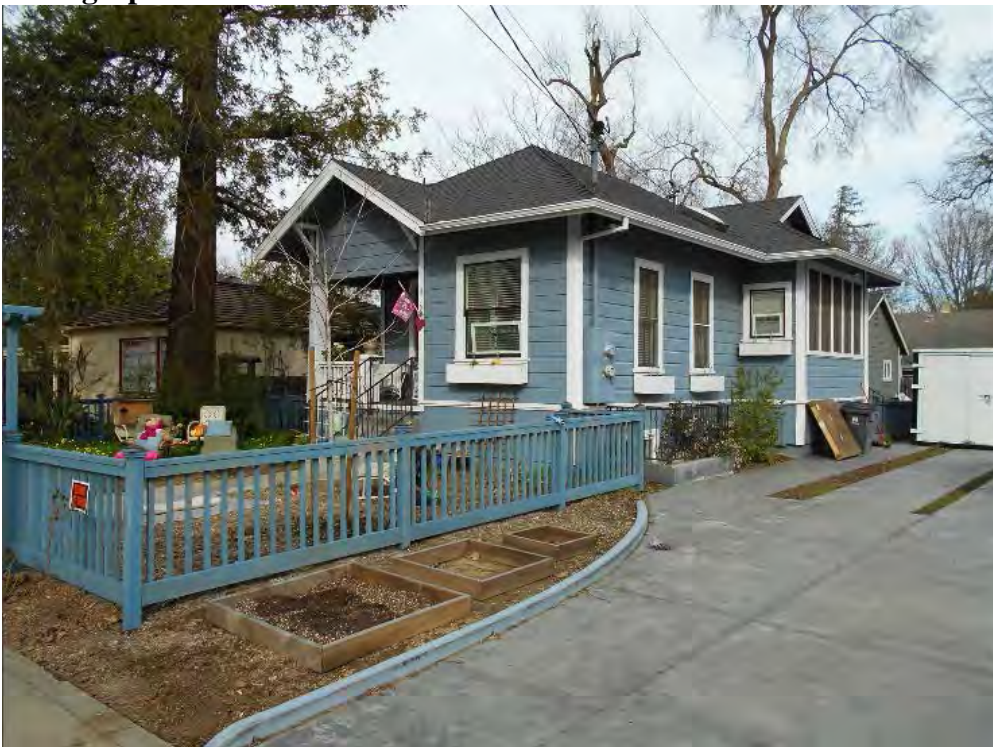
*P3a. **Description:** See original form for architectural style and features. Since 2003, the building has been renovated. Apparent exterior changes include new paint (façades and trim), installation of replacement vinyl windows and planters under the windows, and construction of a short gated fence enclosing the front lawn.

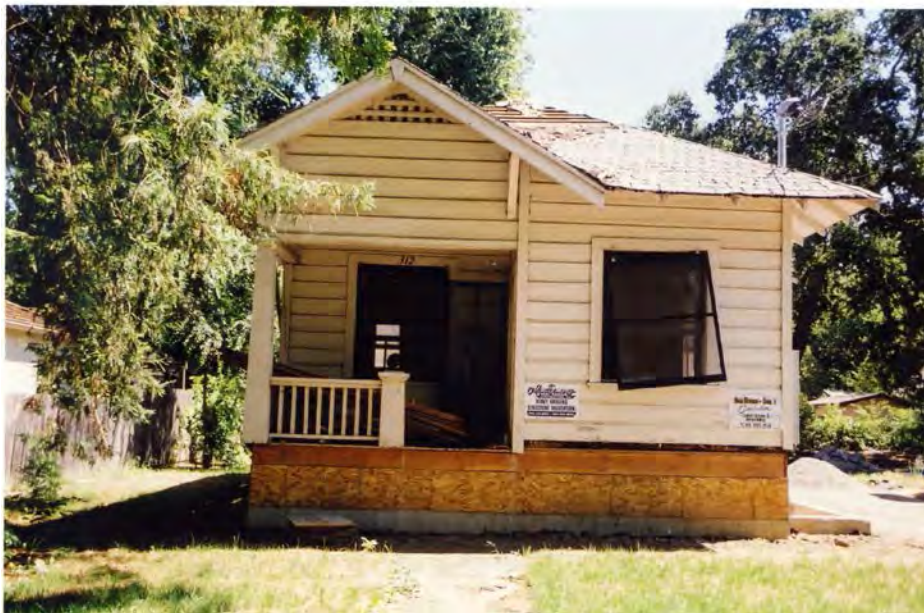
*P3a. Description:
 This hip roof, rectangular plan house with a cut-in porch on the north side According to local sources this house was originally on the historic school block (3rd, B and C Streets). Circa 1918-19 it was moved to 312 D Street because of the construction of a larger school in 1918. It was purchased in 1999 and moved to its present site, a vacant lot at 516 D Street. In its present condition the house consists of the exterior shell of the building which retains its original design, form and cladding. The house is important for its architectural style, early Craftsman Bungalow. Its siting, orientation and setting are consistent with its former location. If restored sympathetically it would contribute to an Old North Historic District.

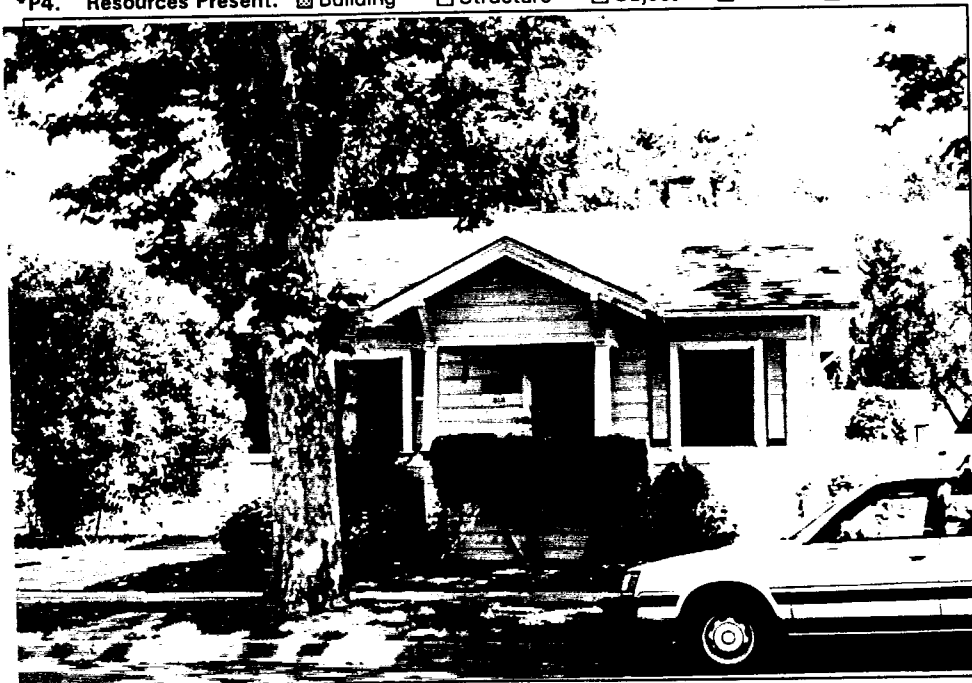
P5b. Description of Photo: (View, date, etc.)
 Front elevation
 Looking north

This is a simple, one story vernacular house with a classically inspired gabled porch. The porch is accessed via side stairs along the eastern end of the front elevation. Two classically proportioned columns support this raised porch. The roof of the main portion of the house is gabled running parallel to the street. An interior brick chimney rises from the rear of the house. The windows are double hung with shutters. The house is clad in white painted horizontal plank siding and is in generally good condition.

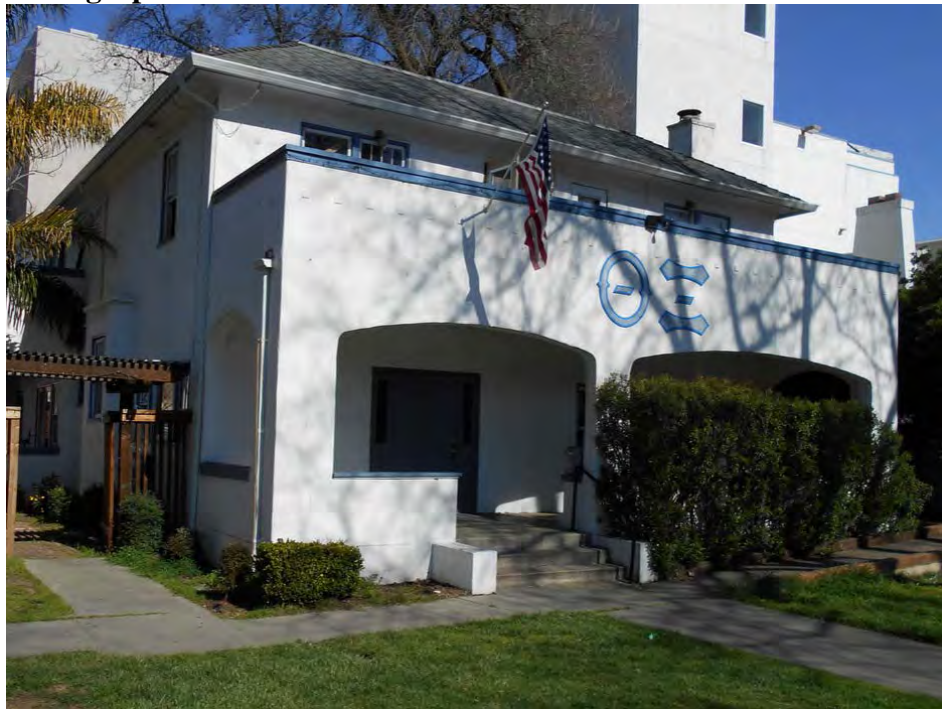
*P3a. **Description:** See original form for architectural style and features. No changes noted from 1996 and 2003 other than re-roofing with similar materials.

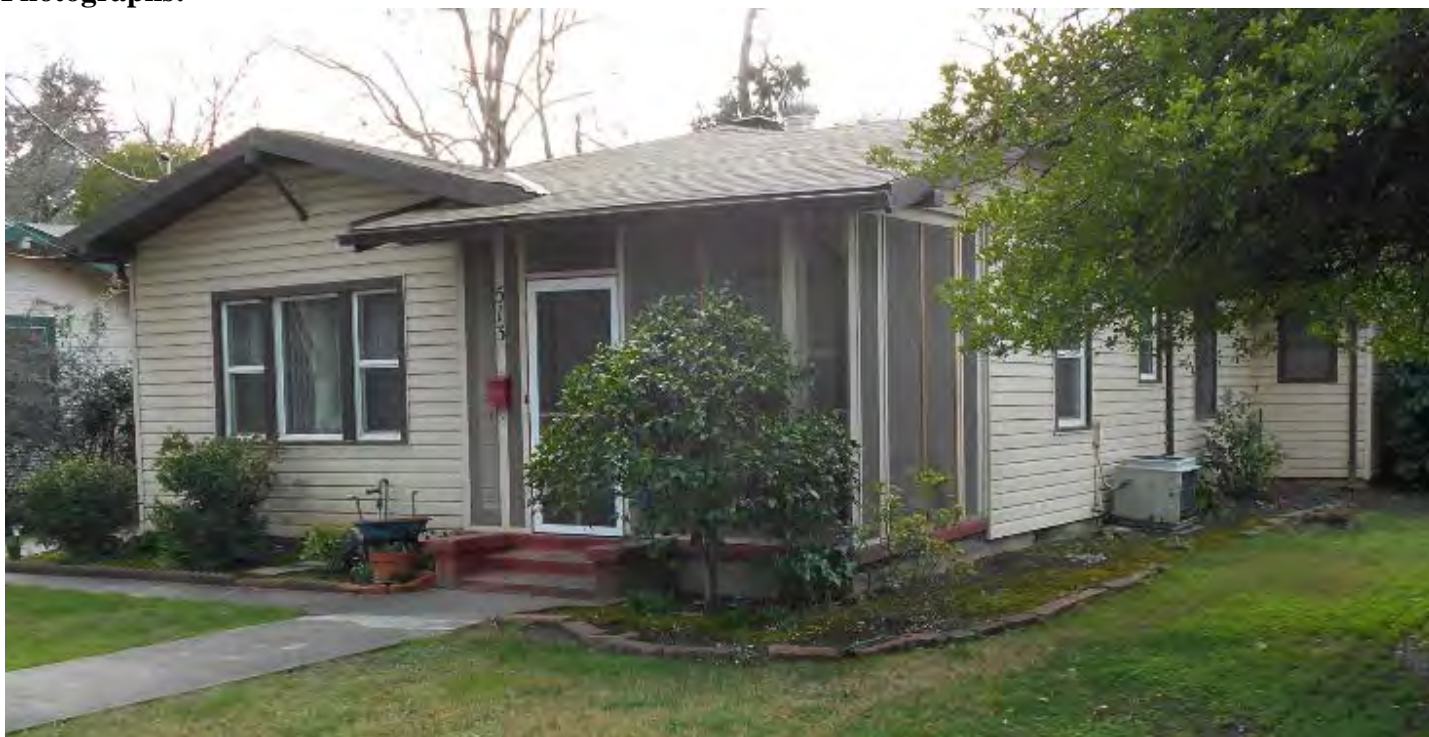
*P3a. **Description:** See original form for architectural style and features; aside from the replacement of the front screen door, this building appears substantially the same as it did when it was inventoried in 2003.

See original form; replacement of the front screen door notwithstanding, this building retains sufficient integrity to warrant its previous evaluation.

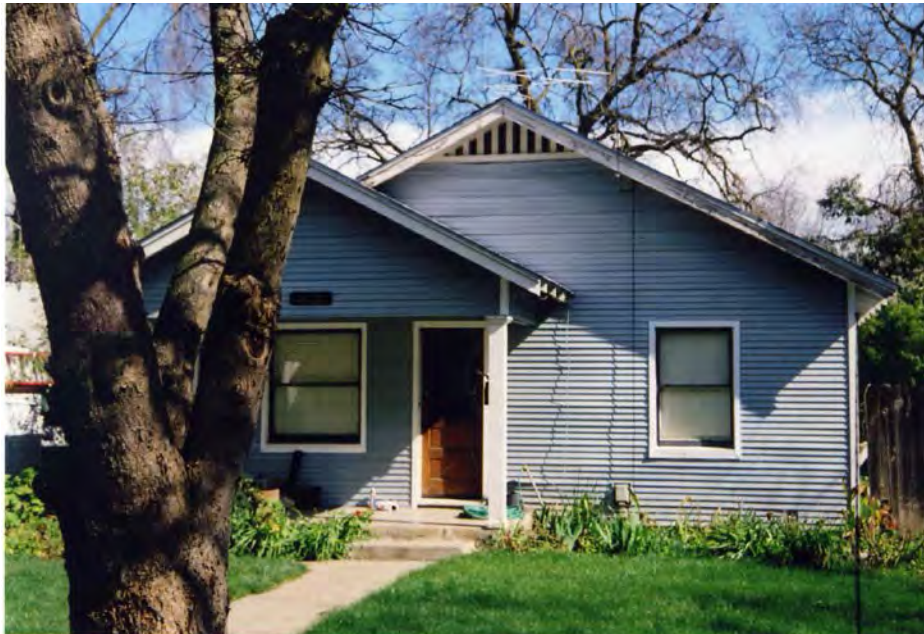
*P3a. Description:
This double gable California Bungalow was constructed in 1923. Rectangular in plan it has a projecting front gable on the north side of the front façade with wide gable overhangs and exposed rafter tails. The gable overhang covers a small cement porch and is supported on 4X6 posts. The porch posts and cement slab appear to be replacements of originals. Fenestration is asymmetrically arranged and consists of one-over-one double hung windows. The building is clad with narrow horizontal novelty siding. The entry door is a replacement. The house retains its integrity of design, setting, feeling and association, but its integrity of materials and workmanship have been compromised by unsympathetic replacement. The residence does not appear to contribute to a district eligible for the California Register.

*P3b. Resource Attributes: HP2
*P4. Resources Present: Building Structure Object Site District Element of District
*P5b. Description of Photo:
View east
*P6. Date Constructed/Age:

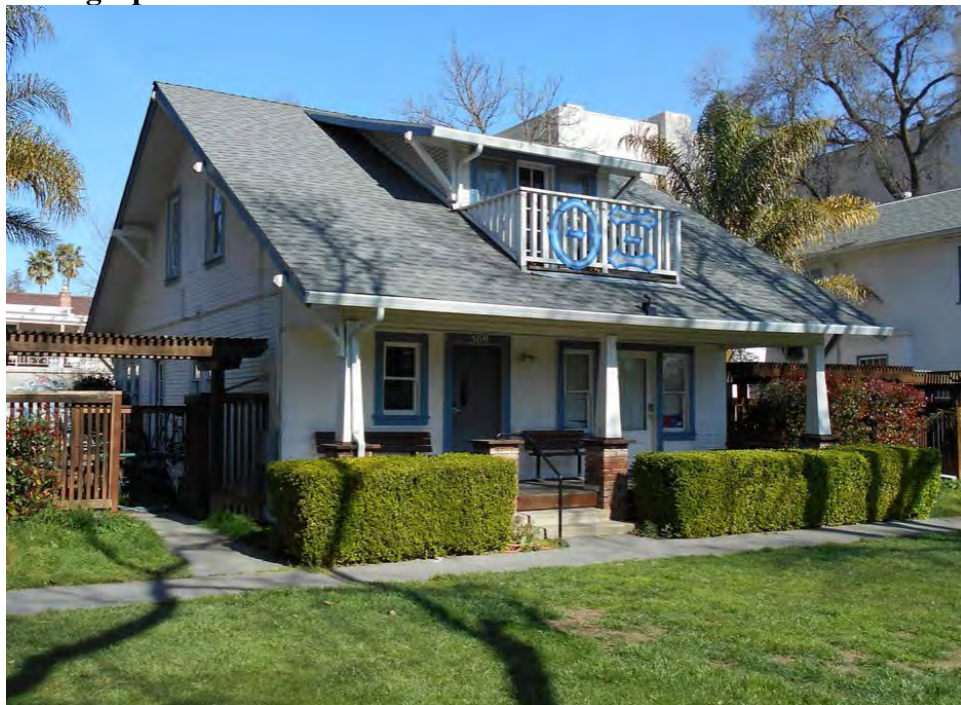
*P3a. **Description:** See original form for architectural style and features. No changes noted from 2003 other than re-roofing with similar materials.

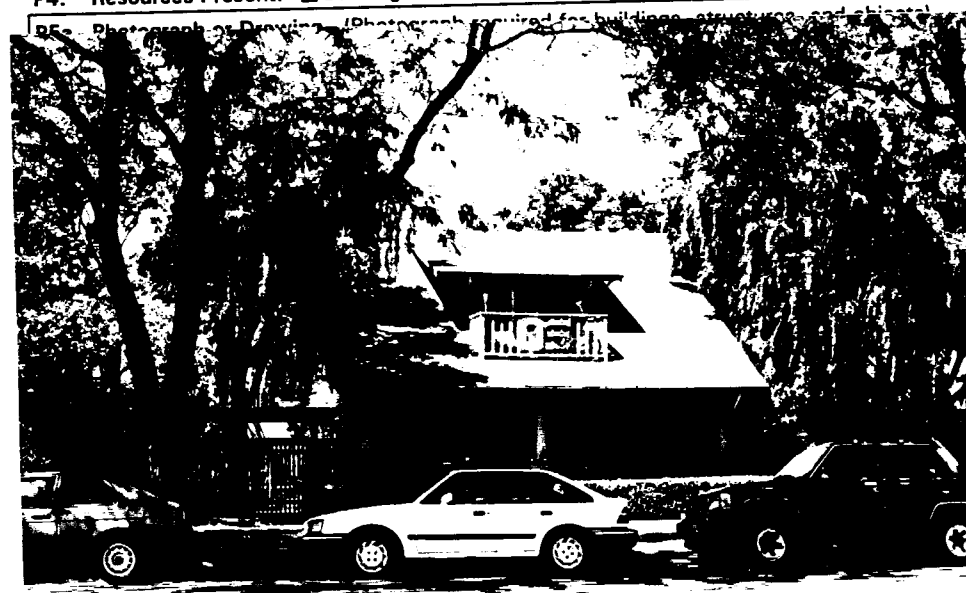
P5b. Description of Photo: (View, date, etc.)
Front facade
looking north

This house resembles its neighbor, 503 First Street. The structure is a one and a half story Craftsman house with a gable roof running parallel to First Street. The gable roof is punctured by a large attic dormer with a balcony. The first floor porch is supported by three canted, but thin posts, that rest on brick bases. A slat railing is present. The house is sheathed in clapboard and is painted tan with blue trim. The house appears to be in fair condition and is presently occupied by a fraternity associated with the University.

This house appears on the 1921 Sanborn Map but not the 1911 Map indicating the likely date of construction as 1911 to 1920. The house contributes to the overall character of the streetscape along this end of First Street. The house at 503 First Street is similar in character and detailing to this house. Both houses are presently occupied by the same fraternity. The houses are in fair condition.

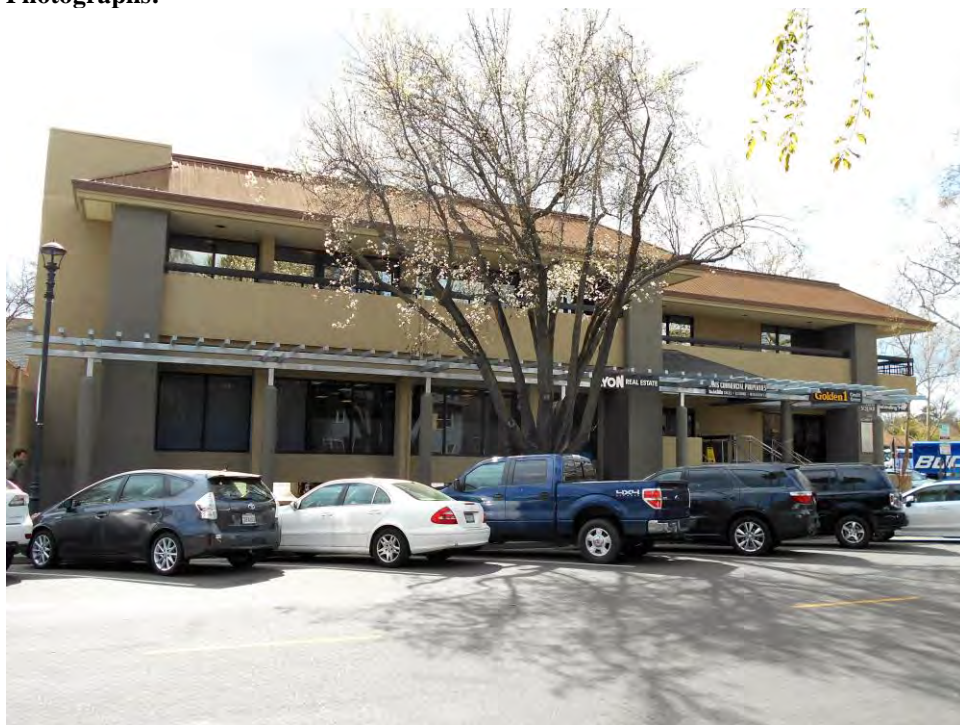
*P3a. **Description:** Building included in 1980 survey, State Market was demolished and replaced by the current building, Regency Square, that houses Golden 1 Credit Union.

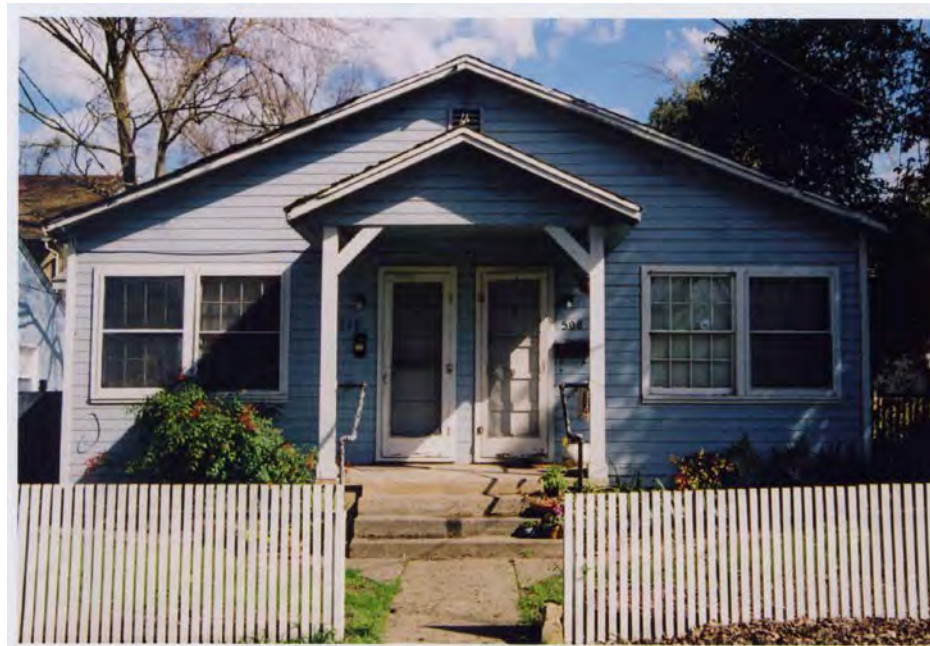
According to John Lofland (*Old North Davis*, Yolo County Historical Society, 1999), this double bungalow was originally a single family dwelling constructed in 1929 and converted in 1940. It is rectangular in plan with a moderately pitched front gable roof. Gable and eave overhangs are minimal with clipped ends. This uncharacteristic bungalow treatment may be the result of the later alteration. The gable end is trimmed with a narrow fascia, as is the gable end of the porch roof. A central, gable roofed projecting porch is centered on the façade, framing the side-by-side duplex entry doors. The porch roof is supported on braced 2X4s. The porch appears to be a replacement, possibly added in 1940. It is not possible to discern the configuration of the original porch or if it has been enclosed to create the flat façade that the building presents to the street. Fenestration consists of eight-over-eight double hung windows. The pairing of these windows lends a strong horizontal emphasis to the front façade. The window sash and glazing are original, but it is unclear if their position was changed to accommodate the conversion in occupancy. The conversion of the house and the accompanying alterations to the porch, entry doors, and possibly the front façade, fall within the period of significance. Therefore, the house retains the integrity of the 1940 building. It appears to be unaltered and it contributes to a district eligible for the California Register.

- *P3b. Resource Attributes: HP2
- *P4. Resources Present: Building
 Structure Object Site District Element of District
- P5b. Description of Photo:
View east
- *P6. Date Constructed/Age:
1929 74 years old documented
 Prehistoric Historic
 Both
- *P7. Owner and Address:
Patricia Loomis
PO Box 482
Davis, CA 95617
- *P8. Recorded by:
Carol Roland
Roland-Nawi Associates
4829 Crestwood Way
Sacramento, CA 95822
- *P9. Date Recorded: 04/07-10/2003
- *P10. Type of Survey: Intensive
 Reconnaissance Other
Describe: Determination of
Local District Eligibility
- *P11. Report Citation: none
- *Attachments: NONE Map
Sheet Continuation Sheet

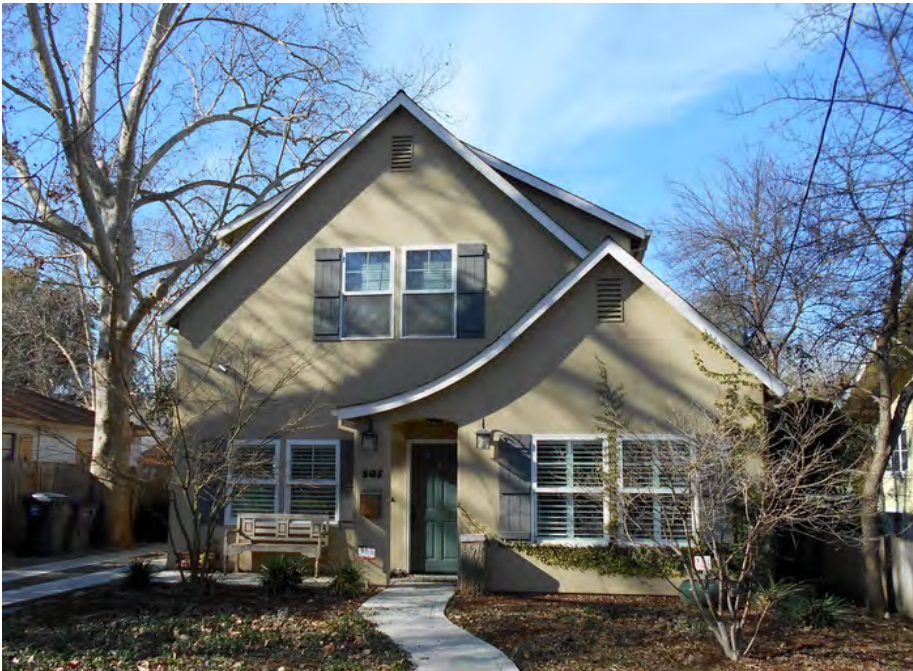
*P3a. **Description:** The small bungalow that was on this lot in 2003 has since been demolished and replaced by this new two-story residence.

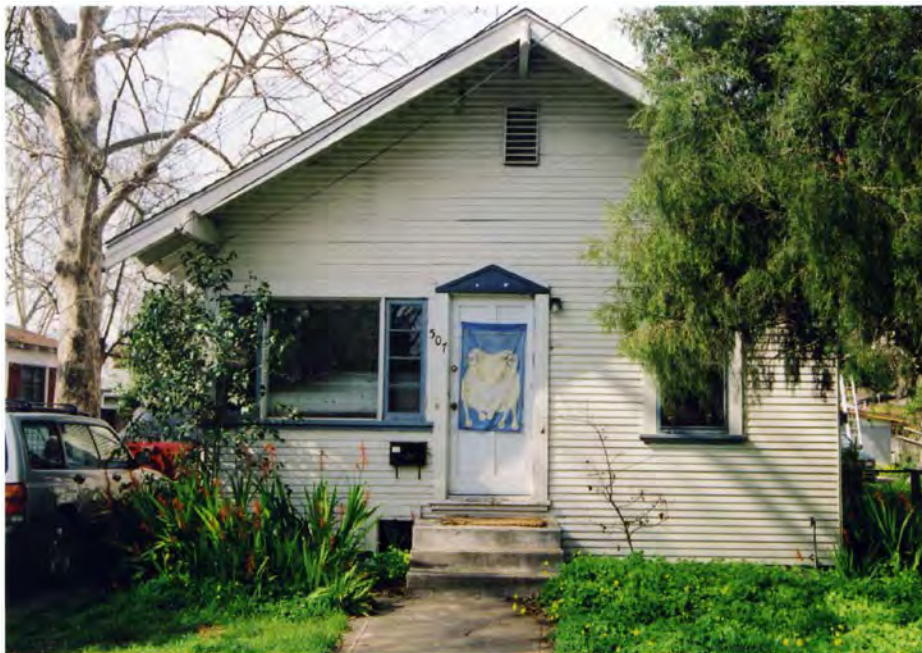
This rectangular plan bungalow is surmounted by a moderately pitched front gable roof. The gable overhang is supported by projecting purlins and is trimmed with a plain fascia. There is a small decorative attic vent just below the gable ridge. The exposed rafter tails emphasize the wide eave overhang. The planar front façade of the house appears to result from later alteration which enclosed the original porch, leaving the house with an uncharacteristic cement stoop porch. The entry door and the south window of the front façade are replacement. Other fenestration consists of double hung windows. The building is clad with a narrow novelty siding. Although the craftsman/bungalow origin of the house is still evident in its form, massing and roof treatment, the enclosure of the porch has deprived the building of some of its essential character defining features. The house does not retain its integrity of design, materials, and workmanship and it does not appear to contribute to a district eligible for the California Register.

*P3b. Resource Attributes: HP2
 *P4. Resources Present: Building Structure Object Site District Element of District
 P5b. Description of Photo:
 View west

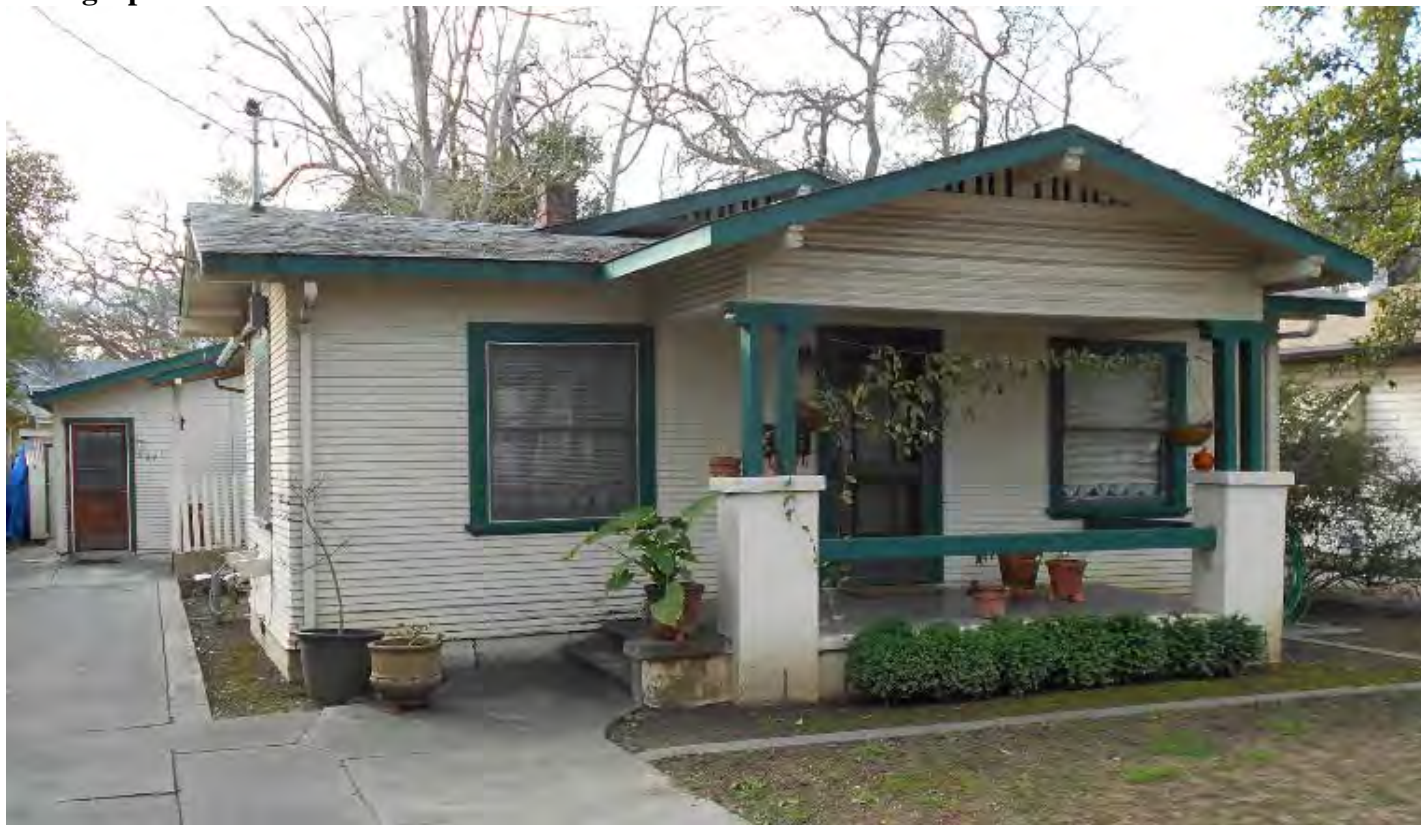
*P3a. **Description:** See original form for architectural style and features; aside from the replacement of the front screen door, this building appears substantial the same as it did when it was inventoried in 2003.

See original form; the replacement of the screen door notwithstanding, the building retains sufficient integrity to warrant its prior evaluation.

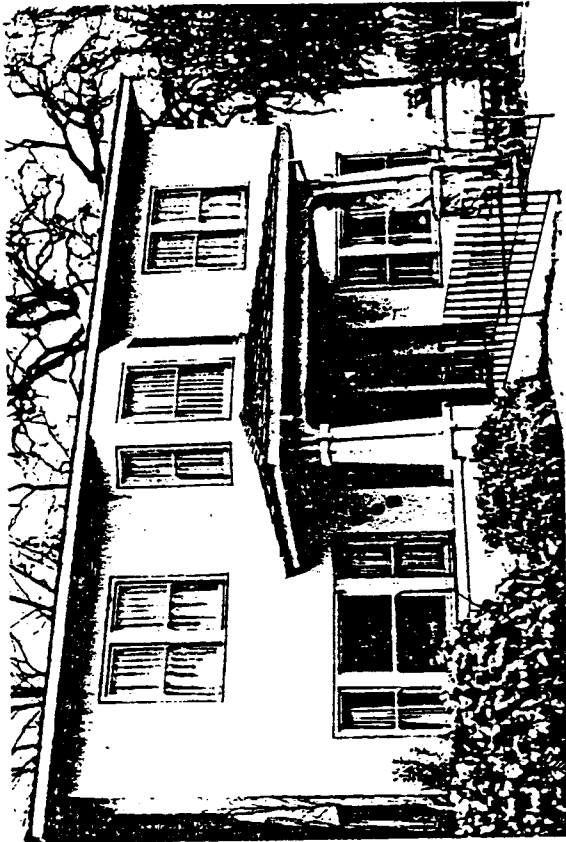
This two story hip-roofed house is symmetrical in composition. The formality of the facade derives from Colonial Revival and Classical Revival examples but the stucco wall surface and the detailing of the porch are essentially Craftsman. There is a central bay window on the second floor. The ground floor entrance has side lights, and is flanked by wide wide windows of tripartite organization. The ramp for handicapped access is a recent addition.

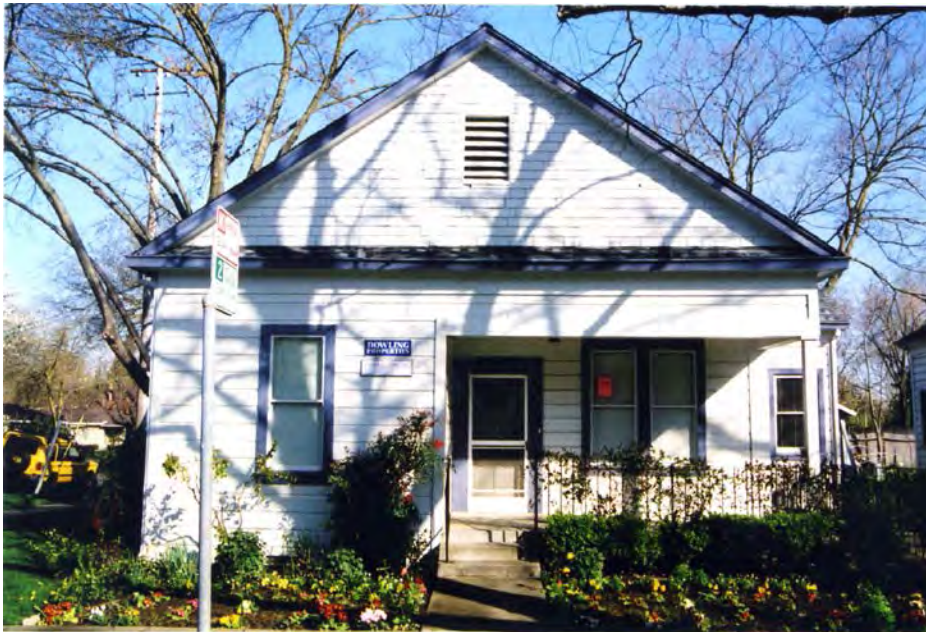
This Craftsman Bungalow/ Vernacular house was identified in previous historical resource surveys. It is associated with the Grieve family, early residents of Davis. With the exception of the replaced porch rails, the building retains integrity of design, materials, workmanship, location, setting and association. It was recognized in the 1996 and 1980 surveys. It appears to contribute to the historic character of the Downtown/ Commercial area of the Conservation District.

*P3b. Resource Attributes: HP2
*P4. Resources Present: Building Structure Object Site District Element of District
*P5b. Description of Photo:
View north*
P6. Date Constructed/Age:
C 1910 93 years old estimated
 Prehistoric Historic
 Both
*P7. Owner and Address:

This was once the home of C.W. and A. Greive, members of the early Davisville Greive family. This small house is typical of vernacular residential design and has some Bungalow features. The house is present on the 1907 Sanborn Map but is out of the city's boundaries on the 1900 map. The construction materials and detailing of this house indicate it was likely constructed between 1900 and 1907 when it appears on the Sanborn Map. The house contributes to the character of the streetscape and is in good condition; however, the porch rails are somewhat out of character. The building now houses Dowling Properties and several other offices.

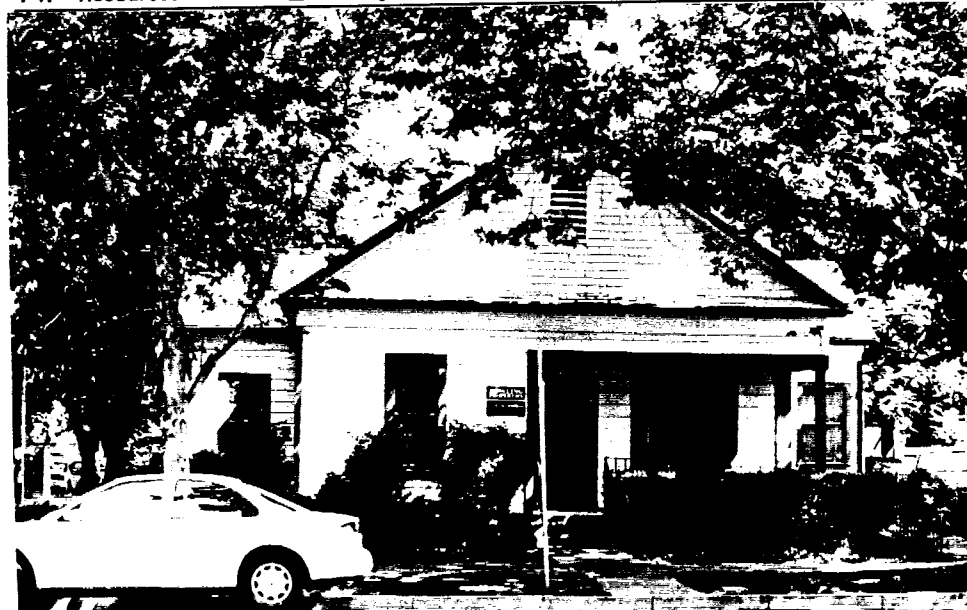
*P5b. Description of Photo: (View, date, etc.)

Front Facade

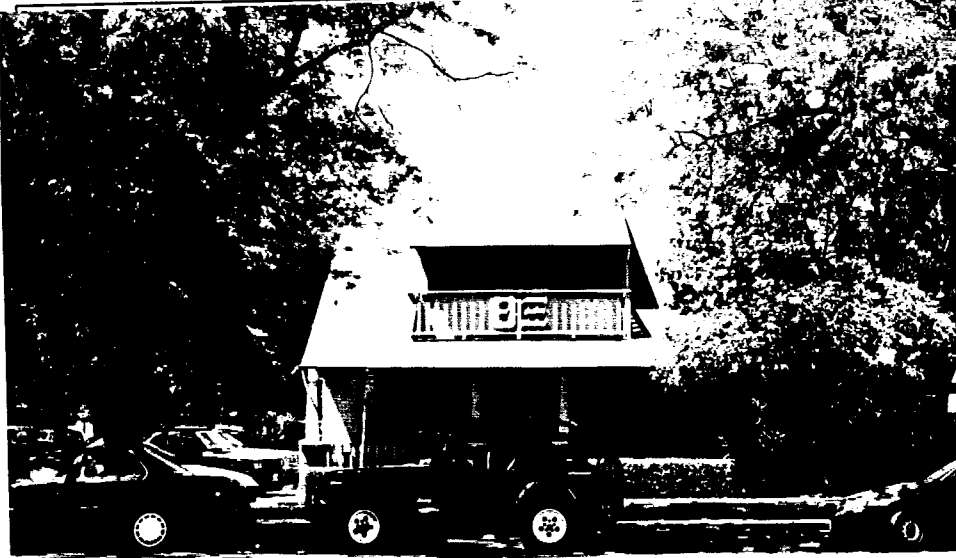
This one and a half story, wood frame, Craftsman style house has a long sloping gable roof running parallel to First Street. The roof is punctured by a large dormer. This attic room dormer has a door that leads to a small balcony. The first floor porch is covered by the long overhang of the gable roof and is supported by four canted, but thin, posts that rest on brick bases. There is a slat railing present. The house is sheathed in clapboard and is painted tan with blue trim. The house appears to be in fair condition and is presently occupied by a fraternity associated with the University.

P5b. Description of Photo: (View, date, etc.)
 Front elevation
 Looking North

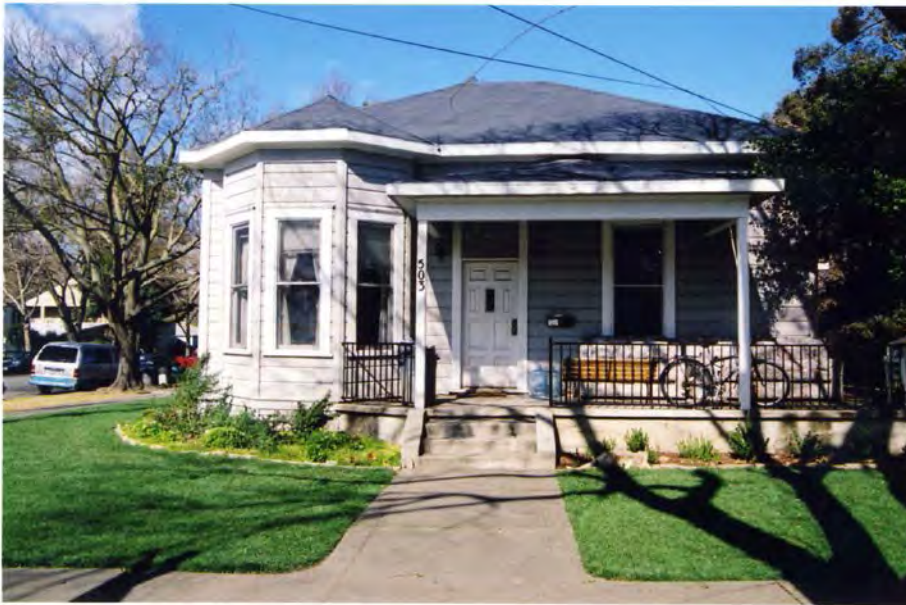
- *P3b. Resource Attributes: HP2
- *P4. Resources Present: Building Structure Object Site District Element of District
- P5b. Description of Photo:
View north
- *P6. Date Constructed/Age:
1896 107 years old documented
 Prehistoric Historic Both
- *P7. Owner and Address:
John Kidd
Arcadian Properties

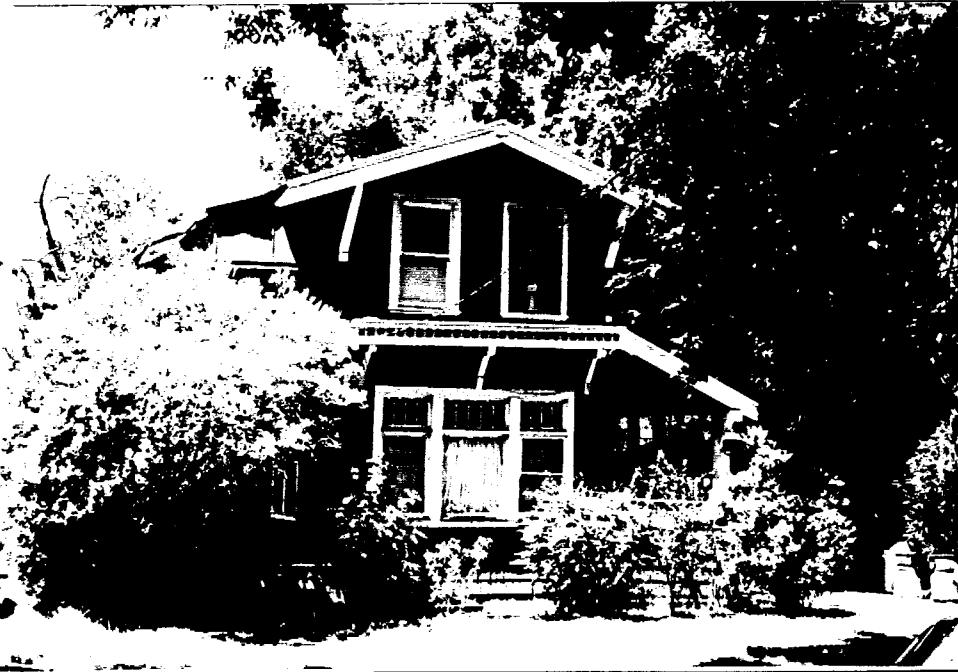
*P3a. Description: (Describe resource and its major elements. Include design, materials, condition, alterations, size, setting, and boundaries.)
The unusual form of this two story shingled Craftsman house appears to be the result of alterations and additions. The form is symmetrical with a large scale tripartite window on the ground floor flanked by deeply recessed entrances. Over this window is a bracketed extension which may be a remnant of the original roof. Above this rises a gabled second story with sleeping porches over the ground floor entry porches.

P5b. Description of Photo: (View, date, etc.)
 Front Elevation
 Looking North

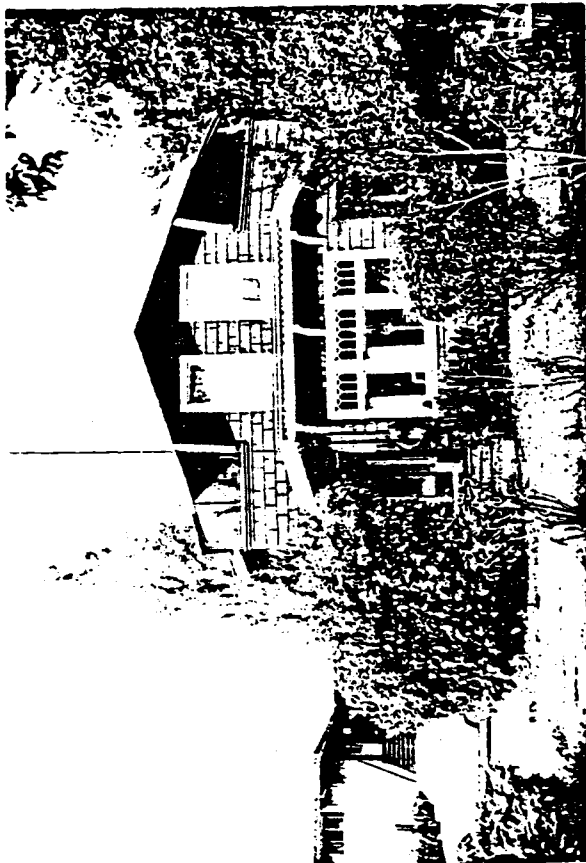
The unusual form of this two story shingled Craftsman house appears to be the result of alterations and additions. The form is symmetrical, with a large scale tripartite window on the ground floor flanked by deeply recessed entrances. Over this window is a bracketed extension which may be a remnant of the original roof. Above this rises a gabled second story, with sleeping porches over the ground floor entry porches.

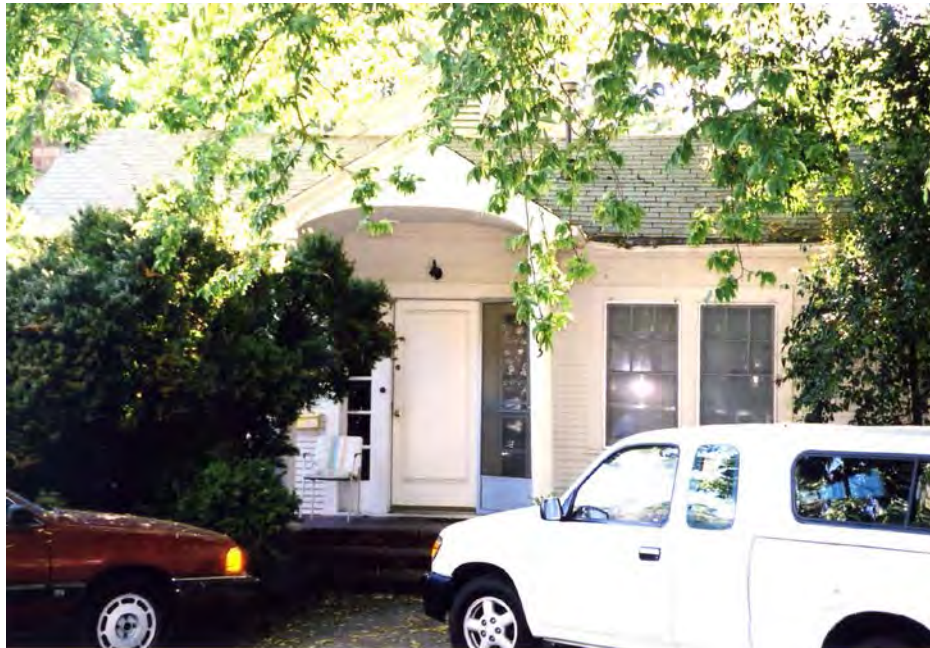
3b. Resource Attributes: HP2
 *P4. Resources Present: Building Structure Object Site District Element of District
 P5b. Description of Photo:
 View west
 *P6. Date Constructed/Age:
