P1. Other Identifier: Hattie Weber Museum

*P11. Report Citation: Davis, California: Citywide Survey and Evaluation of Buildings Constructed Prior to 1976

- *Resource Name or Address 445 C Street
- P1. Other Identifier: Hattie Weber Museum
- *P2. .Location: *a. County Yolo
- b. Address 445 C Street
- *c. City Davis Zip 95616
- d. UTM: N/A
- e. USGS Quad: Davis Quadrangle
- *f. Other Locational Data (APN #): 70-201-001

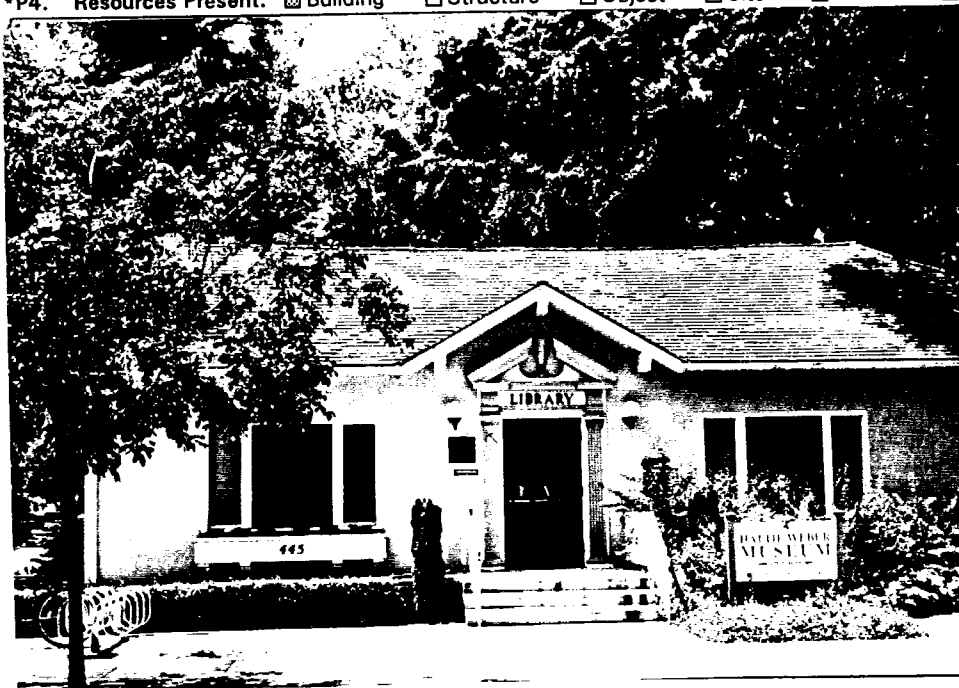
*P5b. Description of Photo: (View, date, etc.)
Front Elevation

This one story stuccoed Colonial Revival building, originally the Davis Public Library, has a jerkinhead gable roof with its ridge parallel to the street. A cross gable in the center of the street facade marks the entrance of the symmetrical composition. The door is flanked by pilasters and topped by a pediment broken with a classically inspired urn. The original Library sign is still present within the pediment. The windows are divided into a tripartite format. The building was moved in 1988 to a prominent site within Central Park and now houses the Hattie Weber Museum.

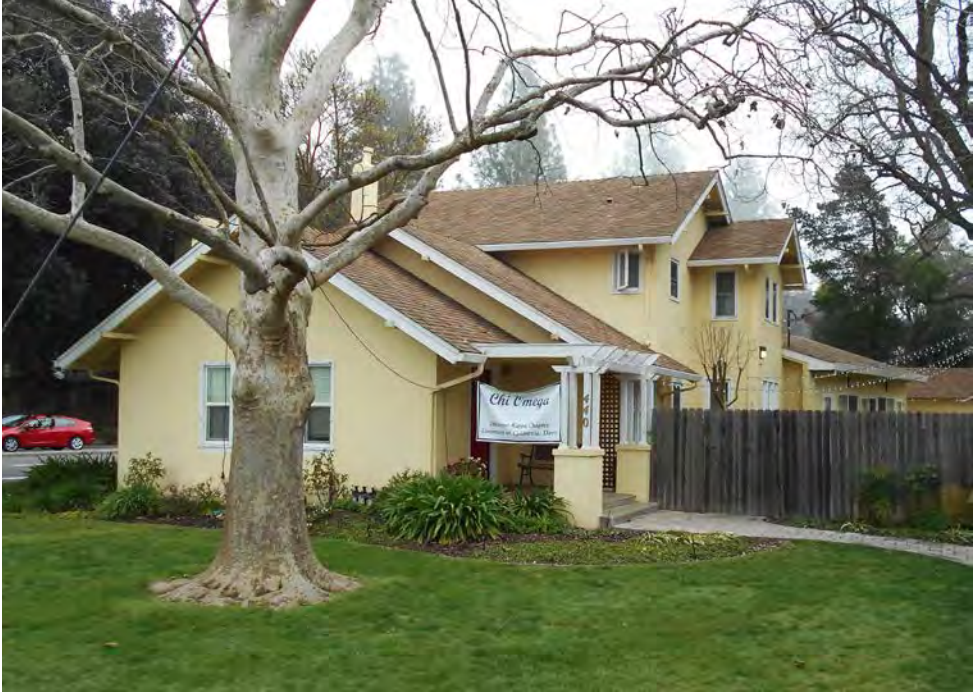
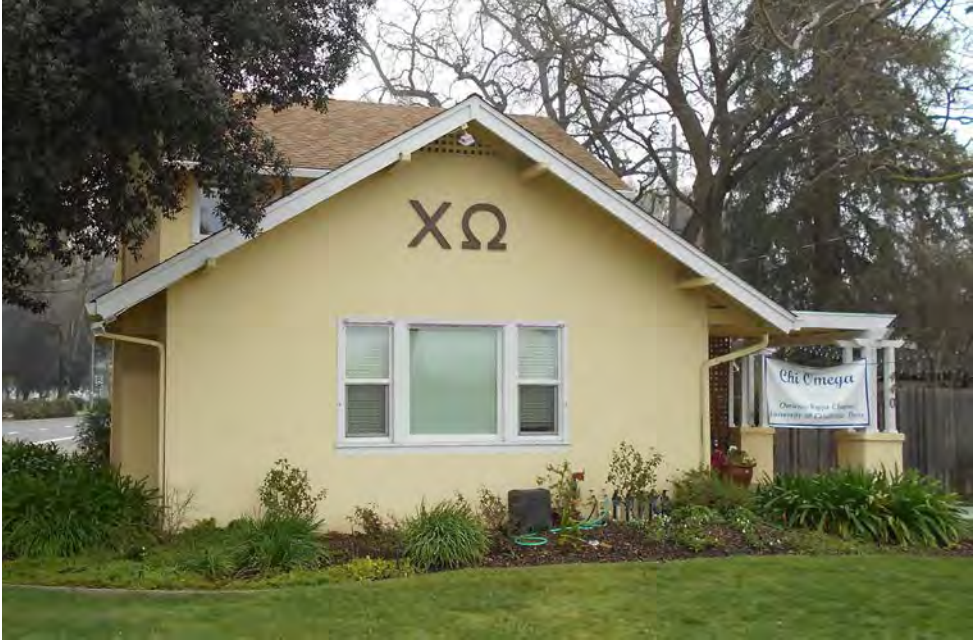
*P3a. **Description:** See original form for architectural style and features. Original double-hung window have been replaced with single-hung Aluminum windows of compatible style except the west central window which lacks the center muntin.

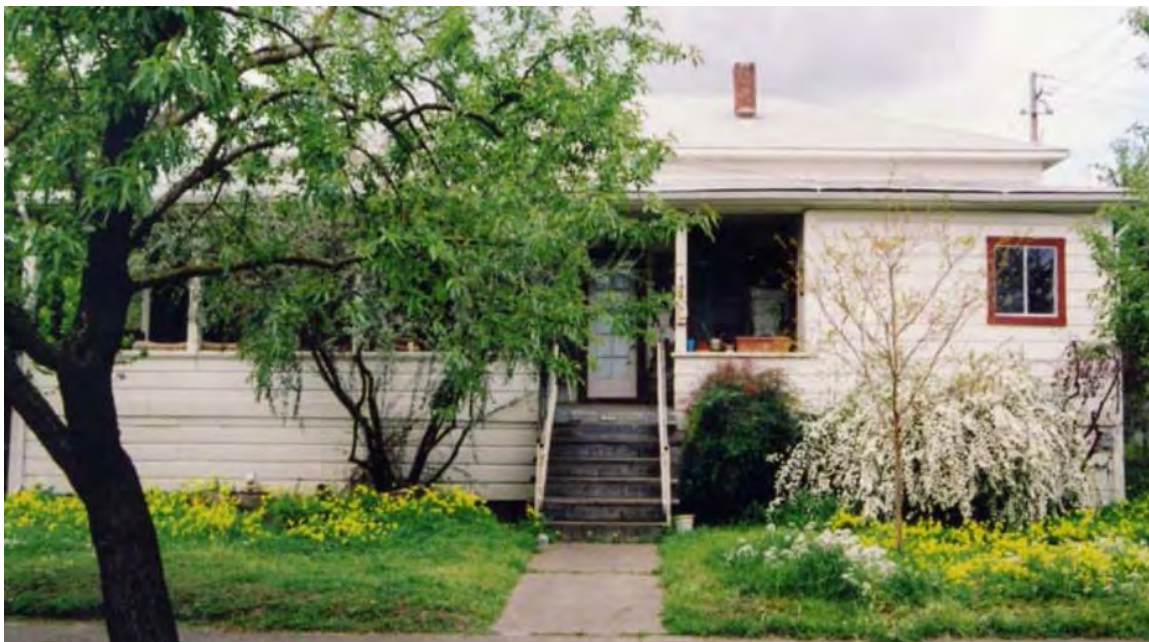
2003 Photograph; note that the right half of the original building has been removed.

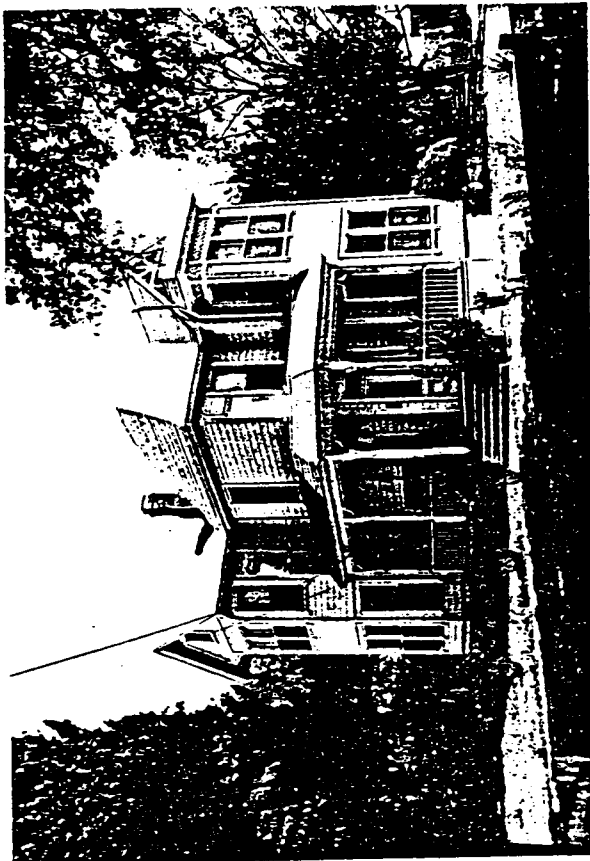
This irregularly shaped two story Stick/Eastlake house is roofed by a combination of hipped and gabled forms. The wood frame house is set on a masonry foundation. There is a machined ornament at the window facings and in the gable ends. The house has square bay windows, which are strongly stick-style in origin, and slanted bays which relate more to the later Queen Anne. There is a wraparound porch and the entry is through a double door with transom. The porch is supported by turned columns with ornamental brackets and the steps are set at an angle towards the outer angle of this corner lot. Presently the house is in in poor condition, however it appears some upgrades are in progress.

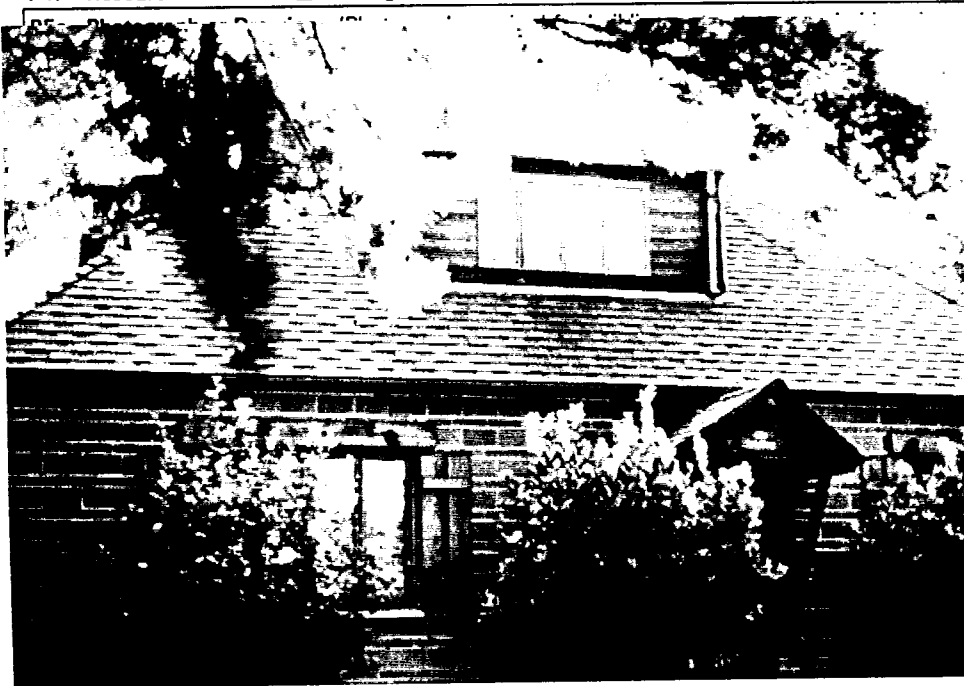
P5b. Description of Photo: (View, date, etc.)
Front Facade

This square, pyramidally-roofed one and a half story cottage is vaguely English or Medieval Revival in its imagery. The facade is symmetrically organized, with a central entry and a centered shed-roofed dormer. There is a symmetrically placed large dormer window within the front face of the roof. The windows are casement type with rustic wood shutters. The wall surface is patterned by alternating horizontal bands of brick and hollow tile.

This home was designed by Tracy and Ruth Storer who lived in the house for many years. Tracy Storer was a zoology professor at the U.C. Campus across the street. The house is unusual in many ways as it incorporates features not found in many Davis homes. Some of these include: tight windows to exclude dust, a fire-resistant exterior, and well-insulated walls. Since the design was unusual the Storer's hired John Jacobson, head of the University's construction and repair shop to supervise the building. This house is significant primarily due to its architectural values which derive from its unusual use of materials and the resultant visual qualities. This style of Period Revival home usually employs brick or half timbering in its choice of material.

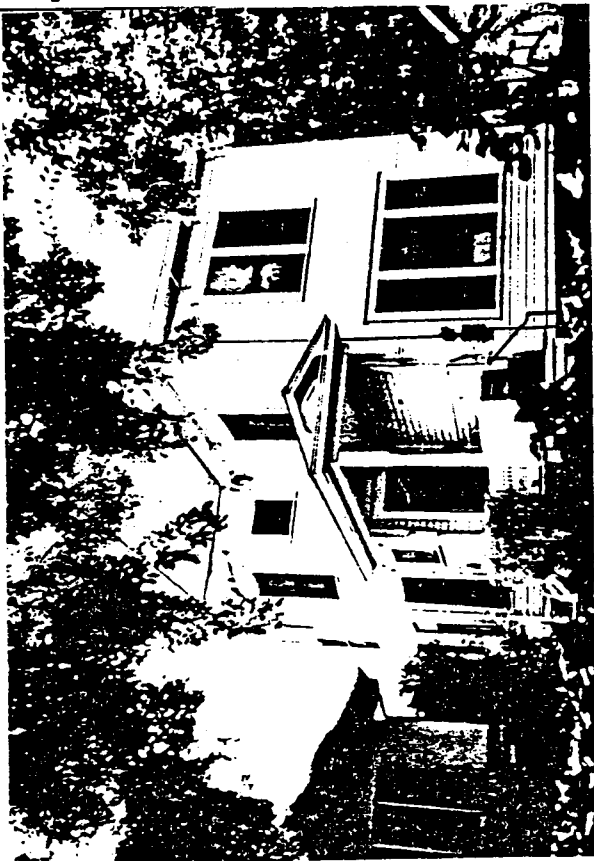
The porch is the focal point with turned balusters and supporting columns. Another decorative touch is the minimal eave bracketing. Facade fenestration patterns are a little unusual with 3 windows at the first floor level and only 2 at the second floor level.

The house contained several stained glass windows of a very unusual design, which were removed by French's daughter, Prudence, when the house was sold.

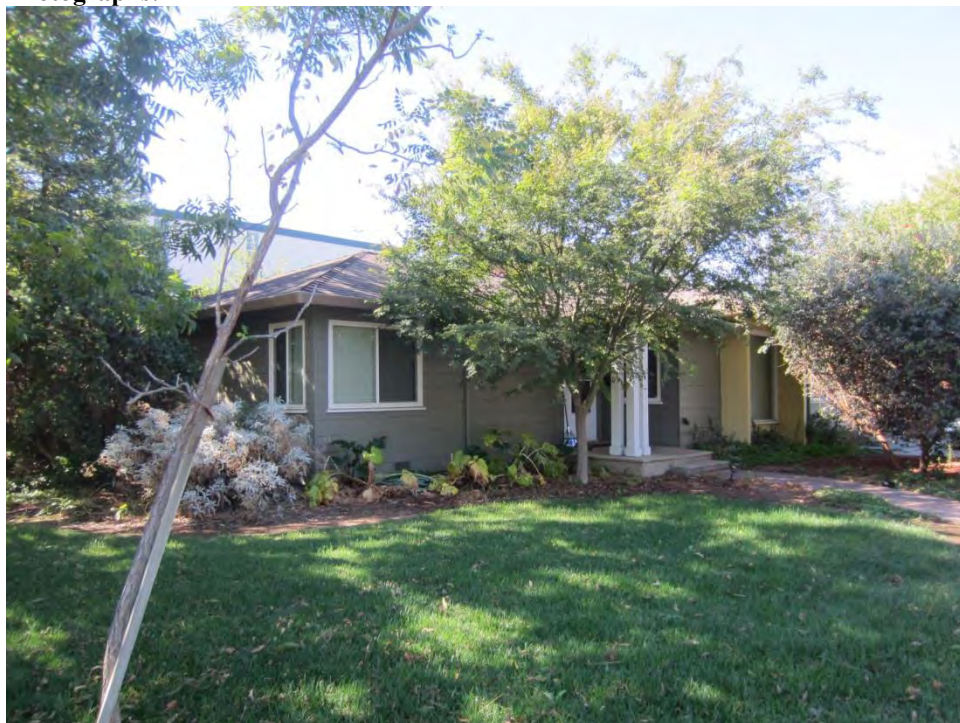
*P3a. **Description:** See original form for architectural style and features. The masonry veneer appears to have been removed, the windows have been replaced, and the building has been divided into a duplex.

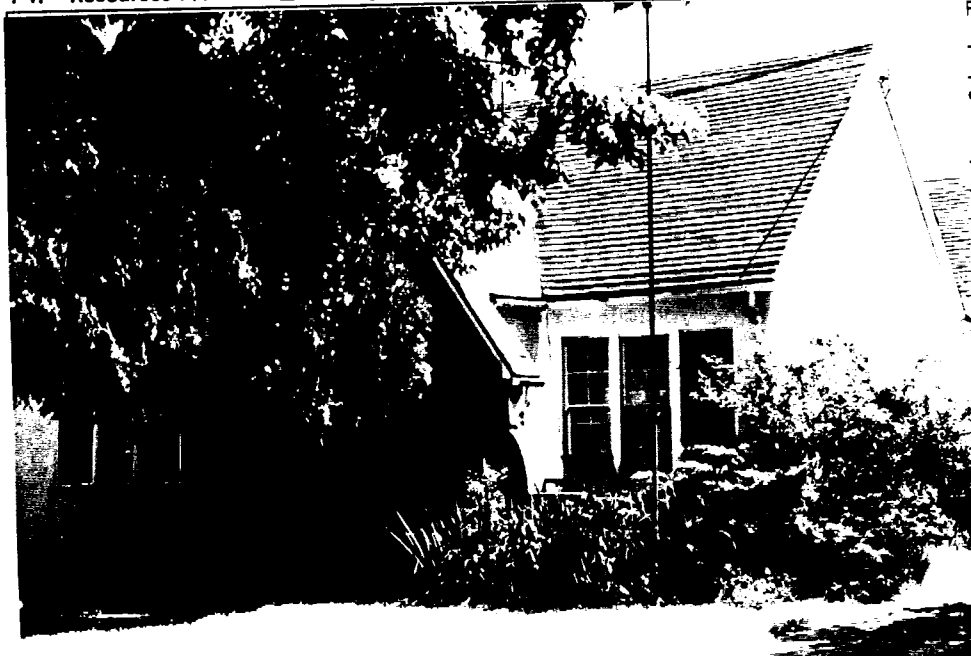
This one story stucco house has a brick veneer decorative false scroll front entry. The roof of the main portion of the house is gabled running parallel to the street. It has a cross gable intersecting it that incorporates the brick false scroll front. Two sets of three double hung windows comprise the north and south sides of the brick veneer entry. The house appears to be in good condition, including the landscaping.

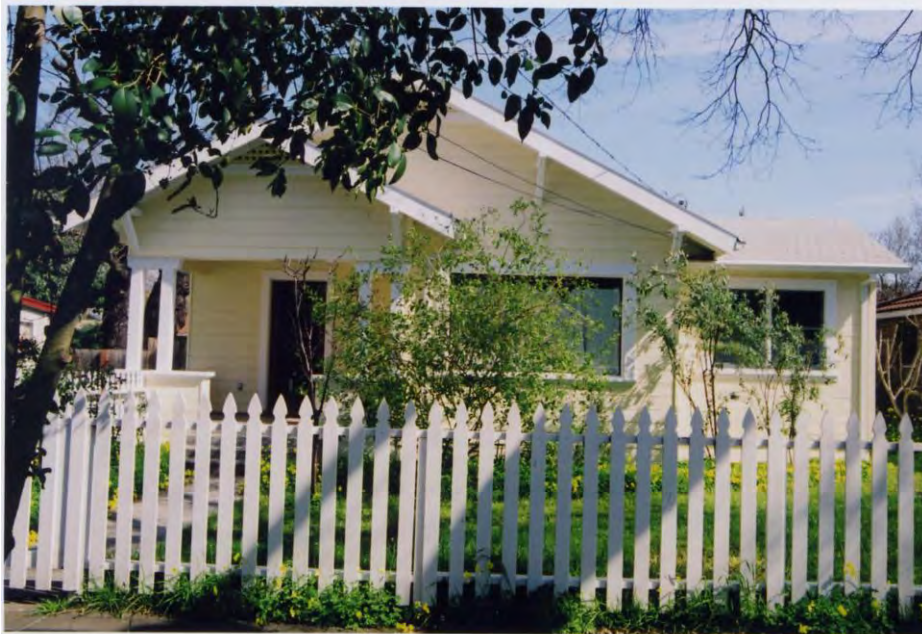
P5. Photograph or Drawing (Photograph required for buildings, structures, and objects.)

This small Craftsman residence has a front gabled roof clad in asphalt shingles. The walls are covered in horizontal siding. It sits on a poured concrete perimeter foundation. Its fenestration is composed of one-over-one double hung windows. The entry is accessed by a short set of concrete steps into a porch, sheltered by an offset front gabled element. The porch shelter and main roof feature latticed vents. The low pitch roof eaves feature simple brackets. The porch has a half height walls, with simple twin-post supports. There is a large fixed pane window on the front façade; the remaining windows appear to be one-over-one double hung sash. There is a detached building at the rear of the residence, not visible from the street.

- *P3b. Resource Attributes: HP2
*P4. Resources Present: Building Structure Object Site District Element of District
*P5b. Description of Photo:
View east
*P6. Date Constructed/Age:

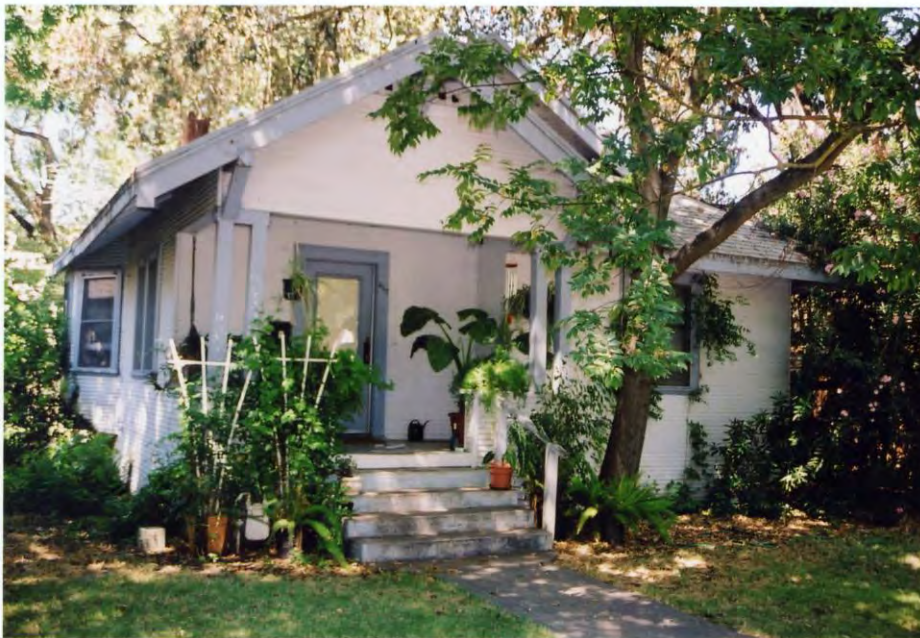
P5. Photograph or Drawing (Photograph required for buildings, structures, and objects.)

This L-plan bungalow has a cross gable roof of moderate pitch. A second gable projects to cover a half porch. The porch gable is supported on knee brace brackets with the gable end supported on double wooden posts that rest on the closed porch rail. A bay is found on the south façade. Fenestration consists of one-over-one double hung windows. The entry door is partially glazed. Cladding is stucco. The house retains all aspects of its integrity. It contributes to the character of the neighborhood.

- *P3b. Resource Attributes: HP2
*P4. Resources Present: Building Structure Object Site District Element of District
*P5b. Description of Photo:
View west
*P6. Date Constructed/Age:
c. 1915 88 years old estimated
 Prehistoric Historic
 Both

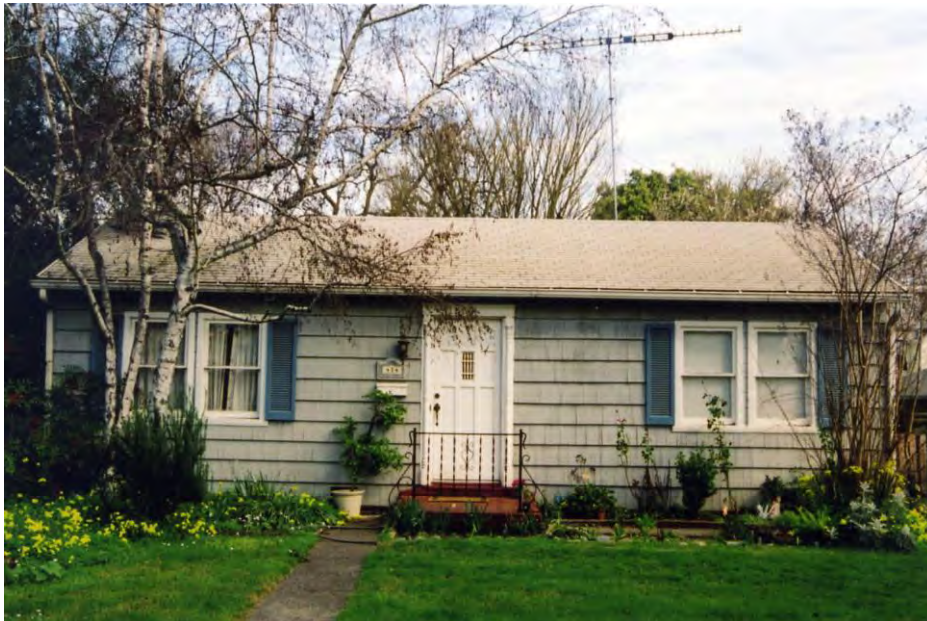
P5. Photograph or Drawing (Photograph required for buildings, structures, and objects.)

This simple one-story Colonial Revival has a moderate pitch side gable roof with virtually no eaves. The walls are clad with wood shingles, with vertical wooden siding in the gable peaks. There is a louvered vent at the gable peak. The entry is placed in the center of the front façade, and features decorative trim. There is no shelter over the entry door. It is flanked by two sets of two double hung windows, and the fenestration of the house in general is one-over-one double hung. The house sits on a poured concrete perimeter foundation. A detached side gable garage with addition sits at the rear the yard. It contributes to the character of the neighborhood.

- *P3b. Resource Attributes: HP2
*P4. Resources Present: Building Structure Object Site District Element of District
*P5b. Description of Photo:
View west
*P6. Date Constructed/Age:
c 1935 68 years old documented
 Prehistoric Historic
 Both

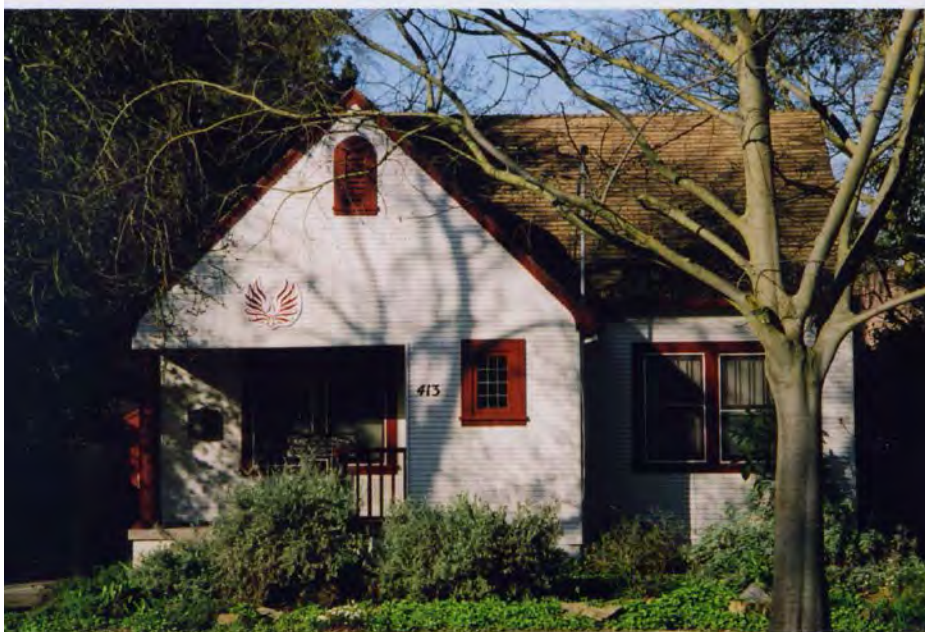
P5. Photograph or Drawing (Photograph required for buildings, structures, and objects.)

This formerly residential building has been converted to office use. It is a small, English Revival cottage circa 1935. L-shape in plan it has a cross gable roof of steep pitch. Eaves and gables are clipped with an arched, louvered attic vent at the apex of the front facing gable. A cut-in porch is found on the south side of the projecting front gable with the gable end supported at the corner with a Tuscan column. The entry is on the south wall of the porch with a vestibule occupying the north portion of the projecting wing. A decorative leaded window is located in the vestibule wall. Other fenestration consists of paired double hung three-over-one windows. The building retains integrity of design, materials, workmanship, location, setting and association. It appears to contribute to the historic character of the Downtown/ Commercial area of the Conservation District.

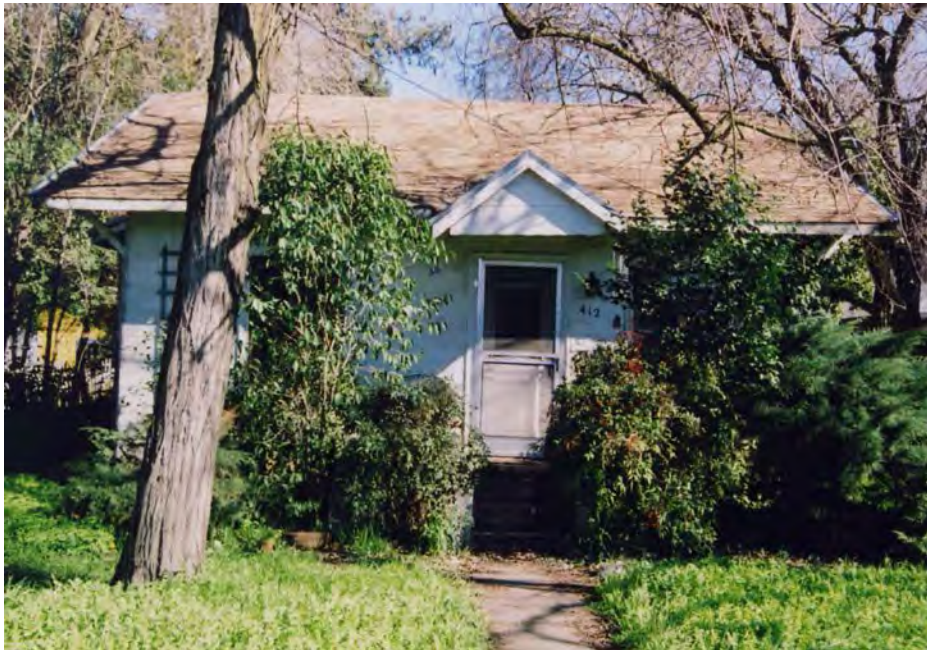
P5. Photograph or Drawing (Photograph required for buildings, structures, and objects.)

*P3a. Description:
 This simplified Craftsman Bungalow was constructed in 1914. This house form with central entry emphasized with a small gable porch roof and symmetrically arranged windows is found elsewhere in the downtown and Old North area. It is rectangular in plan with an overhanging side gable roof. The gables are supported on knee brace brackets. Windows and the central entry door are arranged symmetrically. A small projecting gable is centered over the front stoop and door, sheltering the entry. The house has been clad with asbestos shingles. Although the exterior cladding has been changed and the house is poorly maintained it retains its integrity of design, workmanship, setting, location, feeling and association. It contributes to the historic character of the neighborhood.

*P3b. Resource Attributes: HP2
 *P4. Resources Present: Building Structure Object Site District Element of District
 P5b. Description of Photo:
 View east
 *P6. Date Constructed/Age:
 1914 88 years old documented
 Prehistoric Historic

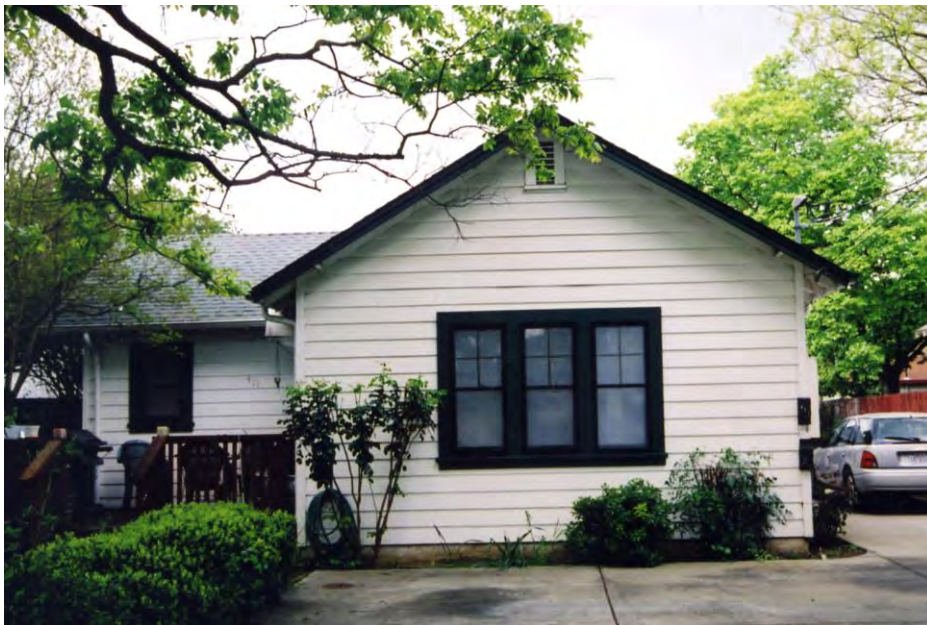
P5. Photograph or Drawing (Photograph required for buildings, structures, and objects.)

This L-shaped, moderate pitch front gable single story residence can be classified as a late Craftsman Bungalow or is a Minimal Traditional style building. Entry is made via a modern wooden deck with half height balustrade. The entry is sheltered by a barrel arch element. The walls are clad with horizontal siding, either drop or metal. Fenestration is composed of 2/1 double hung and 1/1 double hung, some of which appear to be modern replacements. There is an interior stove pipe clad in siding that is sited near the gable peak. A detached building of similar building materials and general design is sited to the rear of the original residence. The modern deck detracts from the historic appearance of the house, but is not a structural change. The house continues to retain its integrity. It contributes to the character of the neighborhood.

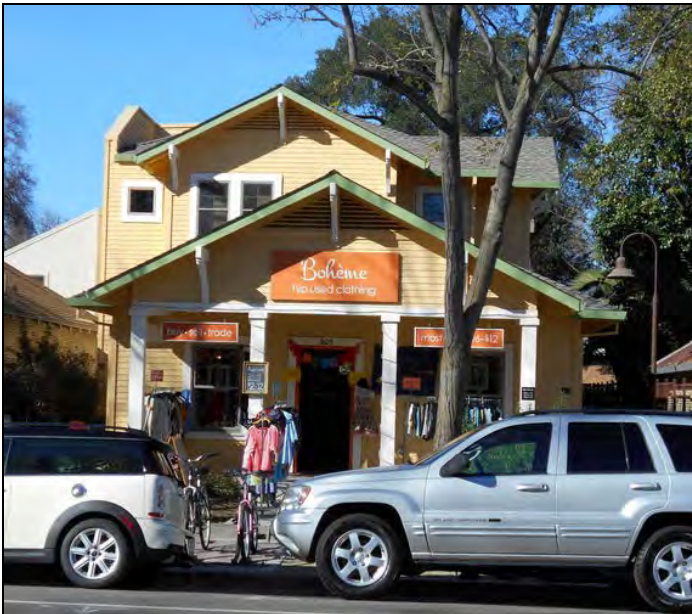
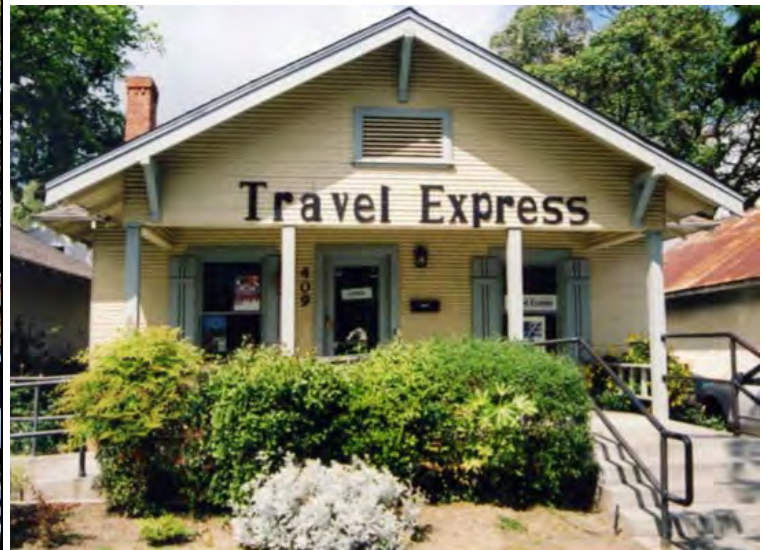
Since 2003 there have been extensive revisions on this house. The chimney has been removed. The vent in the front gable has been replaced along with the balusters supporting that gable. The windows on one side have been reconfigured, the original shutters removed and there are replacement vinyl windows. There is a large second story addition immediately behind the house. The original integrity of this house has been lost.

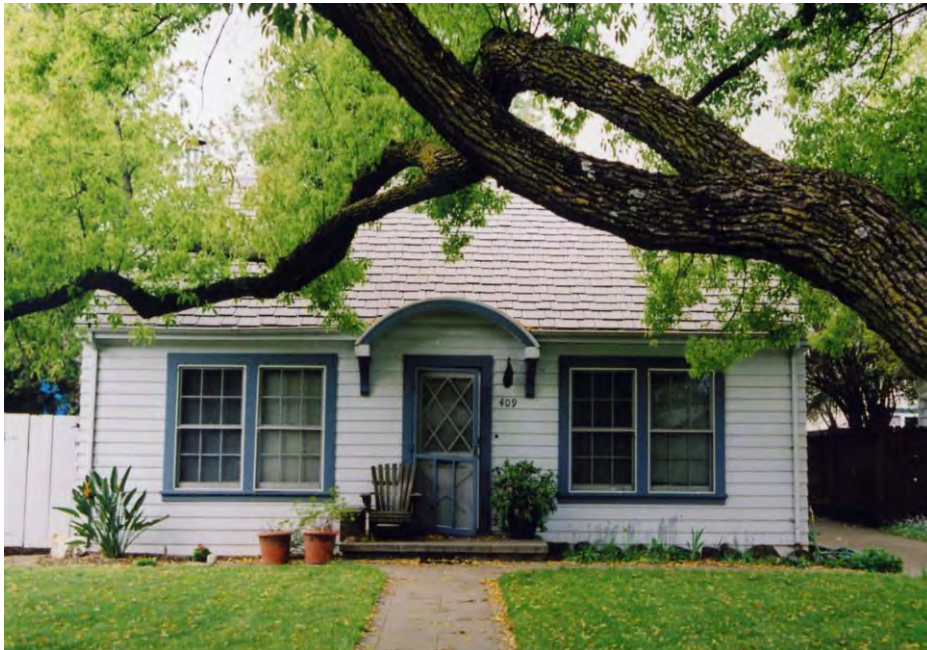
P5. Photograph or Drawing (Photograph required for buildings, structures, and objects.)

This rectangular plan, single story residence is a Cape Cod Revival with a moderately pitch front gable roof. Entry is made via a cement stoop centered on the front façade. The entry door is partially glazed and is probably a replacement. The entry is sheltered by a barrel arch element supported on knee brace brackets.. The walls are clad with clapboard. Fenestration is composed of six-over-six light double hung windows. On the front façade these are arranged symmetrically in pairs on either side of the entry door. This house contributes to the character of the neighborhood.

*P3b. Resource Attributes: HP2
 *P4. Resources Present: Building Structure Object Site District Element of District
 P5b. Description of Photo:
 View west
 *P6. Date Constructed/Age:
 1928 75 years old documented
 Prehistoric Historic
 Both

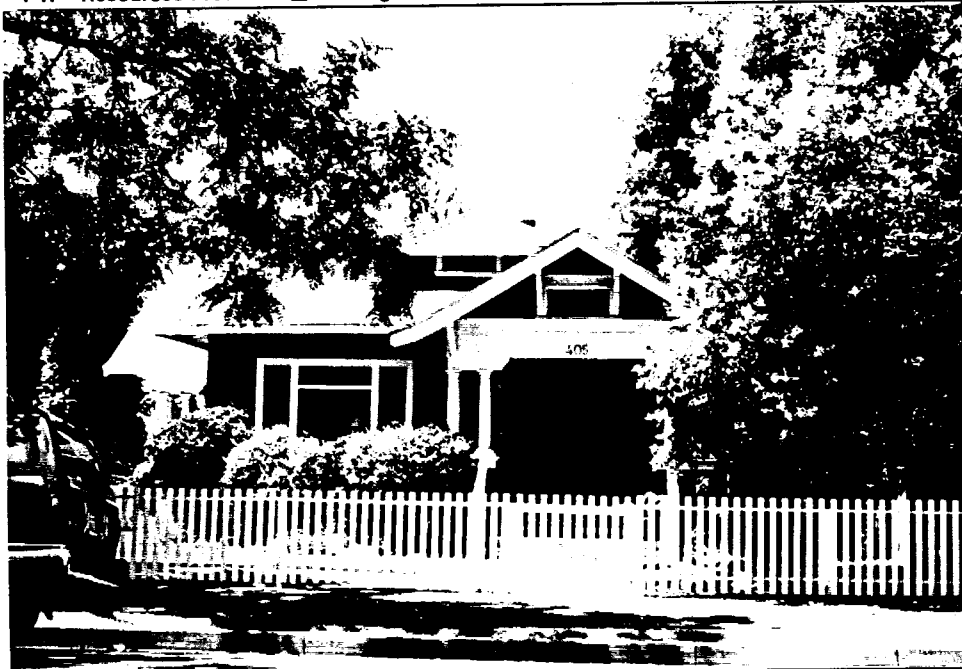
P5b. Description of Photo: (View, date, etc.)
Front Elevation

Looking west w/fr and side porch

This one story Craftsman house has a hipped primary roof, and gabled porch roofs. Both the hipped section and the gable portions have a flare at the eave line. The house is sheathed in narrow clapboard. The porches are railed partly by slatted rails and partly by solid parapets which act as pedestals for Tuscan columns. There are wide overhangs supported by prominent brackets with decorative profiles. Some of the windows have sections with diamond shaped panes.

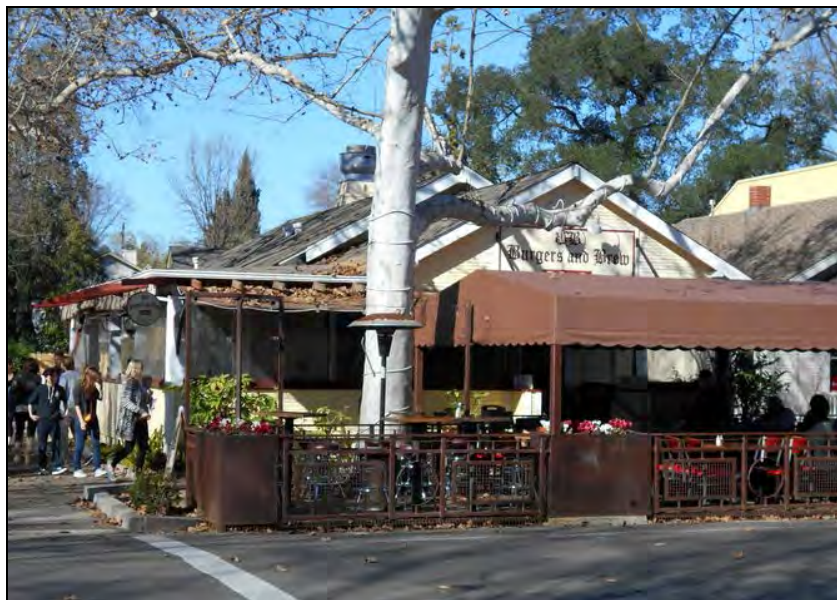
Since 2003 when the building was first evaluated the original chimney has been removed and replaced with industrial vents. The house still has original layout with its shiplap siding.

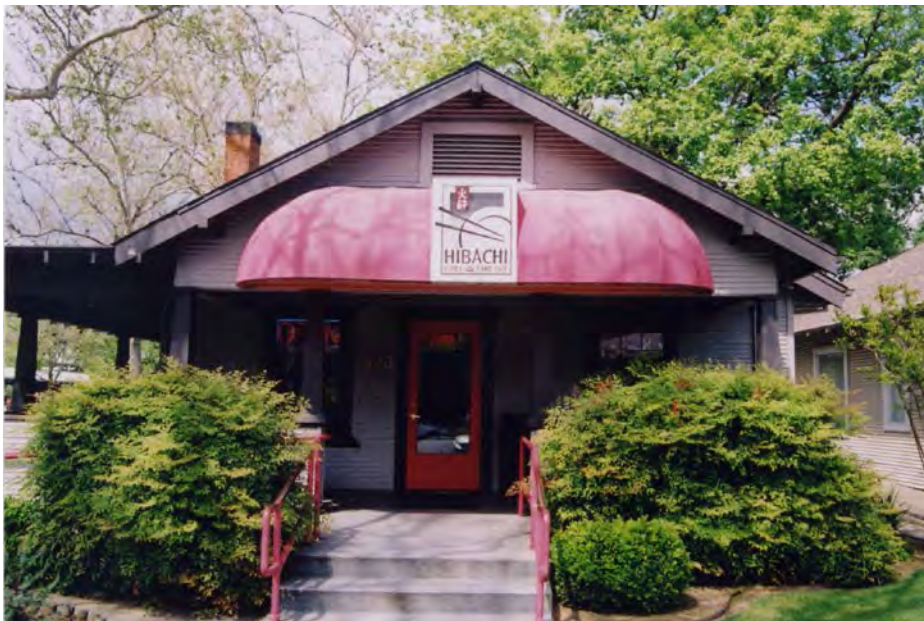
*P5b. **Description of Photo:**
 View north *

*P3a. **Description:** Rectangular in plan, the building is surmounted by a moderately pitched, gable roof that projects to cover the porch. Gable and eaves exhibit wide overhangs, with the front porch gable supported on projecting purlins. A louvered, rectangular attic vent punctuates the gable end. Fenestration consists of one-over-one double hung windows arranged symmetrically on either side of the central entry door which is glazed. A brick chimney is found on the west façade. The original porch columns and rail have been removed. A side porch serves as an outdoor eating area for the restaurant that occupies the property. It has been fashioned with exposed rafters and battered columns in an attempt to integrate it with the original residence. Cladding is narrow novelty siding. The building integrity of design, materials, and workmanship have been compromised by alterations to the front porch area and the side porch addition. Also, a large awning across the front gable end distracts from the bungalow appearance, but is removable. The building is one of three very similar bungalows which are sited next door to each other at the western end of this block of 3rd Street. It retains its essential form and details and is clearly recognizable as a bungalow style residence building. The removal of the side porch and awning would restore integrity. However, at the present time it does not appear to contribute to the historic character of the Downtown/ Commercial area of the Conservation District.

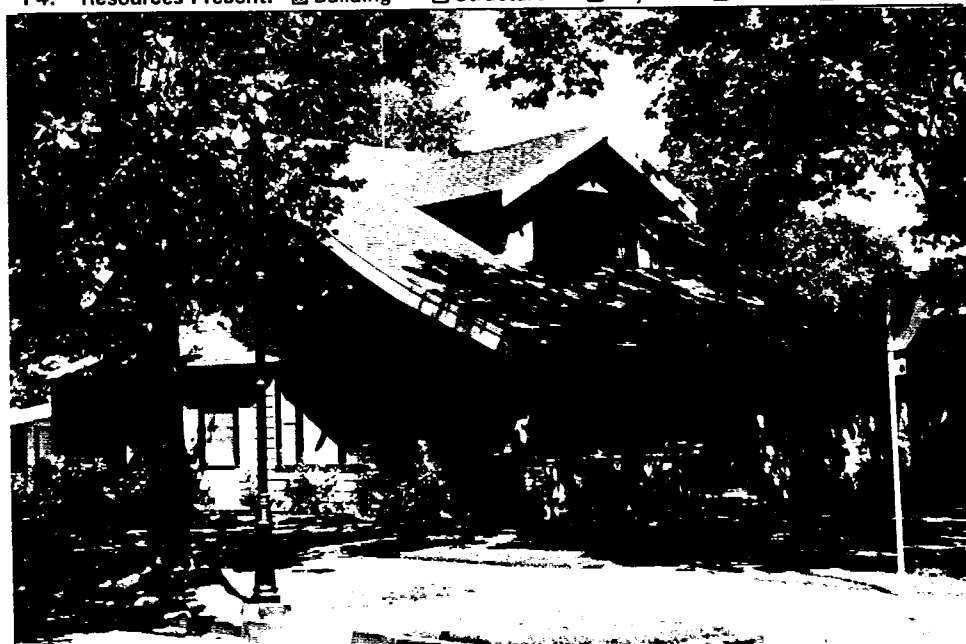
*P5b. Description of Photo: (View, date, etc.)
Front Facade

*P3a. Description: (Describe resource and its major elements. Include design, materials, condition, alterations, size, setting, and boundaries.)
This shiplap surfaced house is essentially two stories in height. A crisp version of Craftsman styling, it also reflects Colonial Revival aspects. The roof is broadly gabled and a dormer extends from it toward the street. The recessed porch is supported at the outer corners by a large pillar; and simple linear balustrade encloses it. A small slanted bay extends from the first story on the south side of the building. Wide fascia boards face the gable edges. The house is in good condition. The shiplap surface of the exterior has been replaced with vinyl siding that although a modern material does not distract from the overall character of the house.

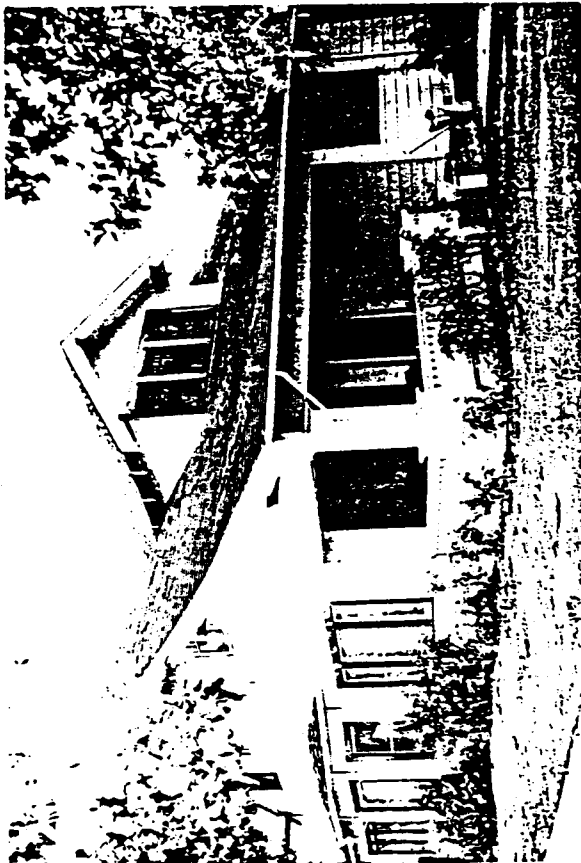
The recessed porch is supported at the outer corners by a large pillar; and simple linear balustrade encloses it.

A small slanted bay extends from the first story on the south side of the building. Wide fascia boards face the gable edges.

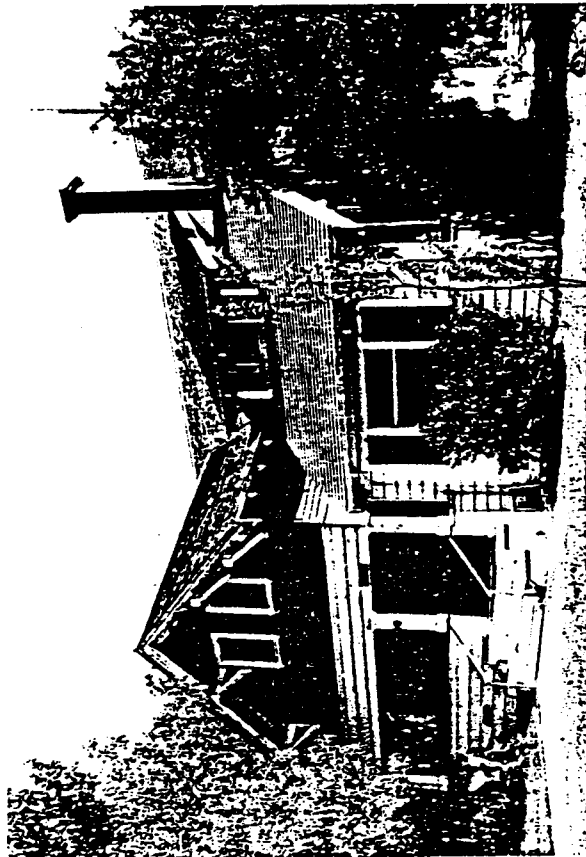
This one and a half story Craftsman house has gabled roofs with prominent braces. There is an emphatically vertical chimney. The first and second floors are differentiated by changes in the texture of their wooden sheathing: the upper floor is shingled, the lower is clapboarded. There is a large porch with a solid parapet railing.

This home is a good example of the less rustic phases of the Craftsman movement. The house is on a corner lot in a neighborhood which contains many 19th century structures.

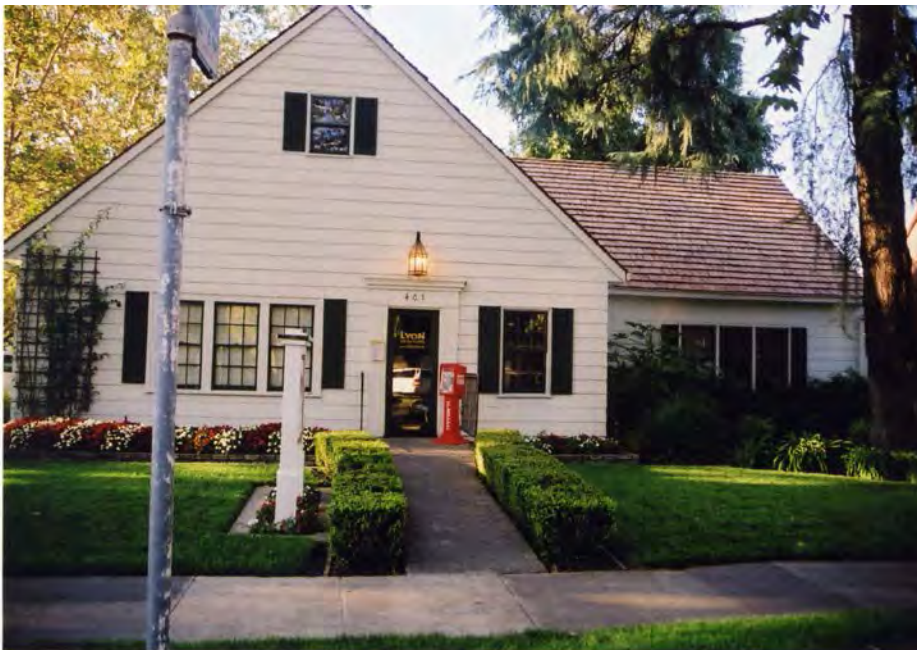
This building originally served as a combination medical office and home for Dr. Walter Bates. T-shape in plan, it is composed of two large two-story intersecting wings surmounted by steeply pitched cross gable roofs. Eaves and gables are clipped. The clapboard clad building is an asymmetrical interpretation of the Colonial Revival Style. The front projecting gabled wing has an entry door which is emphasized by engaged columns and a classical pediment. The original door was multi-light, but has been replaced by a metal and glass commercial building door. Six-over-six double hung windows are arranged in a ribbon across the west side of the front façade. Other fenestration consists of multi-light double hung windows arranged singly and in ribbons. A brick chimney pierces the west slope of the roof, as does a gable roofed attic vent dormer. The building appears much today as it did in a 1940 photograph included in Lofland and Haig's *Images of America*. It retains its integrity of design, materials, workmanship, setting and association. The building appears to contribute to the historic character of the Downtown/ Commercial area of the Conservation District.

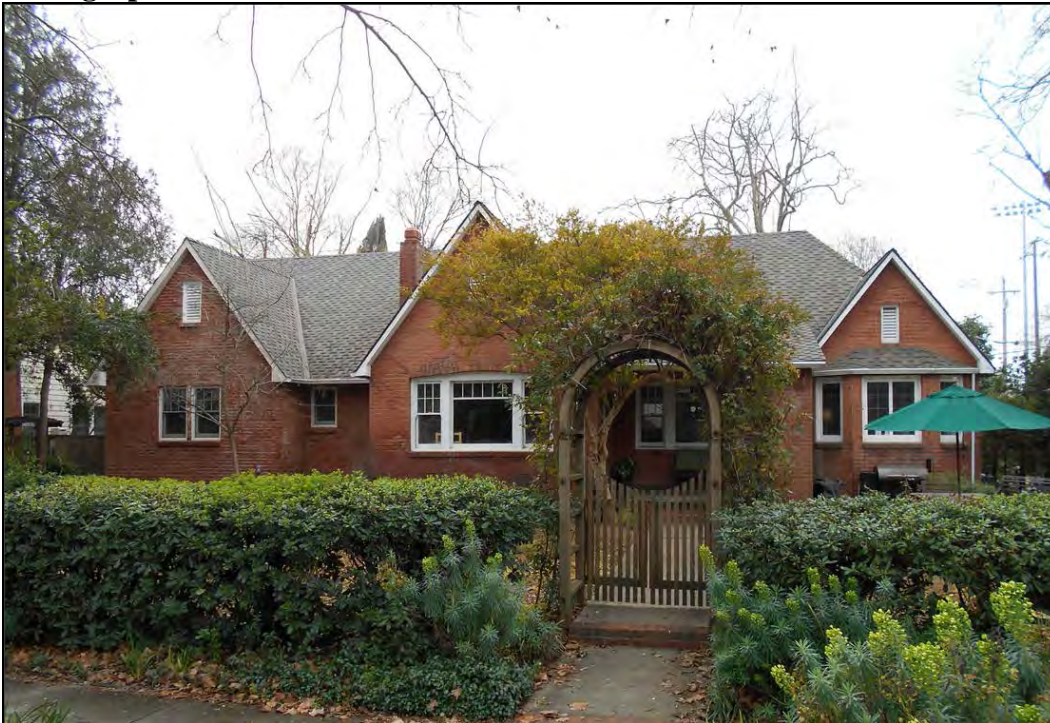
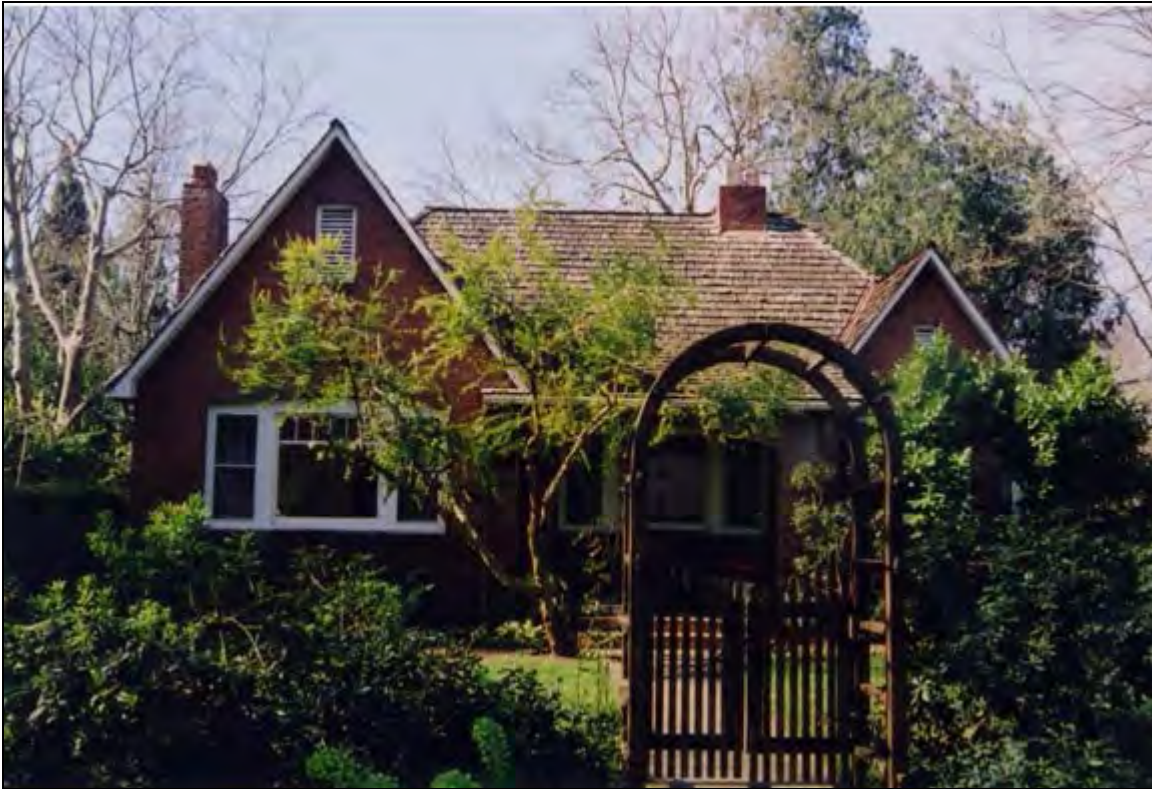
2015

The evaluation in 2003 did not mention that all of the windows and the north gable vent had been replaced with vinyl windows and vent. Additionally, since the evaluation in 2003, there has been a large addition to the south side of the house. Great detail went into the brick work as it does match the original shape, color, size and pattern. The smaller chimney on the north end of the house was also removed and the shake roof replaced with composite asphalt tiles. This addition and other updates were made with the approval of the HRMC.

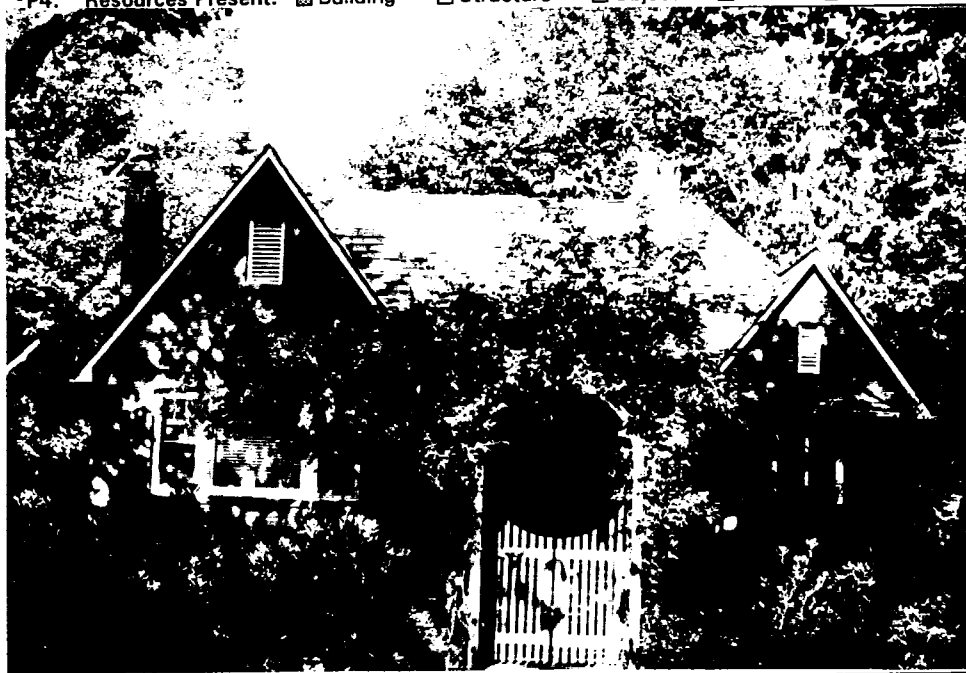
P5b. Description of Photo: (View, date, etc.)
Front elevation
Looking west

This one and a half story, Tudor/Medieval, brick house has a long gable roof running parallel to the street as its primary roof. This roof is intersected by two cross gables both of which have attic vents. A tripartite bay window is present at the first story of the southern gable. The entry is via a recessed porch between the two gables. The house trim is painted white. The yard is nicely landscaped, including a gate with accompanying arched trellis. Overall, this property is in excellent condition and contributes to the character of the neighborhood.

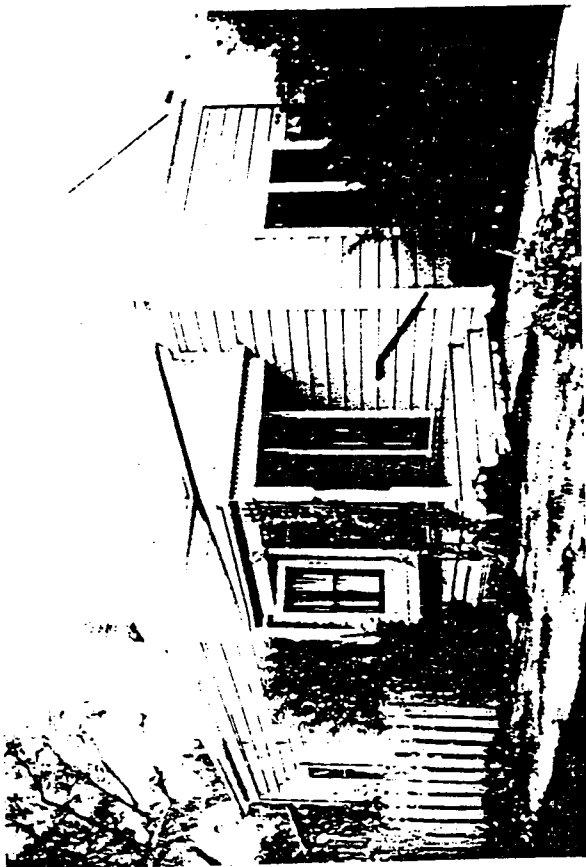
This one story house has a hipped roof portion, with a gabled projection towards the street. The house is sheathed in shiplap, with corner boards and with frieze boards at the eave line. There are transomes over the two entry doors. A turned porch column, a dentil course at the porch eave, and fishscale shingles in the gable are the only ornament in this otherwise vernacularly austere building.

This is an excellent example of the slight decorative touches to be found on some vernacular buildings. The building appears to be one of the older structures in its immediate neighborhood. There are later additions along the porch side.
