P1. Other Identifier: Hattie Weber Museum

*P11. Report Citation: Davis, California: Citywide Survey and Evaluation of Buildings Constructed Prior to 1976

- *Resource Name or Address 445 C Street
- P1. Other Identifier: Hattie Weber Museum
- *P2. .Location: *a. County Yolo
- b. Address 445 C Street
- *c. City Davis Zip 95616
- d. UTM: N/A
- e. USGS Quad: Davis Quadrangle
- *f. Other Locational Data (APN #): 70-201-001

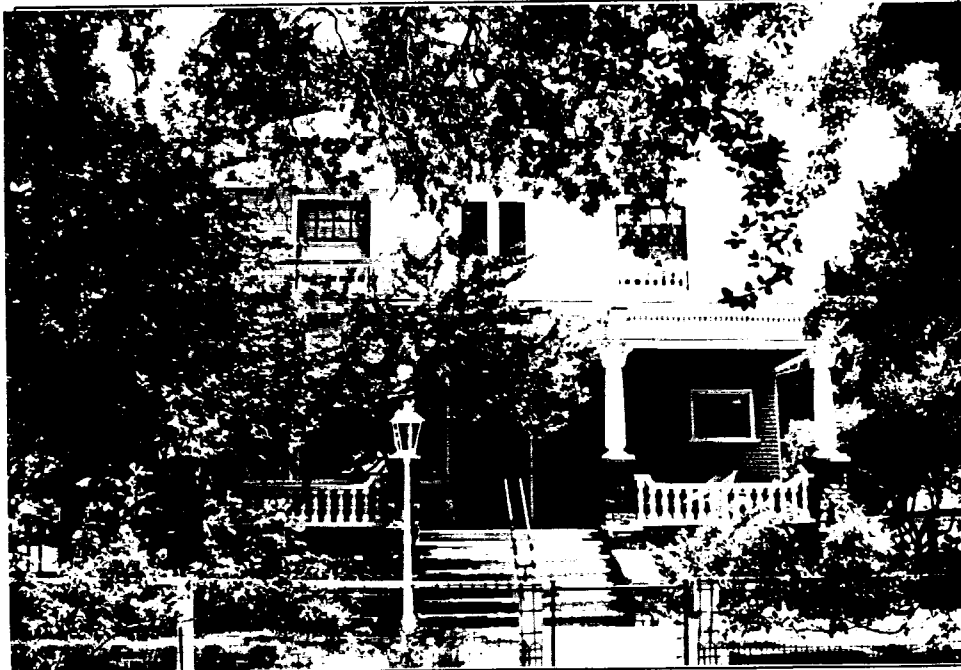
P5b. Description of Photo: (View, date, etc.)
Front Facade

Looking East

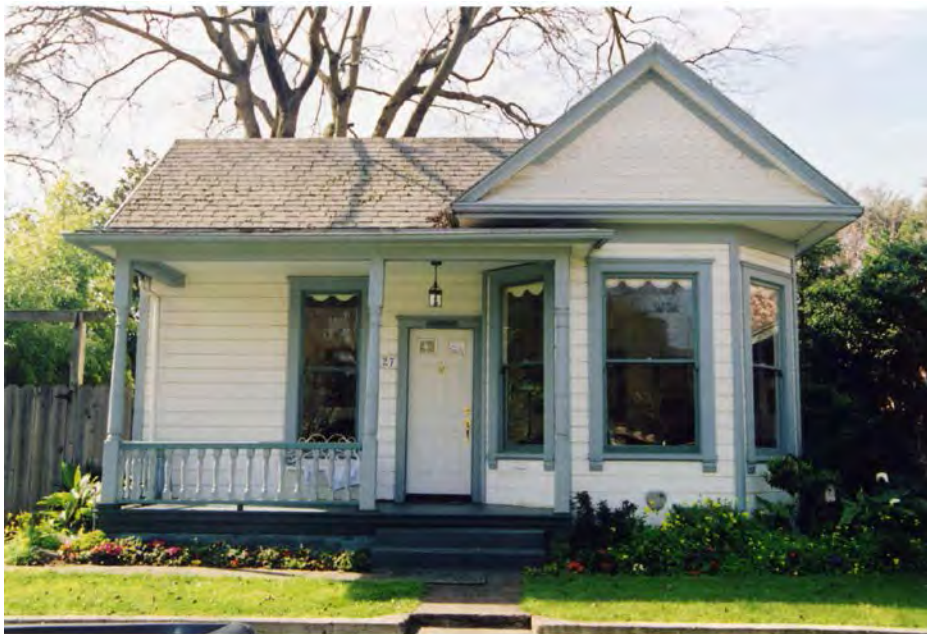
*P3b. Resource Attributes: HP2
*P4. Resources Present: Building Structure Object Site District Element of District
*P5b. Description of Photo:
View west
*P6. Date Constructed/Age:
1900 103 years old documented
 Prehistoric Historic
 Both

This one story Queen Anne cottage is clapboarded with a gable infill of shingles. The gabled roof has a cross gable which covers the slanted bay. There is a porch with a shallow hip roof supported on turned columns and a railing of elegantly proportioned turned balusters. The house generally has one over one sash windows. There have been numerous additions to the rear of the structure. The house appears to be in good condition and contributes to the character of the neighborhood.

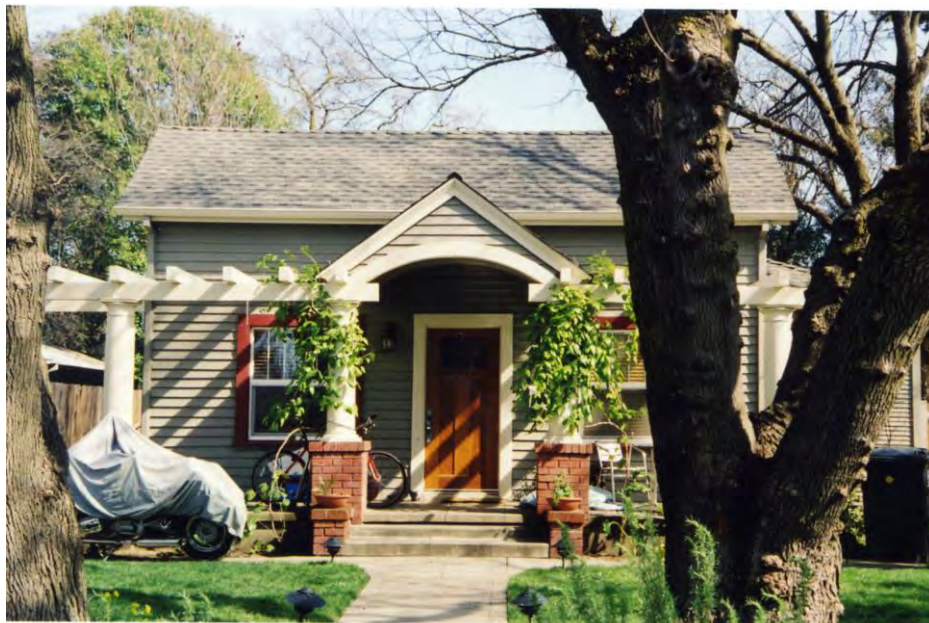
This handsome side gabled residence has a side gable roof, with a hipped addition on the south side, all clad in asphalt shingles. The fenestration is replacement metal sash with false muntins. The house has a full porch formed by a concrete floor, with a shelter over the center entrance and pergola over the sides. The shelter is front gabled, with a decorative circular inner curve. Brick pedestals support Doric columns. The house is clad in horizontal shiplap siding. The front door features 3/2 fixed panes. One column remains of what was apparently a porte cochiere on the north façade. A large second structure at the rear of the residence is currently being built. The 1933 tax assessor record indicates that the house is more than 50 years old. This would place the original construction in the 1880s. The proportions of the central building block tend to support this possibility, however, the front doorway, porch and pediment have been remodeled in such a way as to suggest a Revival Style cottage circa 1920s. It is unclear if these changes were actually made in the 1920's, or more likely, are of fairly recent origin. The evolution of this house should be evaluated and documented more thoroughly. It contributes to the character of the neighborhood.

P5b. Description of Photo:
View east
*P6. Date Constructed/Age:
c 1890/1920 documented
 Prehistoric Historic
 Both
*P7. Owner and Address:
KC Gebhardt
320 I Street
Davis, CA 95616
*P8. Recorded by:
Carol Roland
Roland-Nawi Associates
4829 Crestwood Way
Sacramento, CA 95822
*P9. Date Recorded: 04/07-10/2003
*P10. Type of Survey: Intensive
 Reconnaissance Other
Describe: Determination of
Local District Eligibility
*P11. Report Citation: none
*Attachments: NONE Map
Sheet Continuation Sheet
Building, Structure, and Object Record
Linear Resource Record
Archaeological Record District Record
 Milling Station Record Rock Art
Record

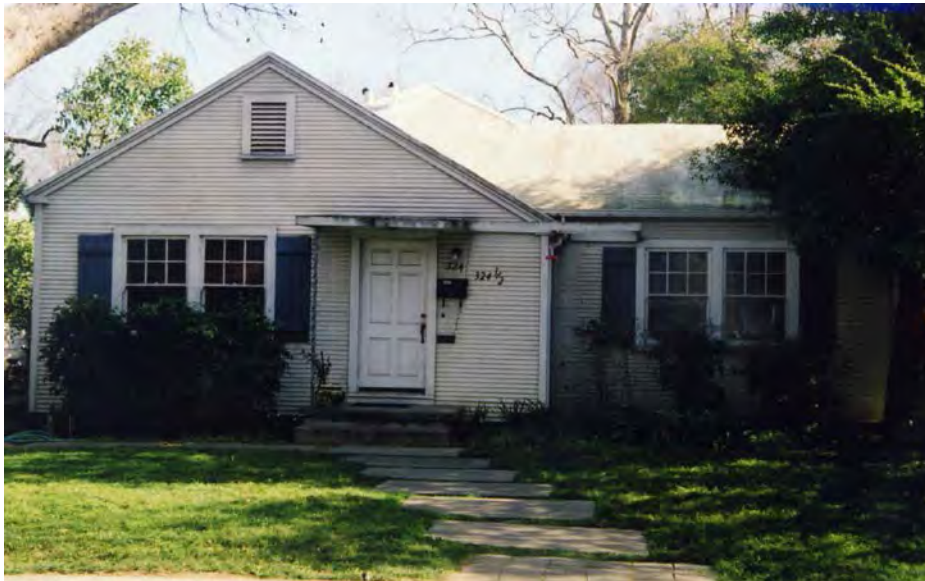
This modest, single story house has an irregular rectangular plan and has sustained significant alterations and enlargement. Roof forms are gables except for a small hipped area that forms the roof's apex, and appear to be covered with composition shingles. Siding is narrow novelty siding. A non-original, L-shaped pergola is located near the entry door. Street façade windows appear to be original wooden double-hung four-over-one with original vertical plank shutters. The entry door is a replacement and the configuration of the entry is not consistent with the style of the house. It appears that an earlier, probably original, porch cover has been removed. Although not maintained in very good condition the house its integrity of materials, workmanship, setting, location, feeling and association. Its integrity of design has been impacted by the alteration of the front entry. It does not appear to contribute to the character of the neighborhood.

View east

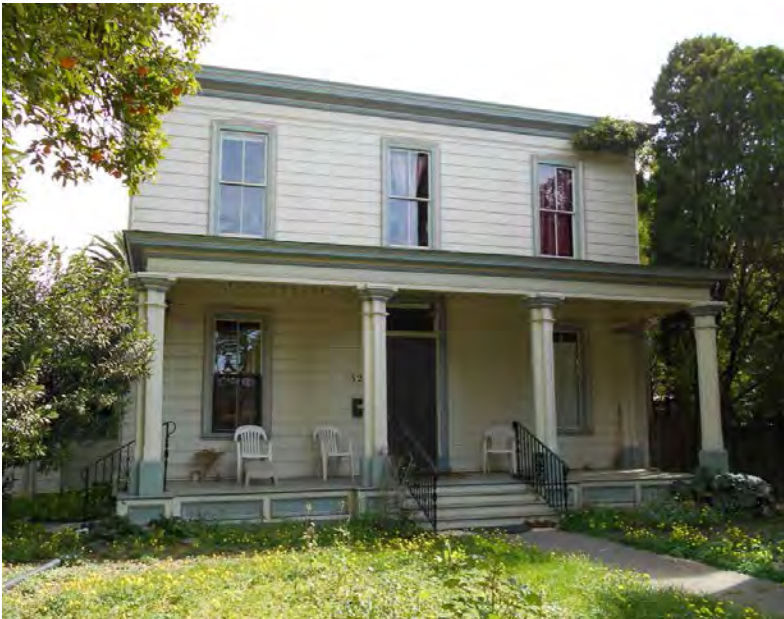
*P3a. **Description:** See original form for architectural style and features. 4x4 porch posts replaced by fluted ornate posts with capitals; window restored to right of entrance door since 2003 inventory. Changes made in coordination with City of Davis Historic Resources Management Commission to restore original conditions based on historical information.

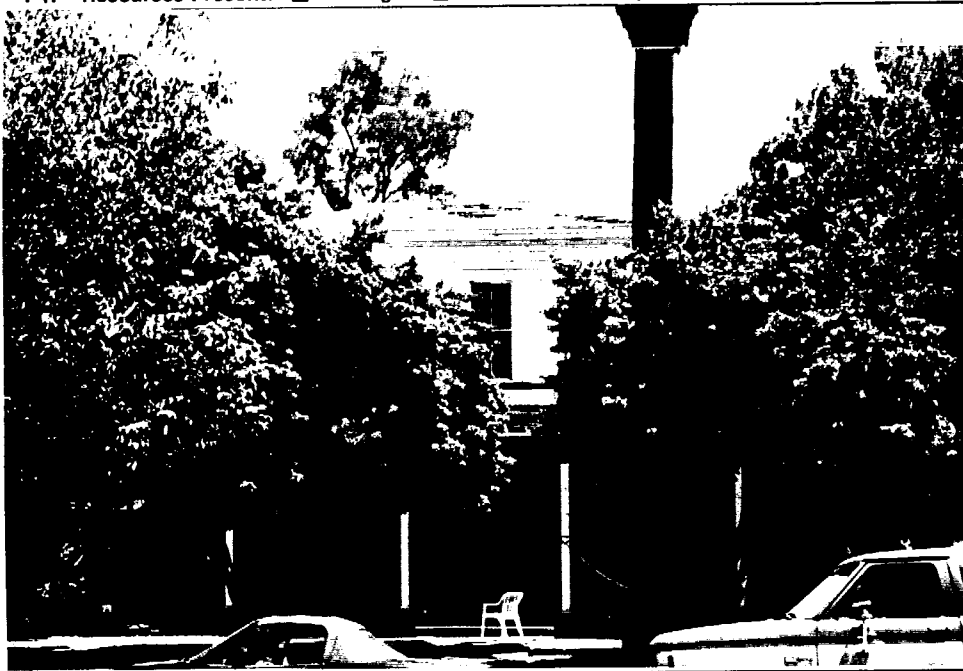
This two story, symmetrical house is Italianate in styling and formal in feeling. The roof is hipped, the eaves are soffited and there is a complex molding at the eave line. The windows moldings with their slight pediment make an elegant reference to their classical precedent. A porch runs across the entire front of the house and is supported on square posts. There have been some alterations to the porch, one ground floor window has been filled, as has the transom over the entry. The house is presently a rental unit and is not in good condition.

P5b. Description of Photo: (View, date, etc.)
Front Facade

Looking west

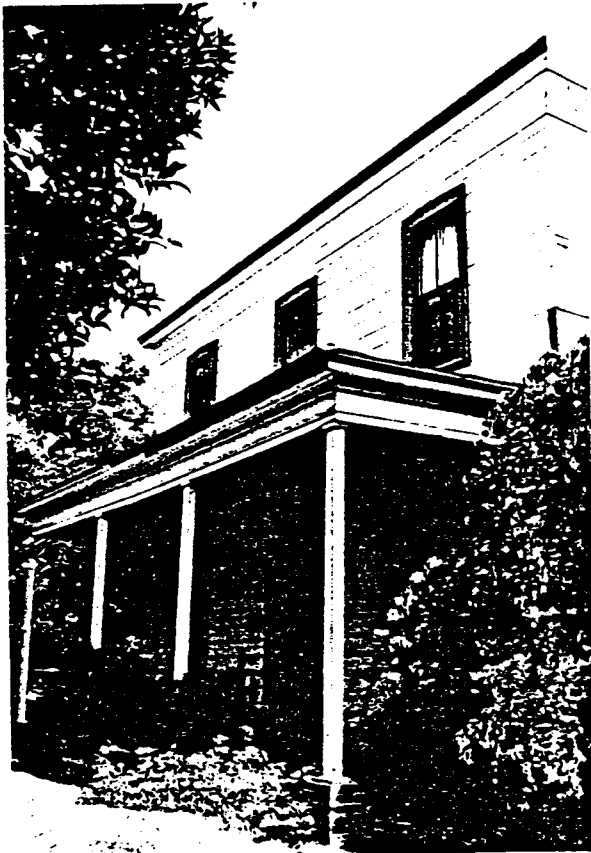
This two story, symmetrical house is Italianate in styling and formal in feeling. The roof is hipped, the eaves are soffited and there is a complex molding at the eave line. The windows moldings, with their slight pediment, make an elegant reference to their classical precedent. The porch runs across the entire front of the house, and is supported on square posts. There have been some alterations to the porch, one ground floor window has been filled, as has the transom over the entry.

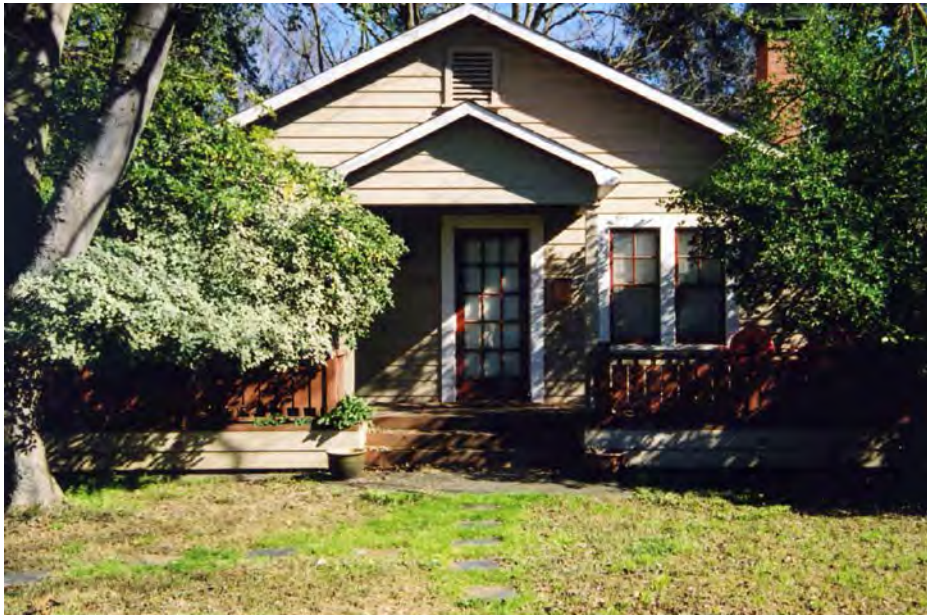
*P3a. Description:
 This is a front gable, rectangular plan Craftsman Bungalow constructed circa 1935. The roof is moderately pitched with a small gable and eave overhang. The gable is trimmed with a fascia and the gable end exhibits a vertically emphasized louvered attic vent. A slightly elevated, cement porch spans the full length of the front façade and is enclosed with an open, possibly replacement, rail. The centrally placed door is covered by a projecting gable supported on slim Doric columns. The porch gable fascia has a return. The placement and detailing of the porch roof suggests a Colonial Revival influence, although the massing and form of the house clearly derives from the bungalow tradition. Fenestration consists of paired, vertically emphasized, four-over-one double hung windows in a wide wood casing. The entry is multi-light glazed. Cladding is of clapboard and a brick chimney is located on the south façade. The house retains its integrity of materials, workmanship, setting, location, feeling and association. It contributes to the historic character of the neighborhood.

View east
 *P6. Date Constructed/Age: c. 1930s 70 years old estimated
 Prehistoric Historic
 Both
 *P7. Owner and Address: Donna Hunt
 318 A Street
 Davis, CA 95616
 *P8. Recorded by: Carol Roland
 Roland-Nawi Associates
 4829 Crestwood Way
 Sacramento, CA 95822
 *P9. Date Recorded: 04/07-10/2003
 *P10. Type of Survey: Intensive
 Reconnaissance Other
 Describe: Determination of Local District Eligibility
 *P11. Report Citation: none
 *Attachments: NONE Map Sheet Continuation Sheet Building, Structure, and Object Record Linear Resource Record Archaeological Record District Record Milling Station Record Rock Art Record Artifact Record Photograph Record

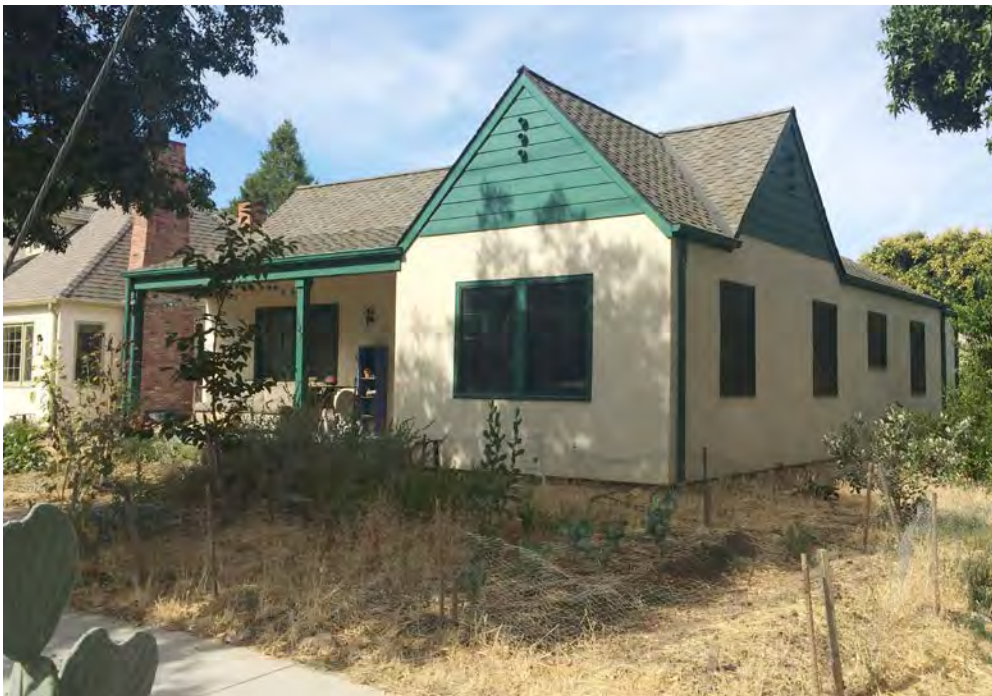
Photograph: 239 J Street, Davis

See original form. Needs re-evaluation in new context. House appears in good condition.

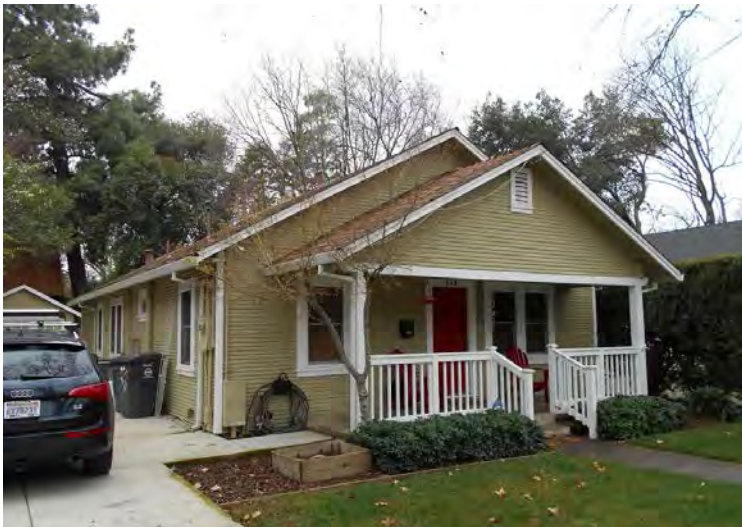
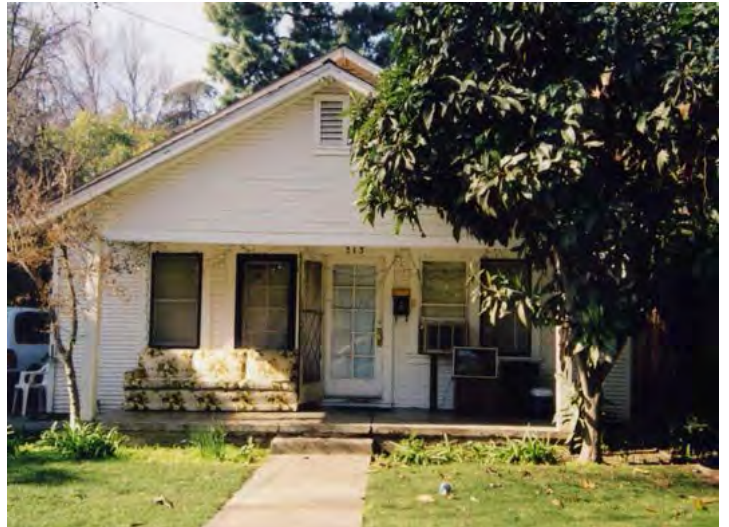
2015

This house has been significantly altered since the 2003 Survey. One of the front windows has been removed and replaced with siding, the front door with its sidelight have been replaced. There is a railing which runs along the front of the porch along with side railings on either side of the stairs. The house no longer retains the same integrity as previously surveyed and the Status Code should be reconsidered.

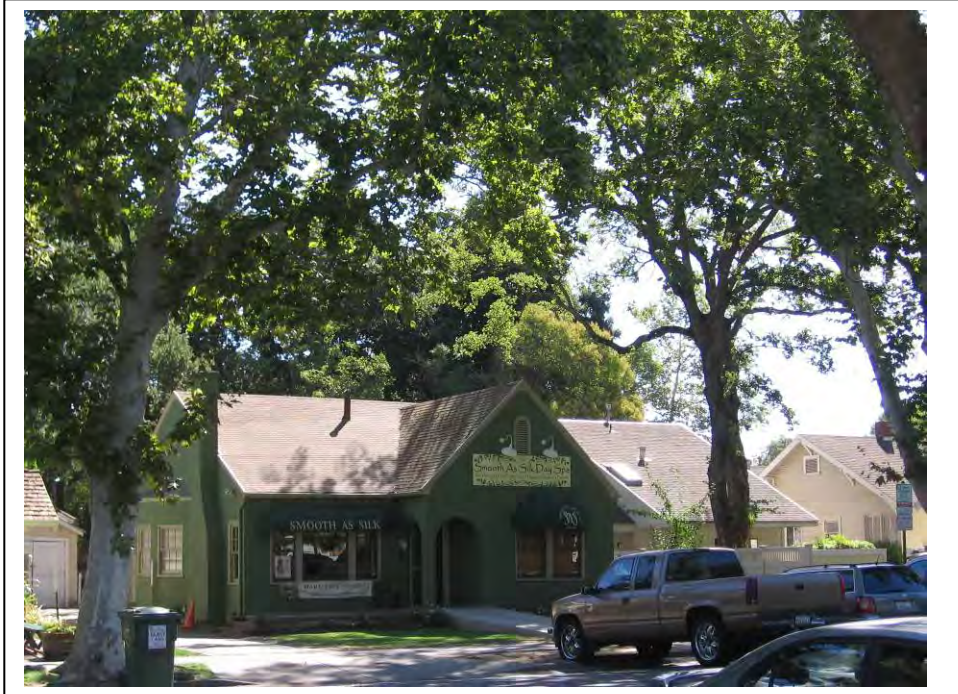
A Tudor style house (**Photograph 1**) and a detached garage are located at 310 C Street. The residence is topped with a cross gable roof that is sheathed in composition shingles. Beneath the west gable on the main façade, is an arched, louvered attic vent. The house is sheathed in stucco. Located on the north elevation is a bay window set with 6/6 units with wood frames. This elevation also has 4/1 wood frame windows. The south elevation features 1/1 wood frame windows and a 1/2 window beneath the south gable (**Photograph 2**). A similar window appears to have been located at the same location under the north gable, but it has been filled and covered with stucco (**Photograph 3**). On the house's east elevation is an enclosed rear porch with wood frame ribbon windows. The entrance to the porch is on the north elevation and is set with a glazed wood door. Leading to this door are two concrete steps. The main façade (west elevation) of the building features a 4/1 fixed center window flanked by 4/1 windows; all are wood frame. The main entrance features a single-entry wood door. Leading from the sidewalk to this door is a concrete ramp that passes under an arched entry. There is also a stone porch below the windows that is accessed by three steps. (See Continuation Sheet)

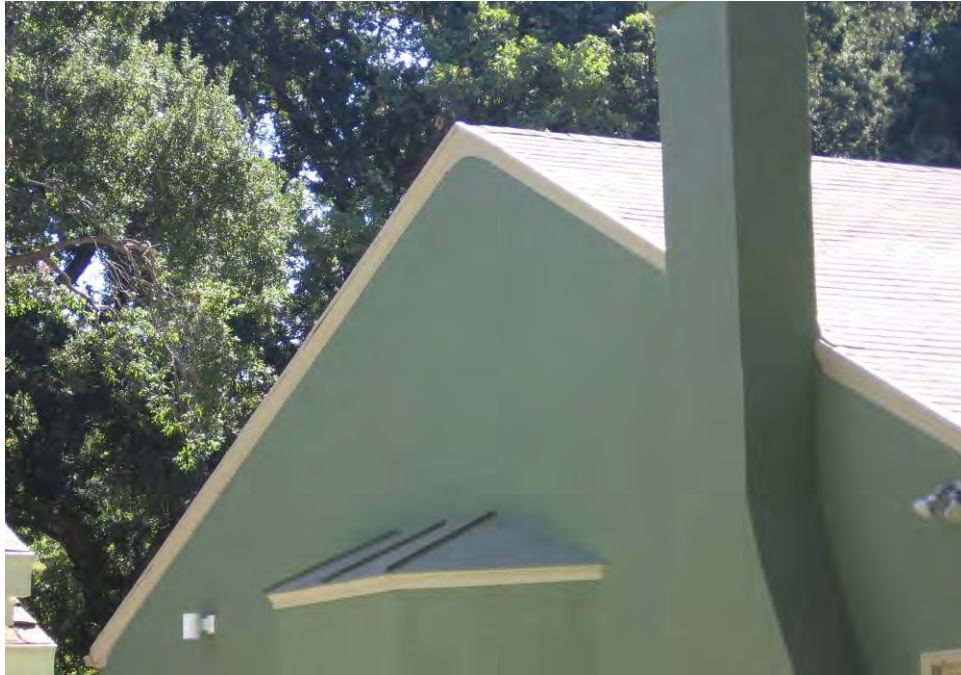
Photograph 3. Infilled window, north elevation

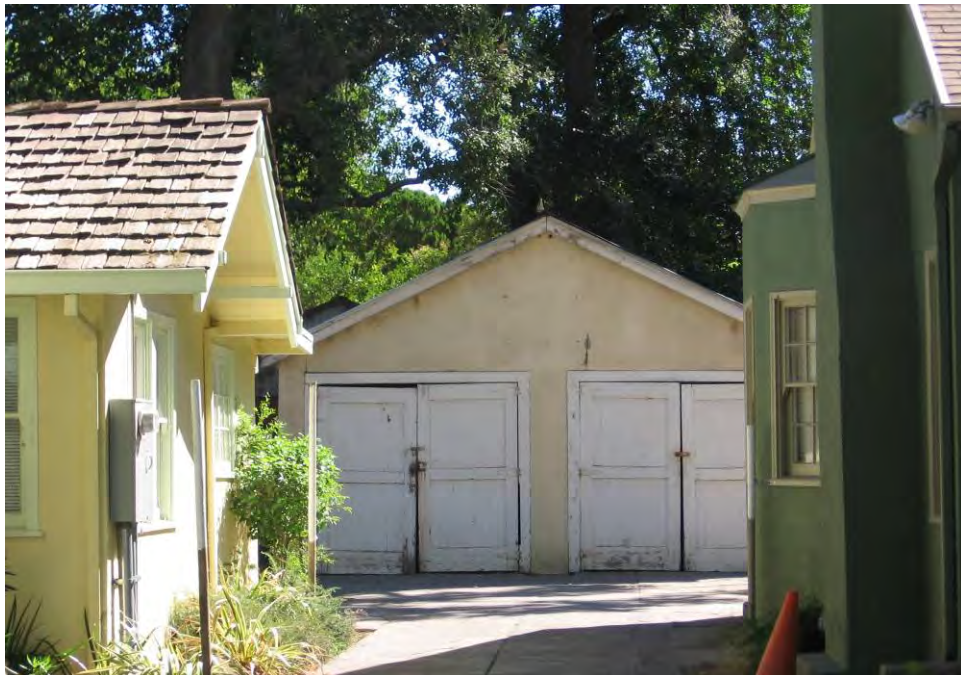
The detached garage is located at the east end of the north driveway and east of the house (**Photograph 4**). The garage sits on a concrete foundation and its walls are clad in stucco. It has a gable roof with medium wood fascia. On its west elevation are two entrances. Both are set with original wood doors.

Photograph 4. Detached garage, camera facing east

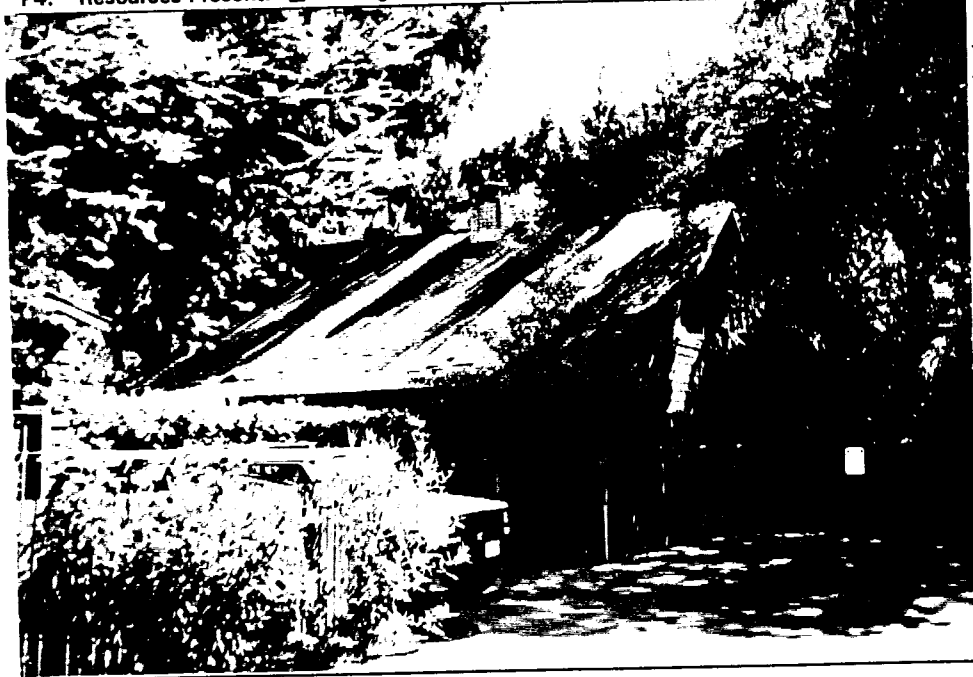
*P3a. Description: (Describe resource and its major elements. Include design, materials, condition, alterations, size, setting, and boundaries.)
This one and a half story shingled Craftsman bungalow is a rectangle in plan. The roof is a simple long, low gable with the ridge parallel to the street with a deep sheltering overhang. The windows are wood-framed casements. The building has been moved farther away from the street and a fence constructed around it making the house difficult to see.

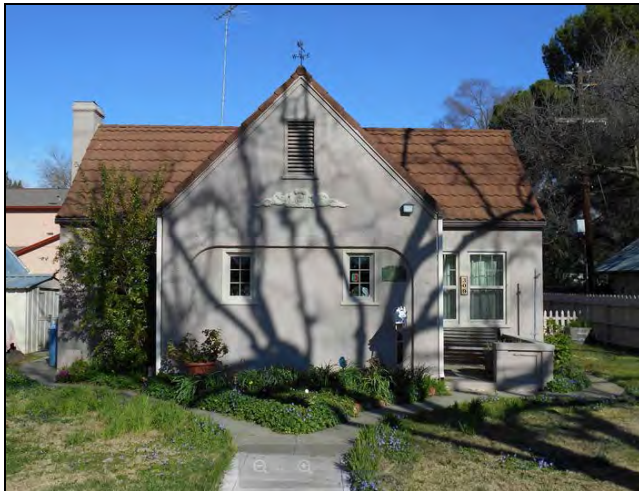
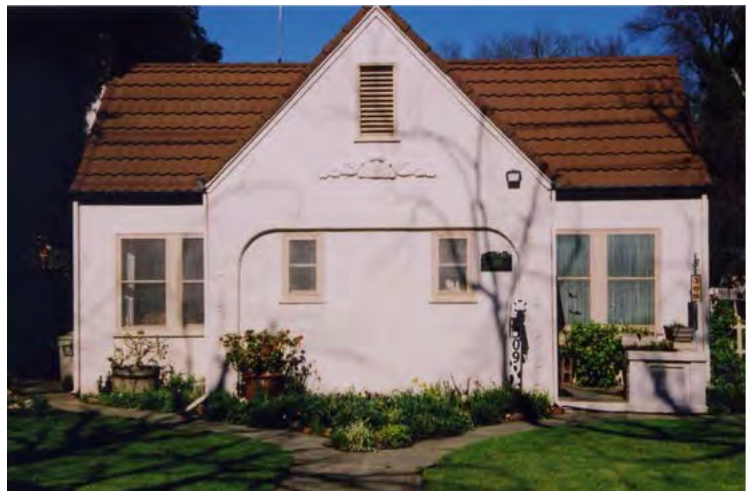
2015

The windows, original in 2003, have been replaced with vinyl. The rest of the structure remains the same. The replacement windows have changed the character of the front of the house and the status code might need to be reconsidered.

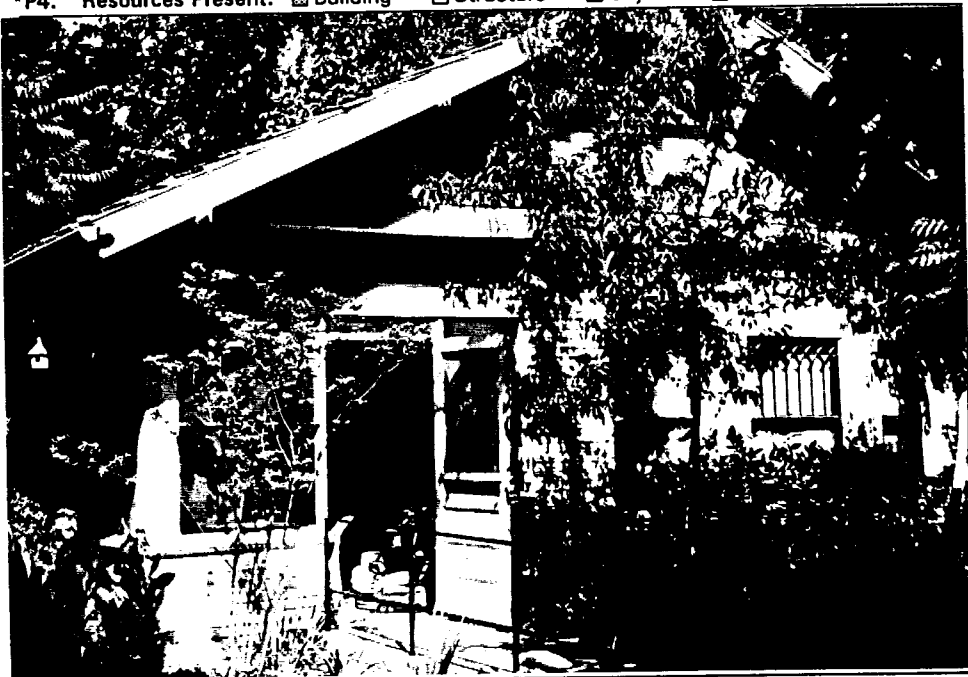
This small, wood frame house is clad in white painted narrow horizontal wood siding. The gable roof is perpendicular to the street and has a wide overhang on all sides supported by brackets. Wood shingles are present at the gable end facing the street. The southern side of the front facade has a screened porch. The northern end of that facade has a bay window with the center window having decorative mullions. A handicap ramp has been added to the main entry. The house appears to be in fair condition.

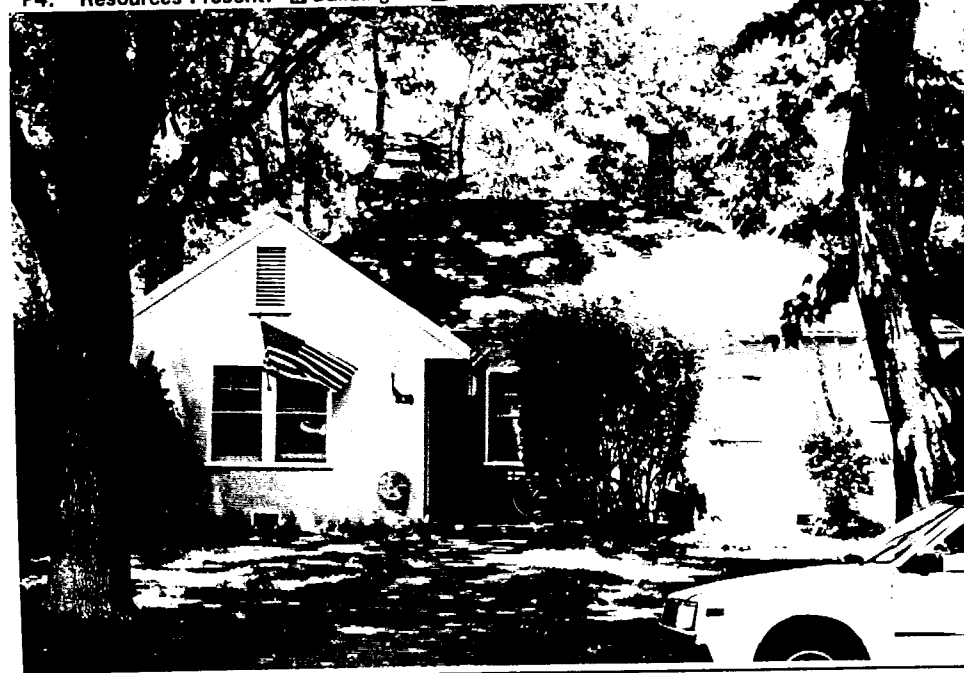
P5b. Description of Photo: (View, date, etc.)
 Front Facade
 Looking North

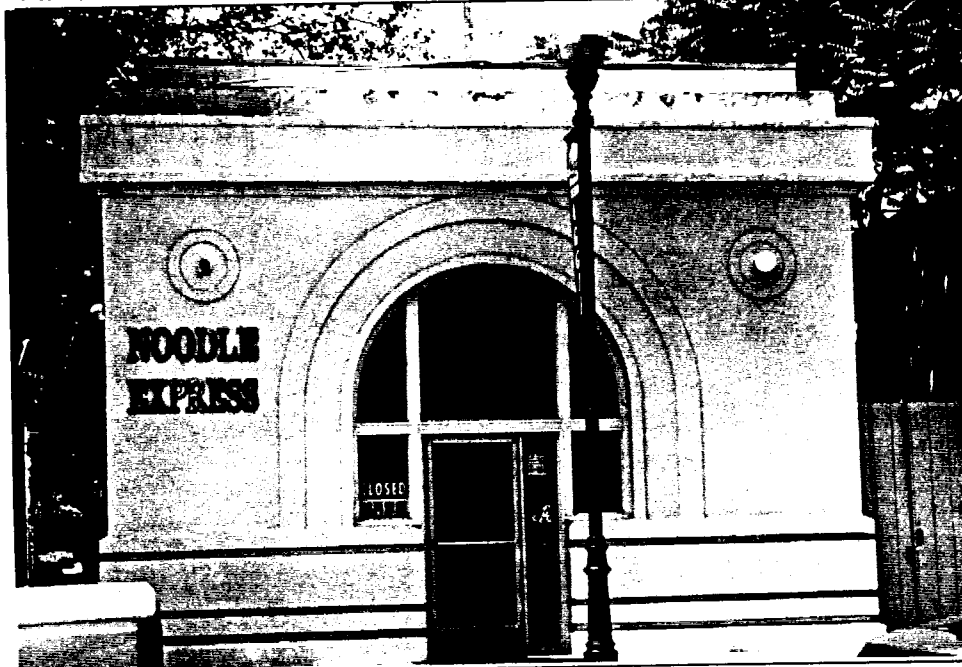
P5b. Description of Photo: (View, date, etc.)
Front Facade

Looking west

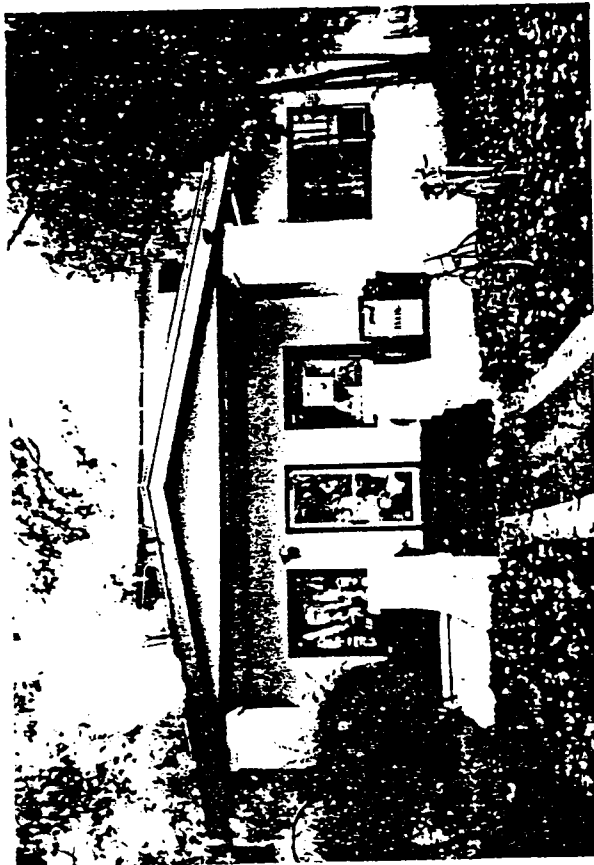
This two story stucco Craftsman bungalow is roofed by a series of shallow gables. The double hung windows have a vertical muntin pattern in their upper portions. The stucco piers which support the porch roof and railings flare out at the bottom. The porch rail consists of evenly spaced vertical wooden slats.

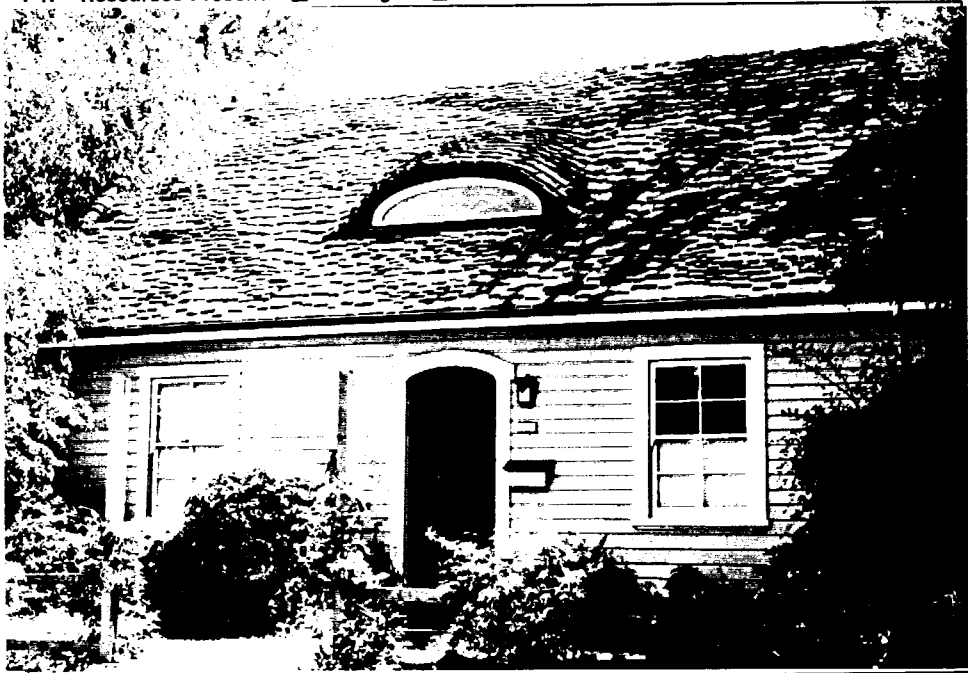
This small clapboard cottage style house has an attic eyelid dormer. The overall composition of the house is symmetrical. Two four over four double hung windows are on either side of the main entry. The front door is of wood and has an arched door surround. The roof is of irregular wood shakes. The house is painted grey with green trim. The house is in good condition, including the landscape. It was renovated in 1994 and the eyelid dormer and roof are new.

P5b. Description of Photo: (View, date, etc.)

Front Elevation

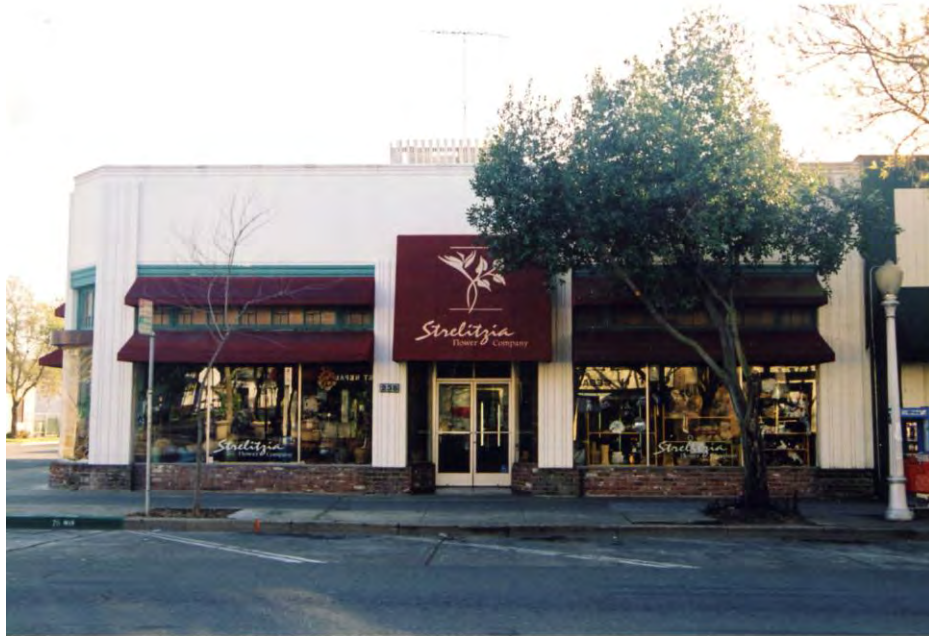
This Streamline Moderne Style commercial building is an excellent example of what architectural historians, Herbert Gottfried and Jan Jennings, have termed the “modern broad-front storefront” This building type represents a distinct break with the design of earlier retail buildings. It is characterized by a double width façade made possible by steel beam and column construction. The façade 238 G is open with large panels of glass, subdivided by thin muntins that facilitate window display. The building is linear and single story, and abandons the upper story office or living space that often characterized earlier commercial buildings. Single story, it has a flat roof and parapet. A divided transom forms a band across the top of the display windows. The double entry is positioned in the center of the building and is slightly recessed allowing for side glass panels in the entry. The entry and curved corner of the building are highlighted by streamline engaged columns. Constructed in 1937, the lower façade wall was originally faced with ceramic tile, but is now covered with a brick facing. A handsome building, it is one of the few Streamline Modern style buildings in Davis and one of the few commercial buildings of this construction type. It appears to contribute to the historic character of the Downtown/ Commercial area of the Conservation District. It should be considered for historical resource designation by the City as one of the few remaining historic buildings in the original City commercial district, and one of the only ones remaining on the east side of the street.

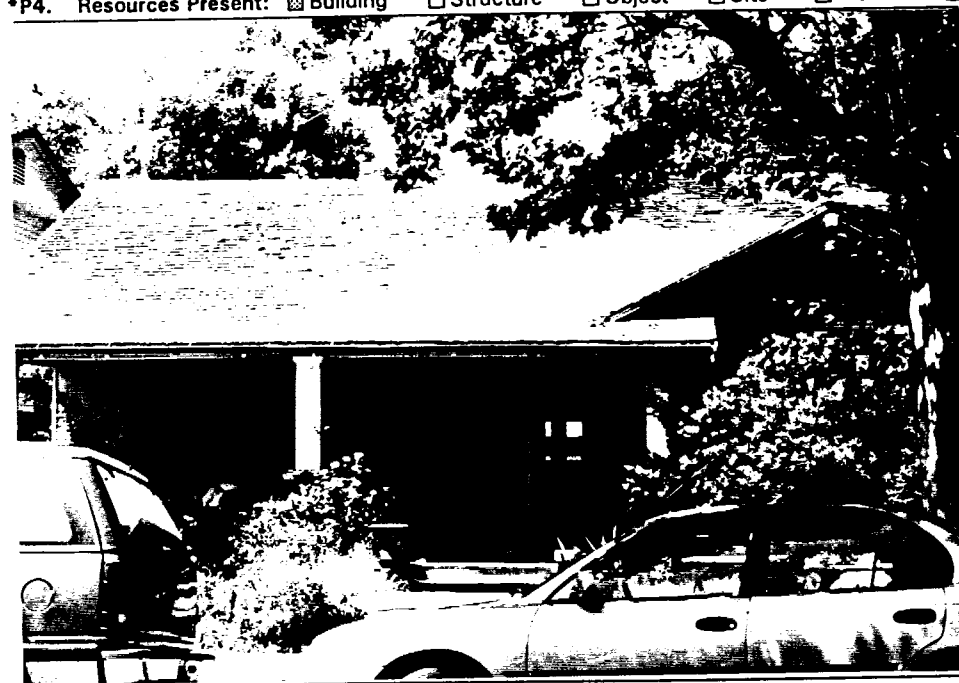
This is a small, one story, ranch-like house. The main roof is gabled with the ridge running parallel to the street. An intersecting cross gable is located at the eastern end of the front elevation. The house is sheathed in thin clapboards and is painted white with blue trim. Two small one over one double hung windows flank the front door. A pair of larger one over one double hung windows is located on the western side of the front elevation. Landscaping blocks the eastern end of the front elevation. The house appears to be in good condition and is currently used as a rental property.

*P5b. Description of Photo: (View, date, etc.)
 Front Elevation

Looking north

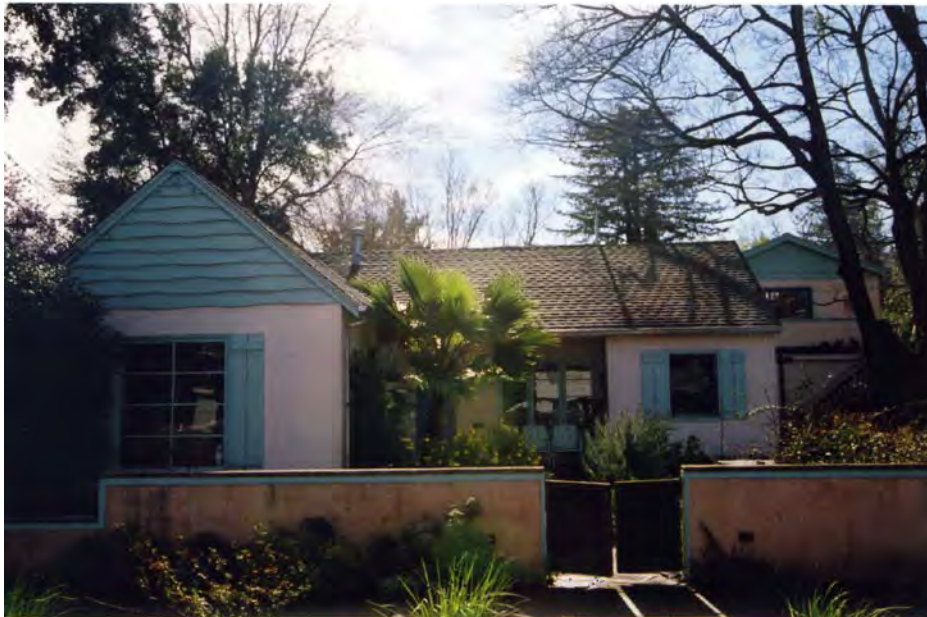
***P3a. Description:**
 This Minimalist Traditional house is L-shape in plan with a moderately pitched cross gable roof. Gables and eaves are clipped with the gable ends finished with a rusticated horizontal stickwork. A prominent eight light metal frame window occupies a large portion of the projecting wing wall. Other fenestration consists of casement and double hung windows. Rusticated, plank shutters flank the front windows. The porch is cut-in. A rear garage has been modified to accommodate a second story office/apartment. The house and garage are clad with stucco. The yard is enclosed with a low wall. The wall, along with the color scheme give the house a southwest feeling, but this is a recent treatment. The house retains its integrity of materials, workmanship, setting, location, feeling and association. It contributes to the historic character of the neighborhood.

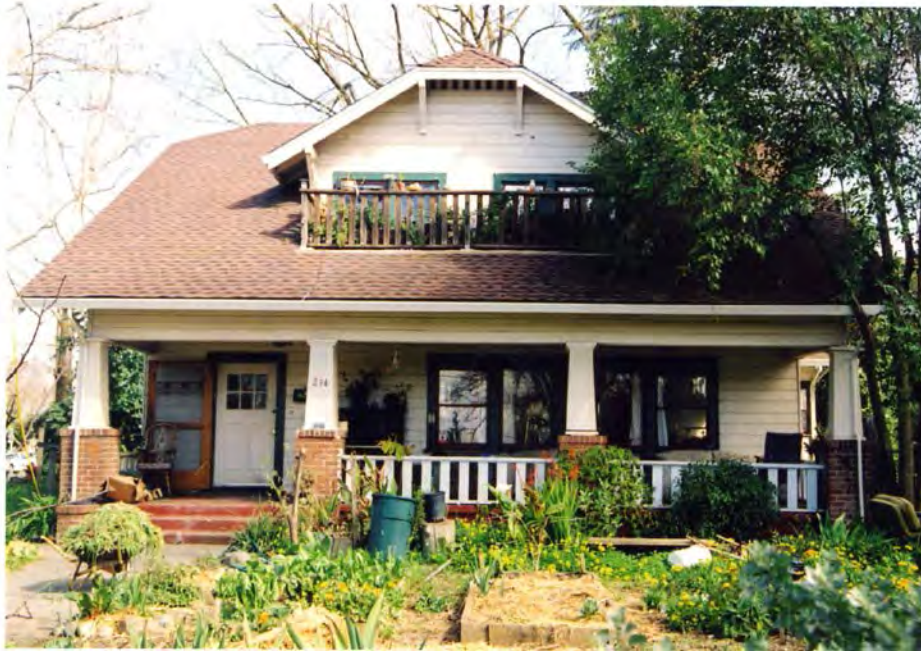
This jerkinhead gable roof Craftsman house is one of the larger and more detailed examples of its type in Davis. It is recognized in both the 1980 and 1996 surveys. At the time of the 1996 survey it appears that the upper story, dormer balcony had been removed. This appears to have been replaced in kind, but has not been painted. Although the landscape around the house has been much altered, the exterior of the house continues to retain its integrity. It contributes to the character of the neighborhood. Because it is one of largest and most detailed bungalows in Davis, it should be considered for local listing as an historic resource.

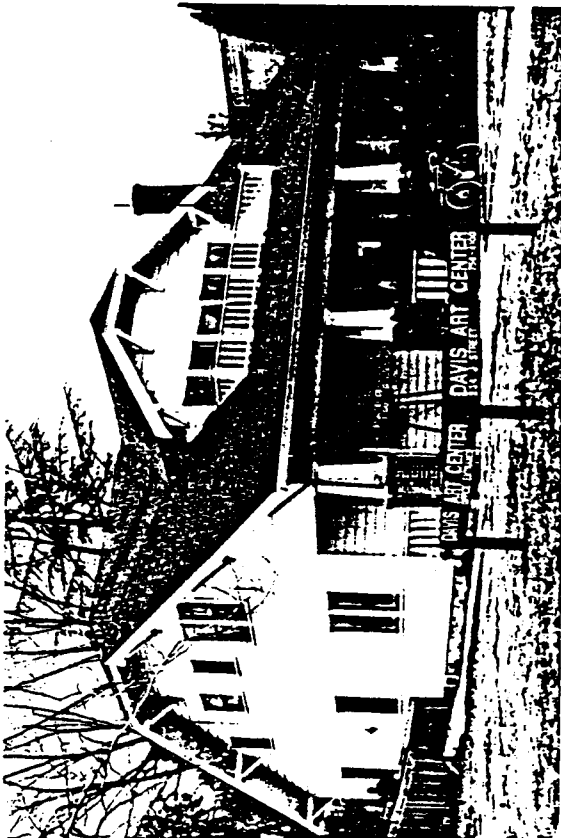
This one and a half story Craftsman house has a jerkinhead gable roof, with a massive roof plane facing the street. In the center of this roof plane is a large jerkinhead dormer which faces a balcony that is recessed into the roof. The recessed front porch has brick pedestals supporting battered wooden posts. The porch and balcony rails are simple wooden slats.

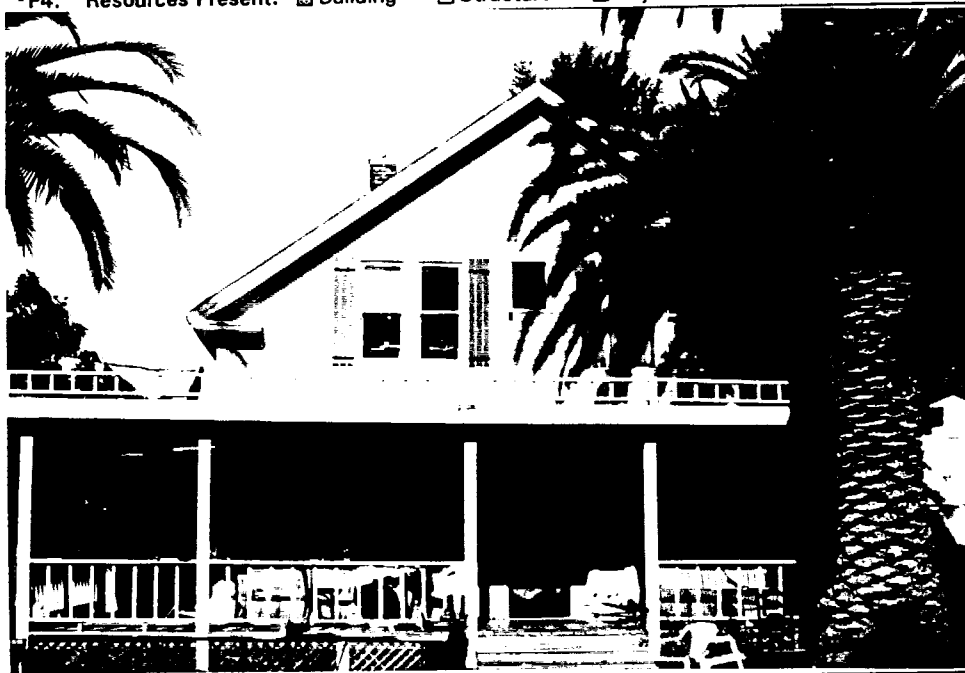
P5b. Description of Photo: (View, date, etc.)
Front elevation
Looking west

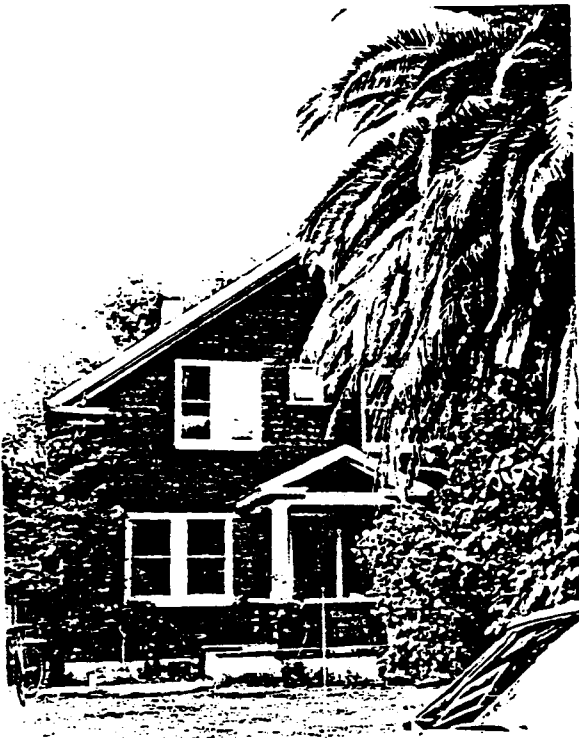
This two story gabled house combines the forms of the Greek Revival with the shingle siding of the Craftsman movement. It may be that the house was shingled in an early 20th century attempt at modernization. The eaves are soffited and there are eave returns. The slightly battered porch support posts are abstracted from Classical columns.

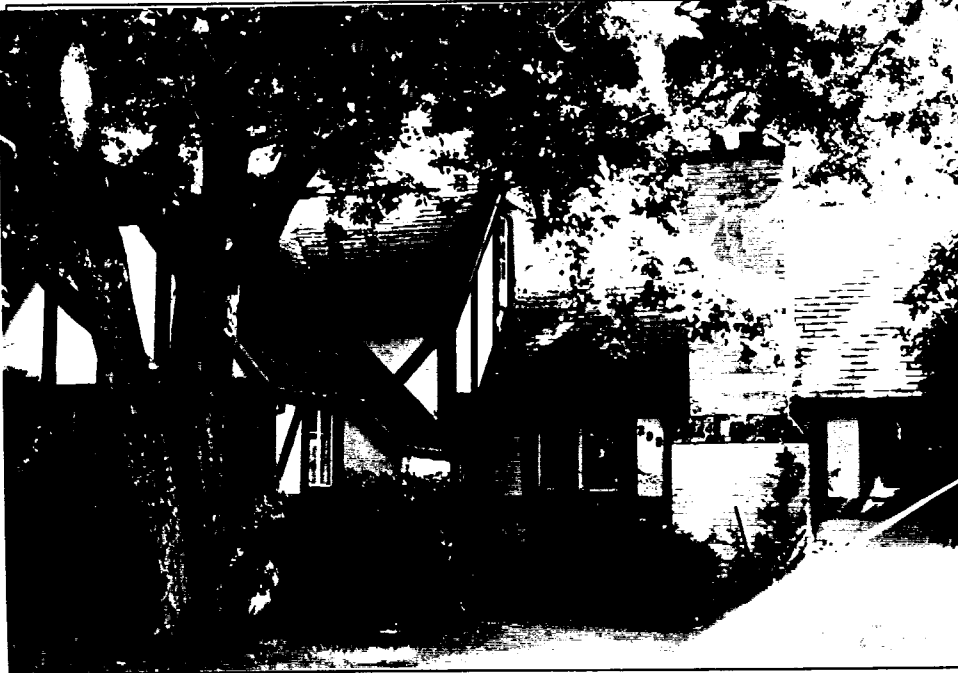
This one and a half story Medieval Revival house has a varied roofline and half timbering over stucco. The house has a projecting section to the south that has a gable perpendicular to the street. The other sections of the house have gables running parallel to the street. The house is painted white with dark grey and brown trim. Casement windows as well as double hung sash windows are present. A large exterior chimney is part of the front elevation. The yard is well landscaped and the house is in good condition.

*P5b. Description of Photo: (View, date, etc.)
Front elevation
looking north

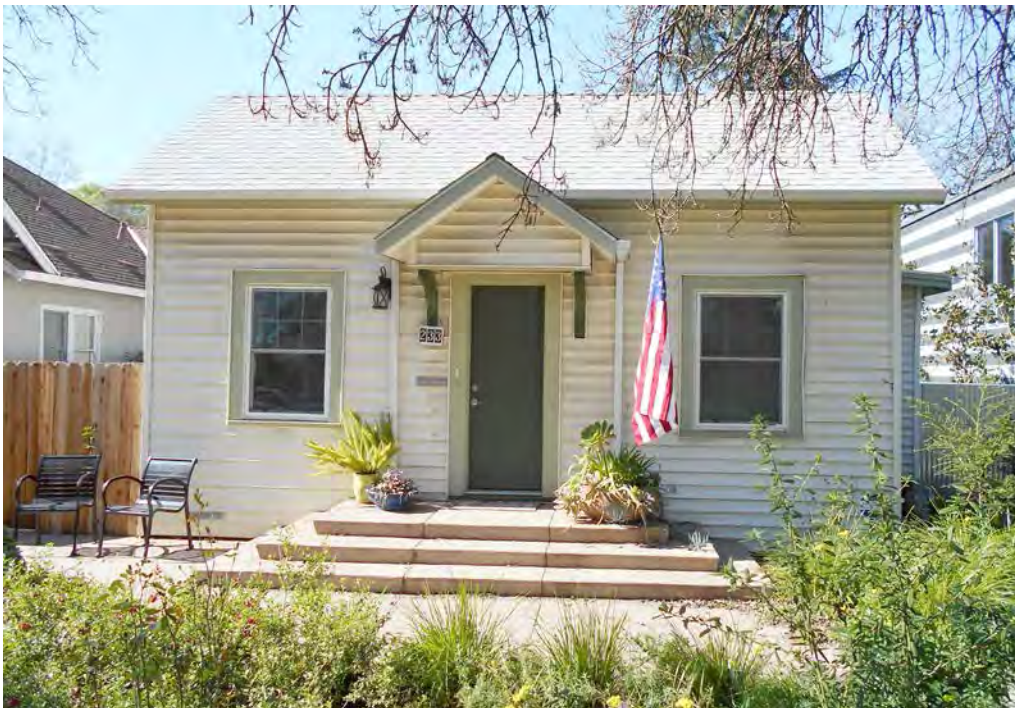
Photographs:

This house contributes to the character of Rice Lane. Many of the houses in the area have been altered or removed. The house was constructed after 1933 as it does not appear on the Sanborn Map for that year. The house is in excellent condition and is well landscaped.
