P1. Other Identifier: Hattie Weber Museum

*P11. Report Citation: Davis, California: Citywide Survey and Evaluation of Buildings Constructed Prior to 1976

- *Resource Name or Address 445 C Street
- P1. Other Identifier: Hattie Weber Museum
- *P2. .Location: *a. County Yolo
- b. Address 445 C Street
- *c. City Davis Zip 95616
- d. UTM: N/A
- e. USGS Quad: Davis Quadrangle
- *f. Other Locational Data (APN #): 70-201-001

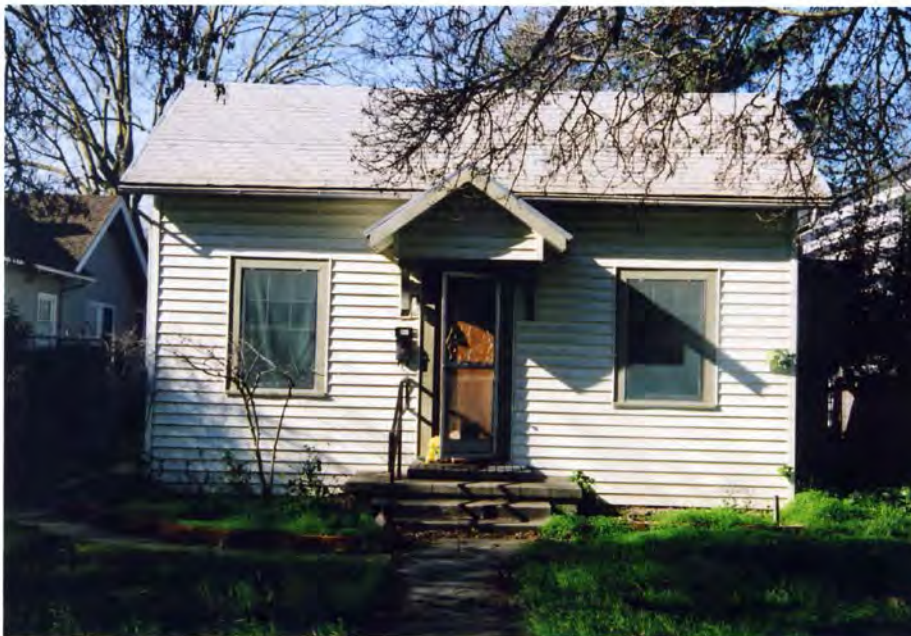
P5. Photograph or Drawing (Photograph required for buildings, structures, and objects.)

*P3a. Description:
 This is a highly simplified rectangular plan bungalow, a house form that appears numerous times throughout Davis. The small building is symmetrically arranged with a central entry door, in this case a replacement. The door is flanked by single windows. Other fenestration is double hung windows display six-over-one glazing. The entry is covered with a gabled porch roof slightly wider than the doorway. It is trimmed with a plain fascia and supported on knee brace brackets. There is an open cement stoop. Cladding is clapboard. The house retains its integrity of design, materials, workmanship, setting, location, feeling and association. It contributes to the historic character of the neighborhood.

*P3b. Resource Attributes: HP2
 *P4. Resources Present: Building Structure Object Site District Element of District
 P5b. Description of Photo:
 View east
 *P6. Date Constructed/Age:
 c 1920 93 years old estimated
 Prehistoric Historic

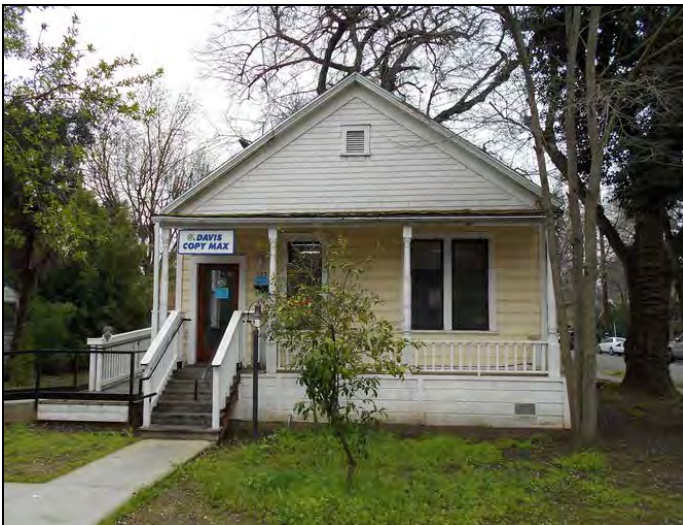
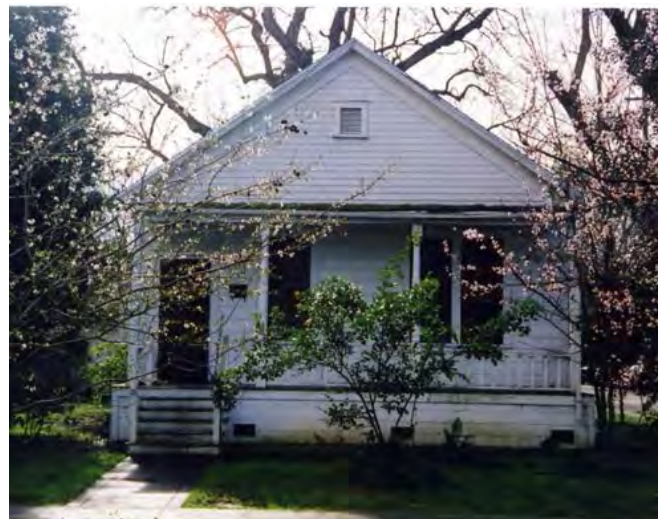
The house maintains the same integrity as in the 2003 survey. The wooden steps and railings in the front of the house have been replaced by concrete steps and new wooden railings but maintain a similar appearance. The railings are of the same design and material. There is now a handicap ramp on the side of the house, the railings also built in the same style as the front railings.

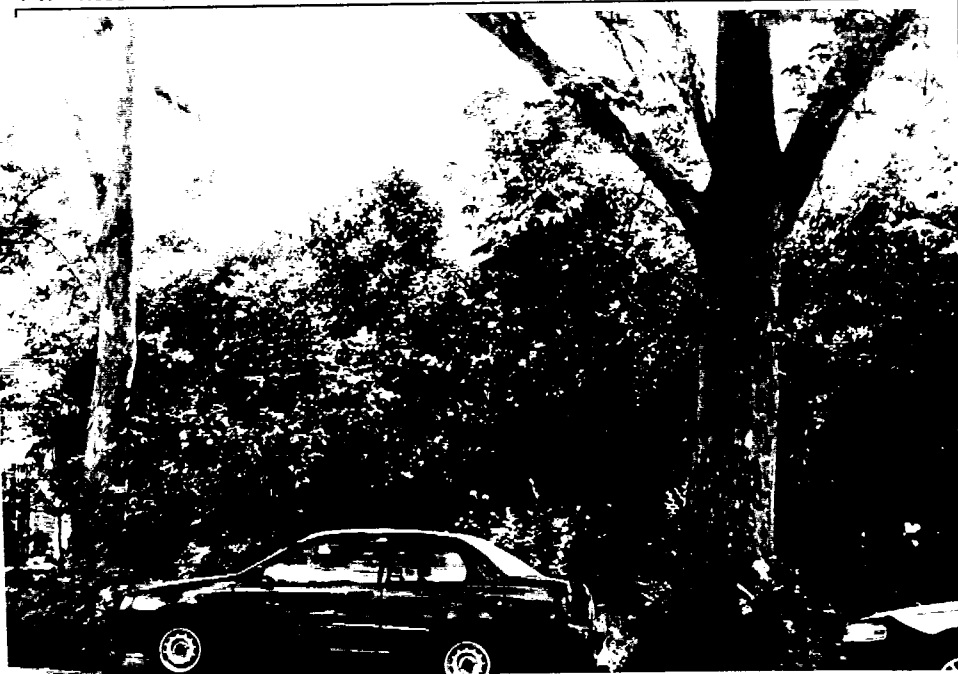
P5b. Description of Photo: (View, date, etc.)
Front facade

*P3a. Description: (Describe resource and its major elements. Include design, materials, condition, alterations, size, setting, and boundaries.)
This one story bungalow fuses the Craftsman with the Colonial Revival styles. The roof is gabled, and there is a small gabled dormer with geometrically mounted windows. The house is sheathed in very narrow clapboards. The porch is supported by piers whose taper is repeated in the unusual, yet well crafted, door and window facings. There is an abstract geometric stained glass window. Presently the house is almost completely hidden from street view with heavy growth vegetation.

This one story bungalow fuses the Craftsman with the Colonial Revival styles. The roof is gabled, and there is a small gabled dormer with geometrically muntined windows. The house is sheathed in very narrow clapboards. The porch is supported by piers whose taper is repeated in the unusual door and window facings. There is an abstract, geometric stained glass window.

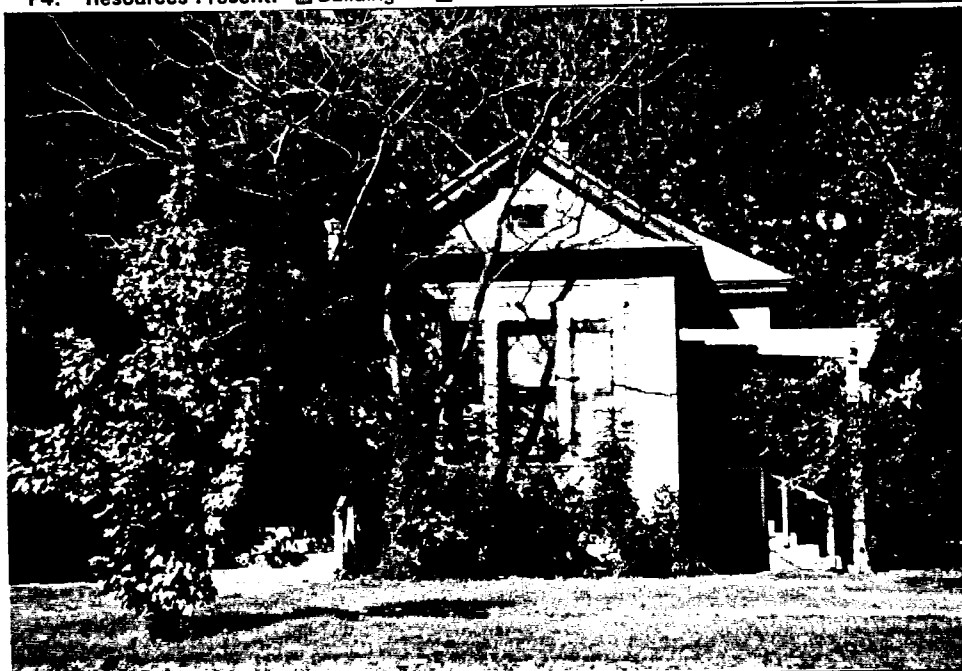
P5b. Description of Photo: (View, date, etc.)
Front Facade

This rambling, clapboarded, one story building is best seen from its 3rd Street side. The roof is a combination of hipped and gabled forms with soffited eaves. There are trellisses, shingled gabled ends, and tripartite window compositions. The house appears to be the result of compatible additions. It is a vernacular Queen Anne in its stylistic commitment.

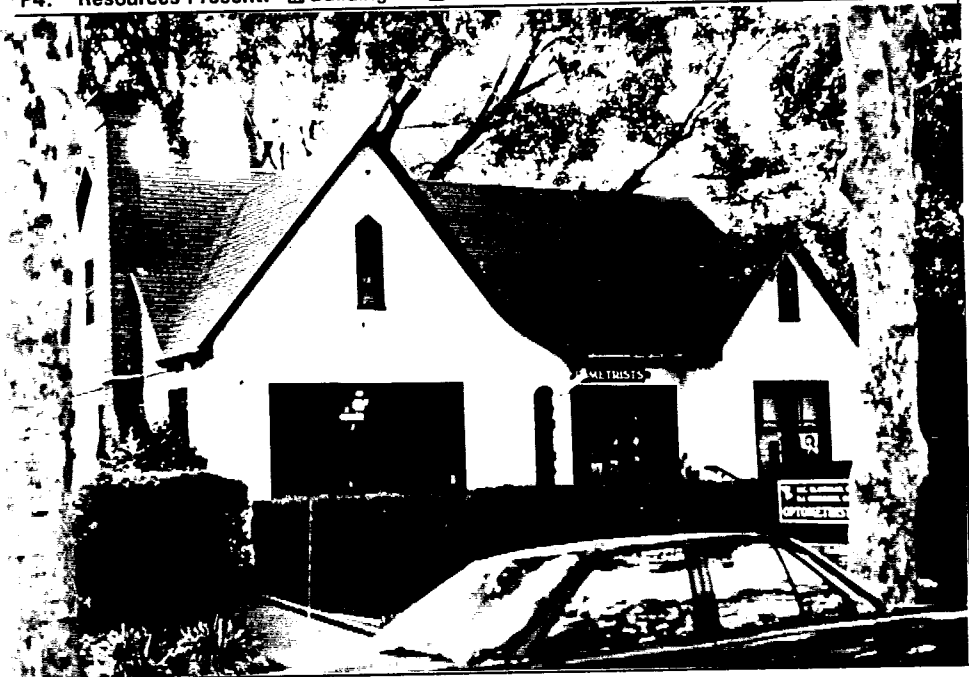
P5b. Description of Photo: (View, date, etc.)
 Front elevation

This two story stucco house has Cottage Revival and Craftsman features. Wood sash, double hung, windows are found throughout the house. Most of the windows are eight over one in configuration with the eight light window having symmetrically off set mullions. A large tripartite window is present on the south side of the front facade. Just south of the main entry porch is an arched cut out with decorative ironwork. The main portion of the roof is a gable running parallel to the street. This roof is offset by two perpendicular gables one with a long slope to the north. The western face of the second floor is currently sheathed in plywood indicating some remodeling project. Additions to the house include a large concrete patio and ramp on B Street. The house is in good condition and is currently used an optomitrist's office. The second floor was converted into a psychologist's office and the garage into a one bedroom cottage under the new mixed-use zoning ordinance.

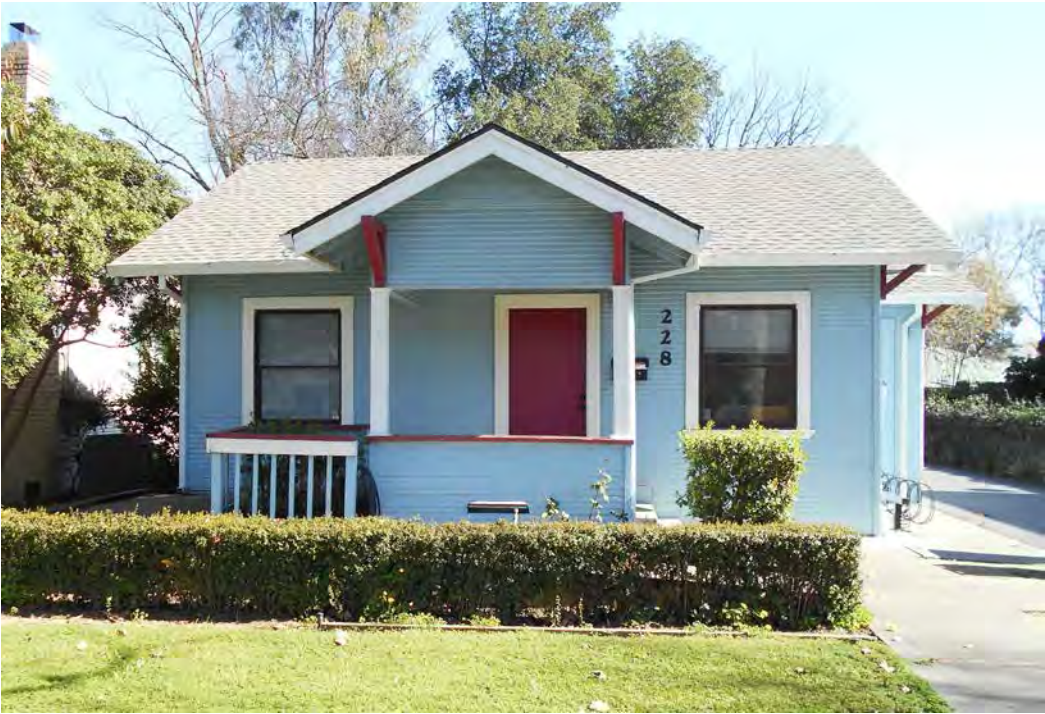
Photographs: 2015

*P3a. **Description:** See original form for original architectural style and features. Old rear addition includes second unit.
 2015: Original front door replaced with inappropriate slab door. Current age is 95 years.

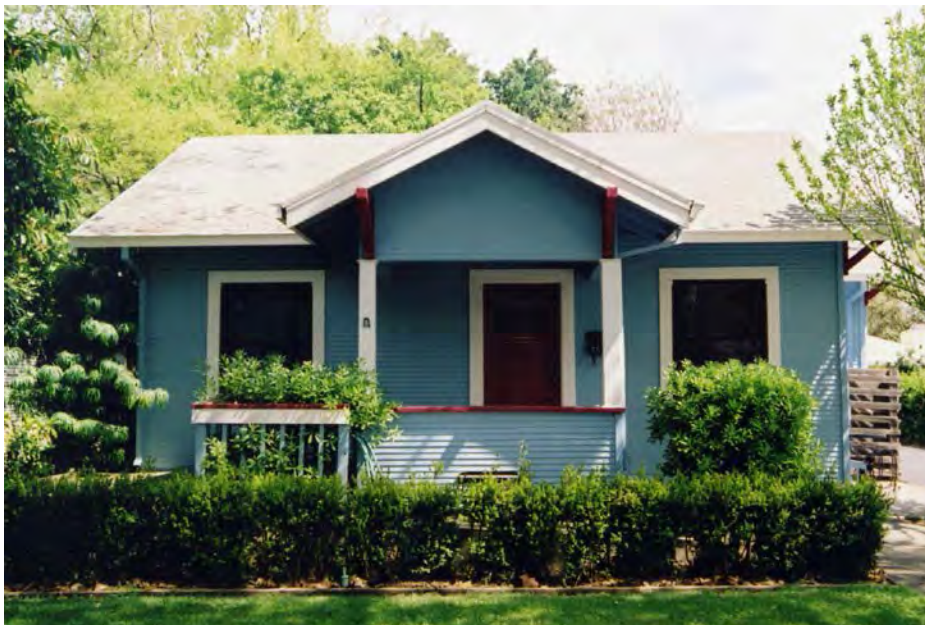
P5. Photograph or Drawing (Photograph required for buildings, structures, and objects.)

This simple bungalow is rectangular in plan with a moderately pitched side gable roof. Gable ends are supported on knee brace brackets. A small gable projects from the front façade to cover the centered porch. The gable exhibits knee brace bracketing with the gable end supported on square posts that are set on the closed front rail. Entry to the porch is located on the south side. Six-over-six double hung windows flank the entry door. The house is clad with narrow novelty siding. The design of the house is one that is found in other locations in the downtown and Old North area. The building retains integrity of design, materials, workmanship, setting, location and association. The building appears to contribute to the historic character of the Downtown/ Commercial area of the Conservation District.

*P3b. Resource Attributes: HP2
 *P4. Resources Present: Building Structure Object Site District Element of District
 P5b. Description of Photo:
 View east *
 P6. Date Constructed/Age:

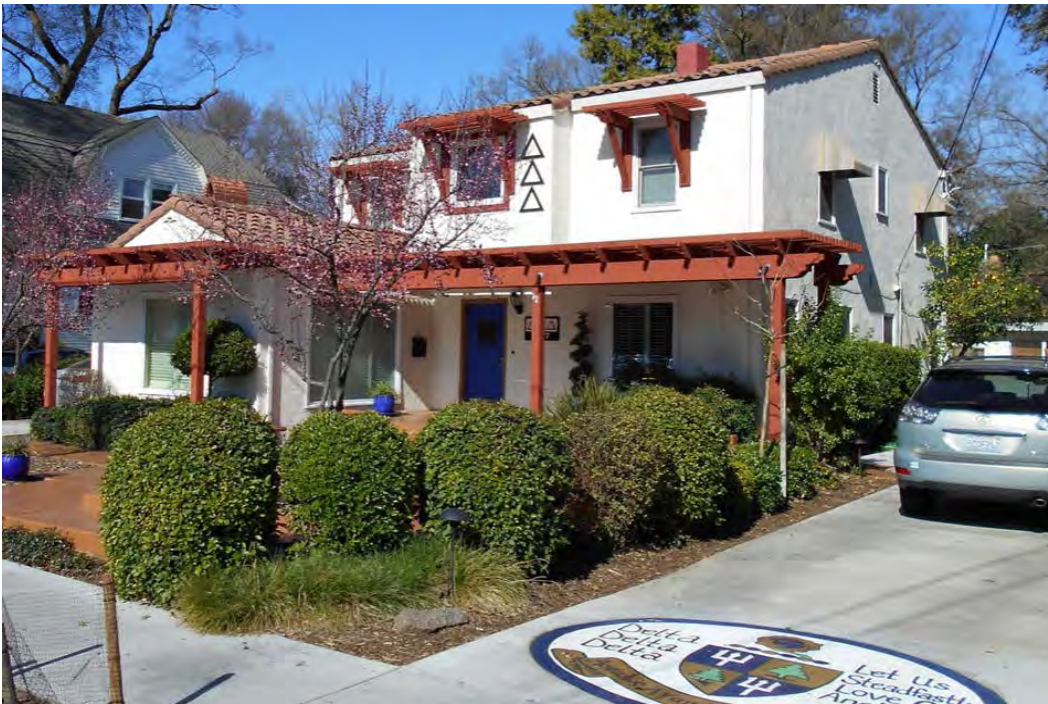
Photographs:

*P3a. **Description:** See original form for architectural style and features. Main façade window replaced since 2003 survey

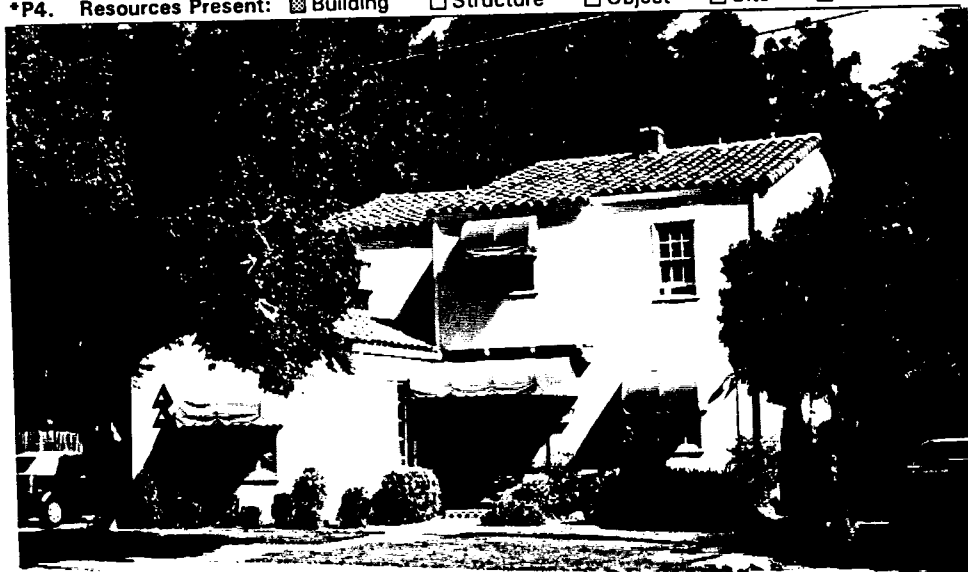
P5b. Description of Photo: (View, date, etc.)
 Front Facade
 Looking North

This large Mission Revival house has a series of gable roofs covered with red clay tile. Painted white with numerous types of fenestration the house has a classic Mediterranean feel. The smooth stucco walls are accented by awnings that have been added to many of the doors and windows. A projecting wing creates an L-Shaped front facade. There is a bracketed overhang with a window above the front door. The house appears to be in good condition overall.

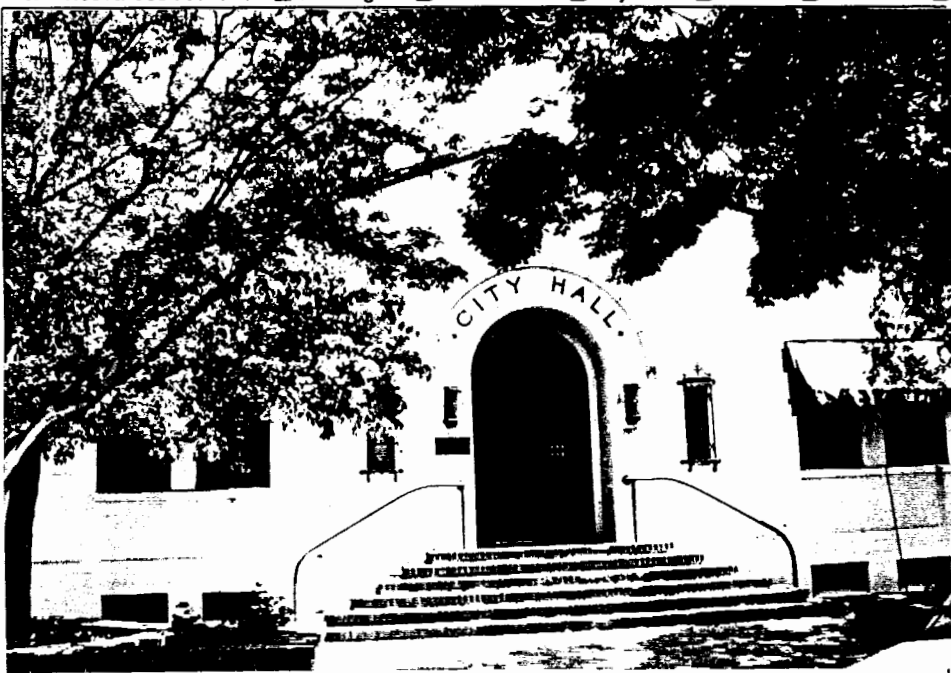
P5b. Description of Photo: (View, date, etc.)
West Facade

The Davis City Hall is a one story Spanish Colonial Revival building with stucco walls and red tile roof generally associated with the style. The main entrance is in an end wall which terminates in a shallow gable. This gabled end wall is symmetrical in its organization with the arched entry in the center, flanked by a pair of small narrow windows covered by decorative iron grillwork. A brick stairway leads to the main door. There is a pierced geometric vent grille in the upper portion of the gable. The fenestration consists of paired casement windows with awnings. The foundation of the structure has a series of small windows for basement or storage ventilation.

6. Briefly describe the present physical appearance of the site or structure and describe any major alterations from its original condition:
 The Davis City Hall is a one-story Spanish Colonial Revival building with stucco walls and red tile roof generally associated with the style. The main entrance is in an end wall which terminates in a shallow gable. This gabled end wall is symmetrical in its organization with the arched entry in the center, flanked by a pair of small narrow windows covered by decorative iron grillwork. There is a pierced geometric vent grille in the upper portion of the gable.

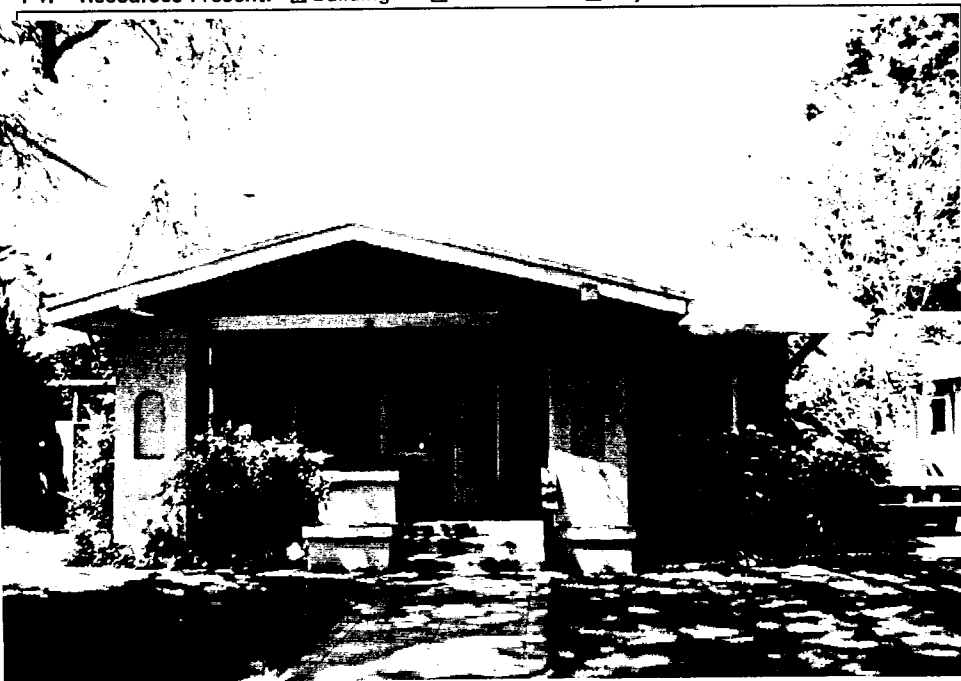
P5b. Description of Photo: (View, date, etc.)
Front Facade

Looking west

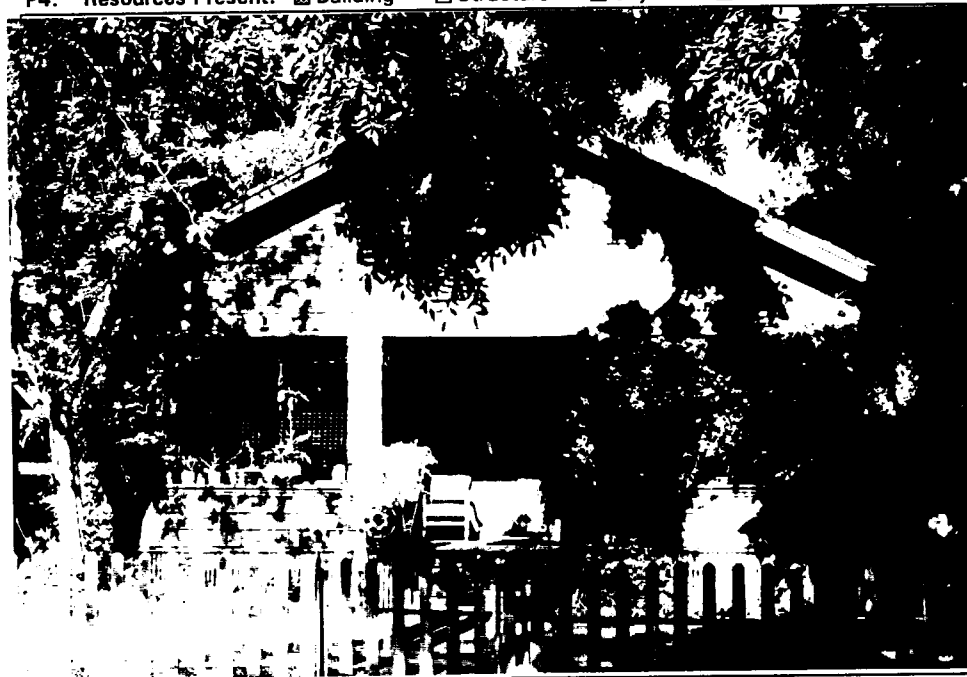
This shingled, one and a half story house is essentially Craftsman in detailing and it resembles the house at 219 Univeristy. The entry is recessed and centrally located. The gabled roof is perpendicular to the street and is pierced by an attic vent. The exterior cladding is of unpainted shingles. Little ornamentation other than the surfacing material occurs. The house has a second story apartment in the rear. Landscape features complement the character of the building. Overall the house is in good condition.

P5b. Description of Photo: (View, date, etc.)
Front elevation

Looking west

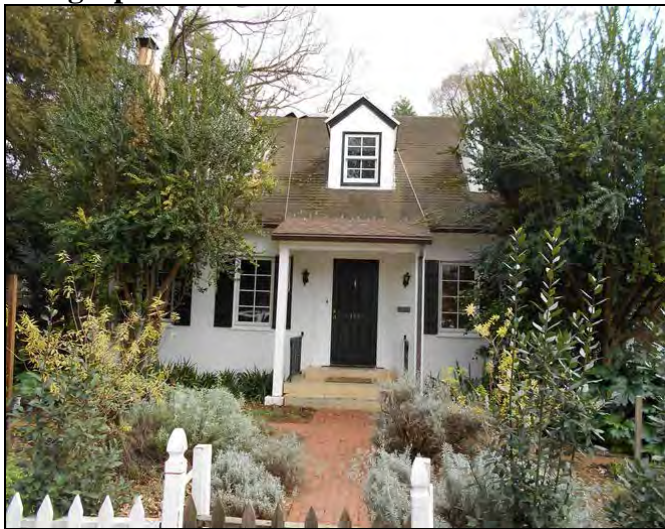
2015

The first floor windows have been replaced. In 2003 they appeared to be double-hung windows and now are casement windows with a similar light pattern.

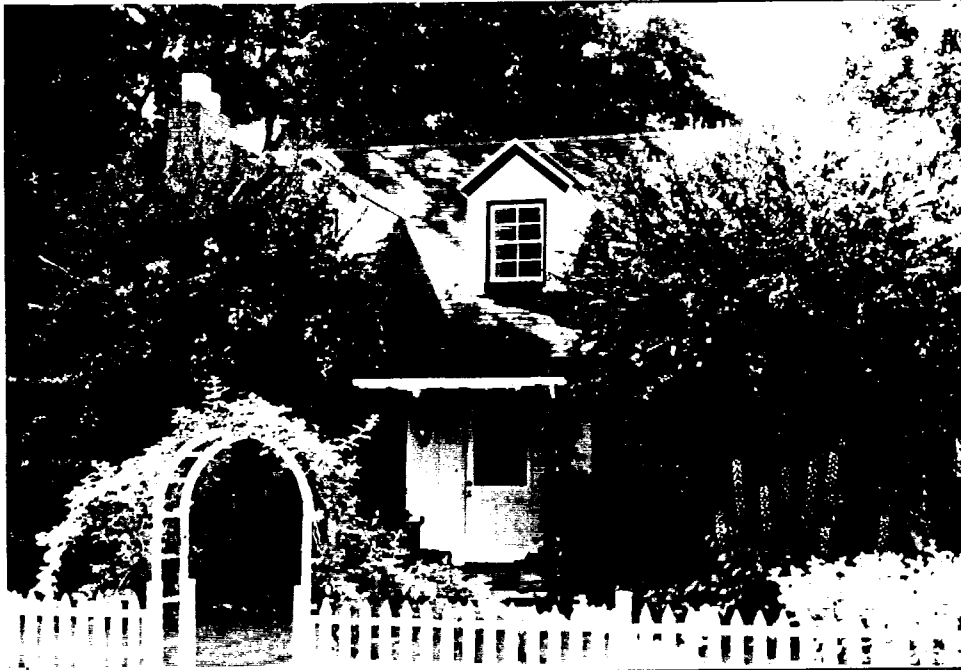
This small cottage like residence has a gable roof with the line of the gable parallel to the street. Two dormer windows mark the second story of the house. An exterior brick chimney is located along the east elevation. A shed porch is present at the front entrance and is supported by two posts. The yard is heavily landscaped and there is ivy growing up the porch posts. A white picket fence encircles the property which has an arched trellis at the entry leading to the front porch. The house appears to be in excellent condition.

P5b. Description of Photo: (View, date, etc.)

Front elevation
 looking south

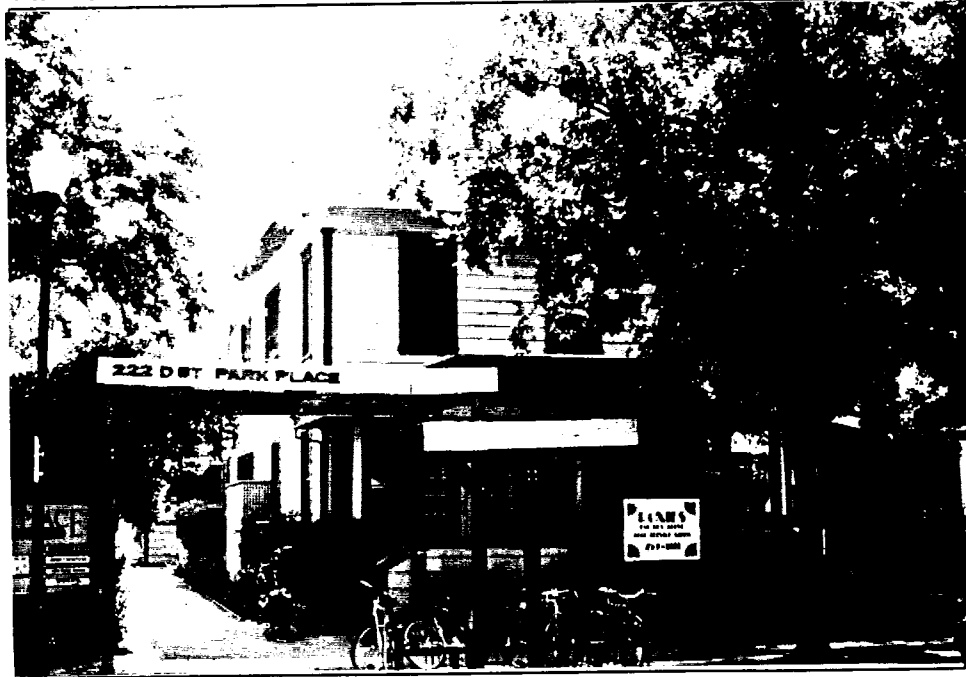
*P5b. Description of Photo: (View, date, etc.)
Front Facade

Looking east

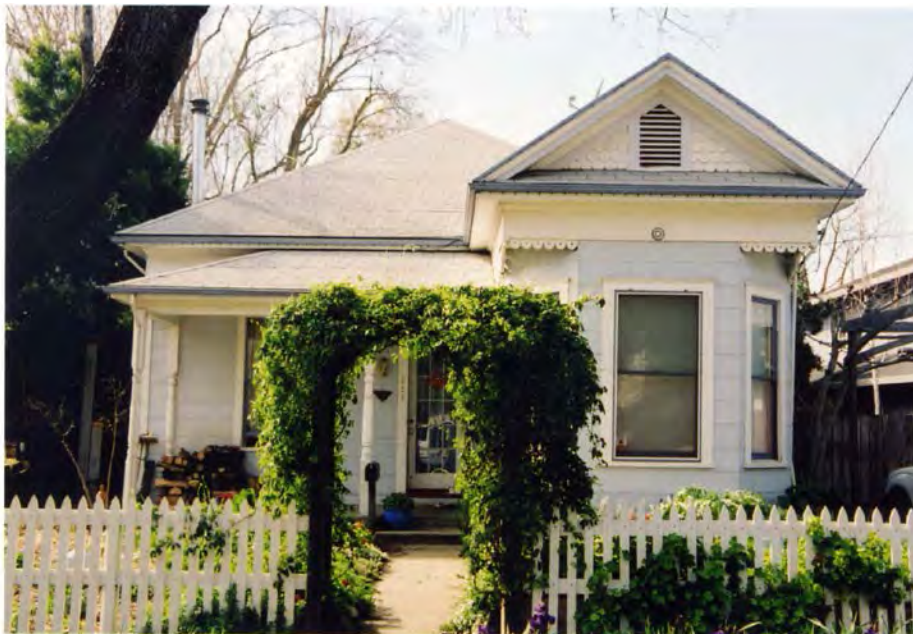
*P3a. **Description:**
The classic Queen Anne cottage is an excellent example of its type and period. It was noted in the surveys of 1980 and 1996. The house continues to retain its integrity. It contributes to the character of the neighborhood and may contribute to a multiple property district composed of Victorian period residences in the City of Davis.

*P3b. **Resource Attributes:** HP2
*P4. **Resources Present:** Building Structure Object Site District Element of District
*P5b. **Description of Photo:**
View east
*P6. **Date Constructed/Age:**
1897 106 years old documented
 Prehistoric Historic
 Both

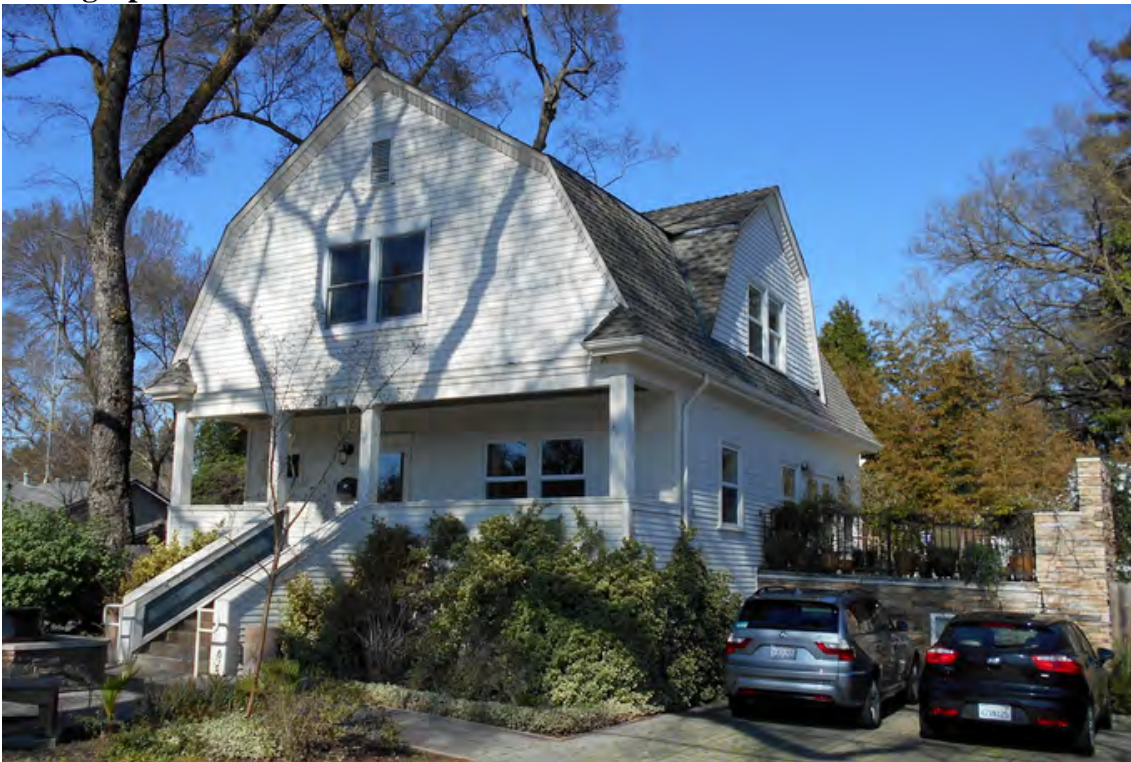
*P3a. **Description:** See original form for architectural style and features. The replacement of the front door is the only apparent change since 2003. A flush wooden door has been exchanged for a single-lite French door.

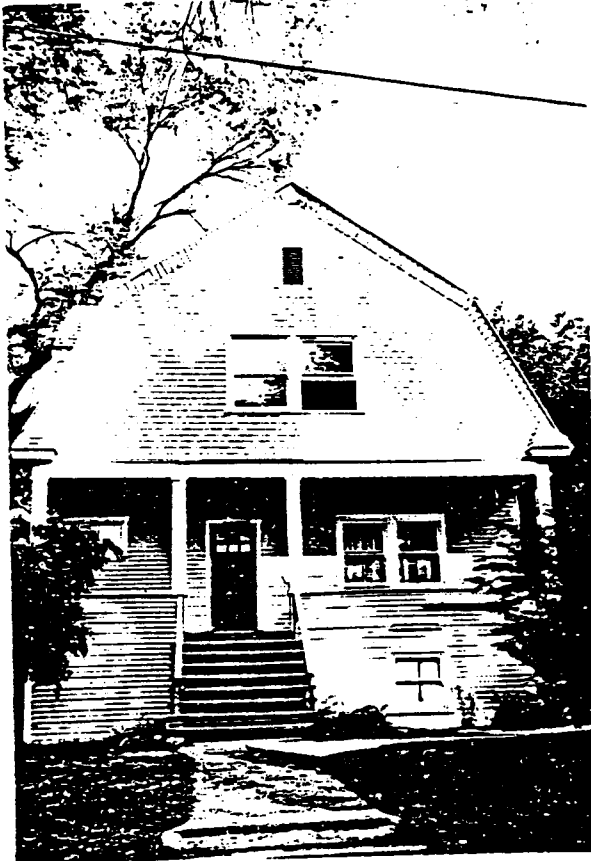
This one and a half story Colonial Revival house has a gambrel roof with the gable end facing the street. The porch, which is recessed into the body of the building, has solid parapet railings, and is supported by square posts. There is a chamfered eave with a row of perpendicularly placed shingles.

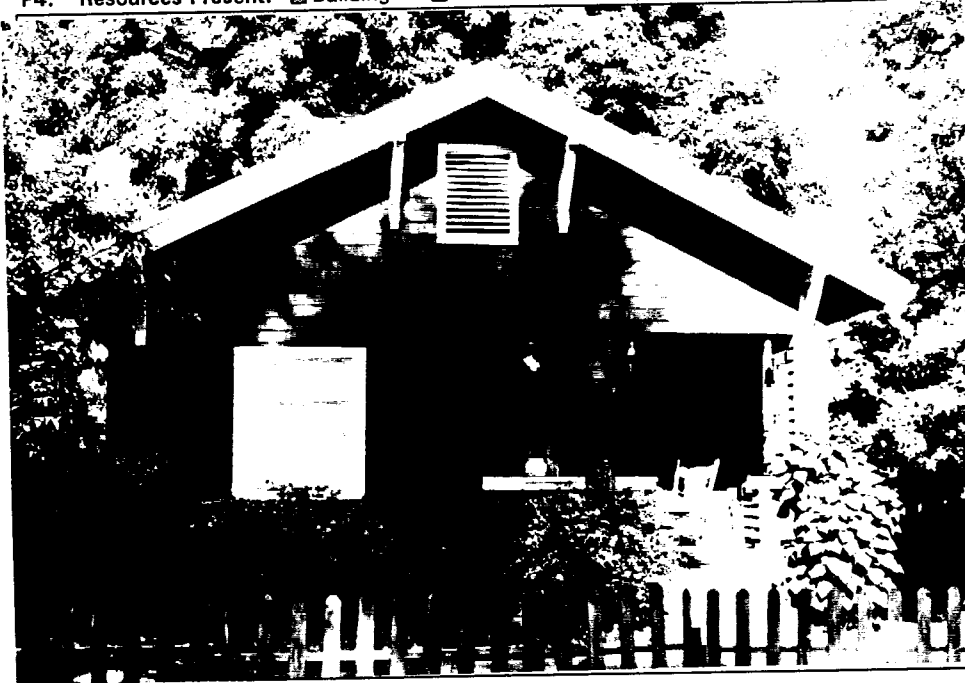
P5b. Description of Photo: (View, date, etc.)
Front elevation

Looking west

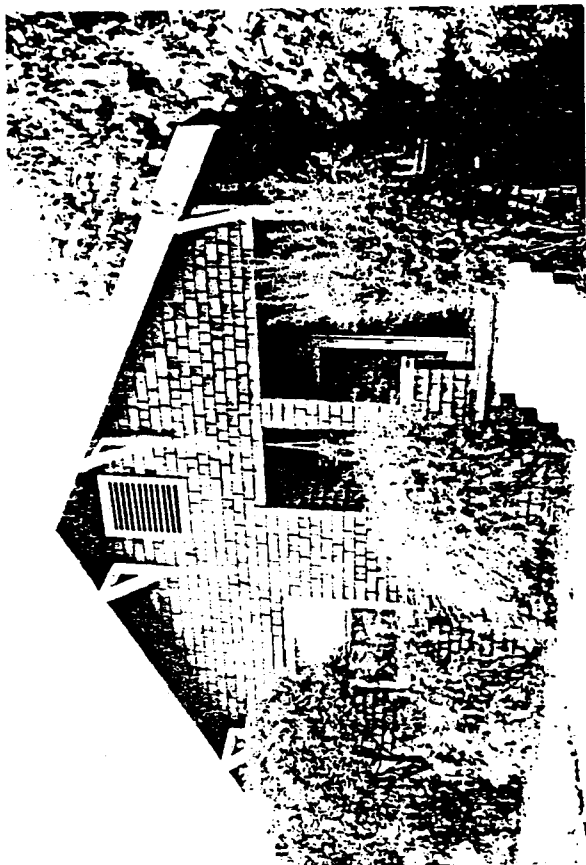
The structure is a one story shingled building of Craftsman stylistic origins. The roof is gabled and the overhang is supported by brackets. Fenestration is simple and the entry porch is created by a cut-out corner of the house with one shingle covered post support. Ornamentation is limited to the eave bracketing and texture pattern of the shingles. A wide fascia emphasizes the strong roof form.

The back porch was enclosed and additional bathroom facilities were added in the 1930's.

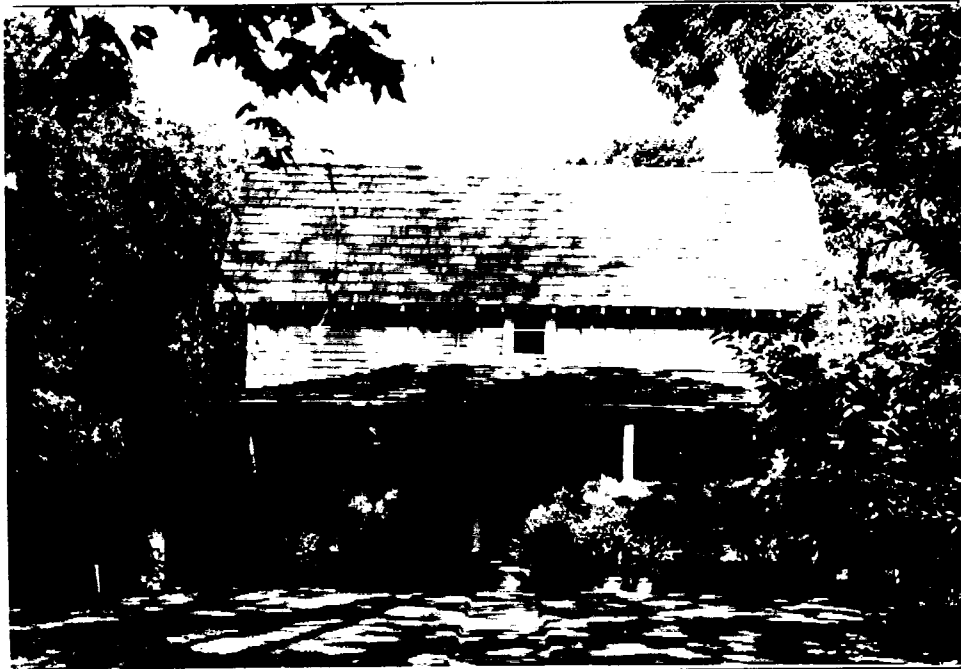
Front facade

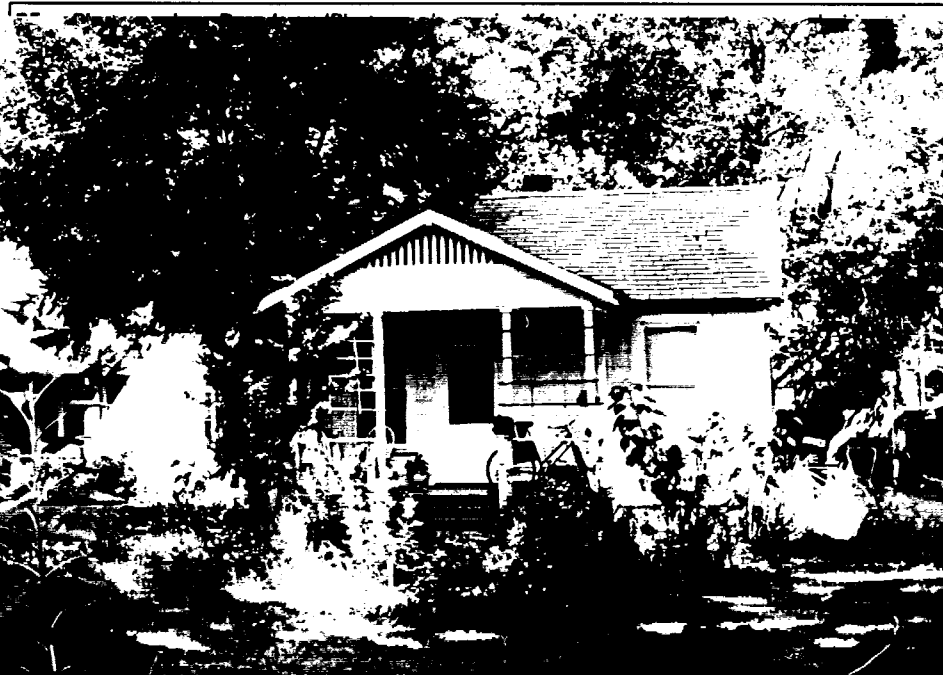
This one story vernacular cottage is roofed by a gable with its ridge parallel to the street. A cross gable protects a small porch and is supported on four square posts. There is an attic vent of vertical slats present in the porch gable. Asymmetrical in composition, the front elevation has two one over one wood sash windows on either side of the front door. The wood frame structure sits on a masonry foundation. The house is sheathed in horizontal wood siding. Additions have been made to the rear of the structure.

Front elevation

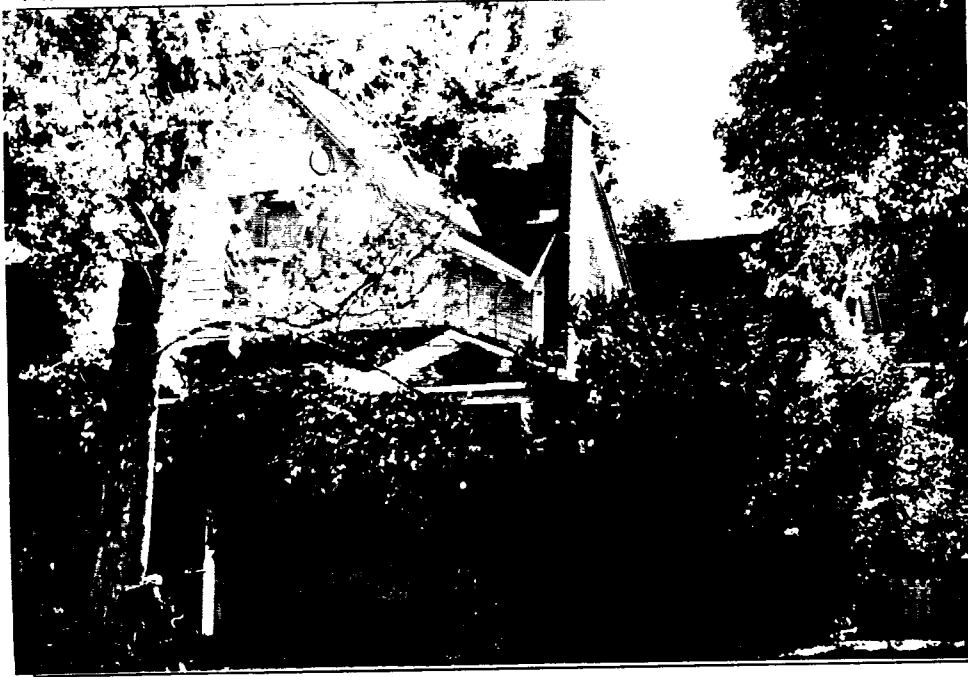
*P3a. Description: (Describe resource and its major elements. Include design, materials, condition, alterations, size, setting, and boundaries.)
This large, two story, rambling, vernacular house has always been used as a rooming house. Irregular in plan, the building appears to have been constructed in phases although there is no proof of this. Of wood frame, the house is clad in white painted shingles. The roof line is a series of intersecting gables. Several porches added to the jumbled lines of the roof. The main entrance to the house is off a front wrap around porch. The front door is wood with a panel on the lower portion and a light on the upper portion of the door. The windows are primarily one over one double hung wood sash. Many of them have rustic wood shutters that have been painted grey as the rest of the house trim. The overall composition of the front elevation is asymmetrical. The house is in fair to poor condition likely due to the continual use of the structure as a rental or boarding unit.

P5b. Description of Photo: (View, date, etc.)
 Front Facade
 Looking east

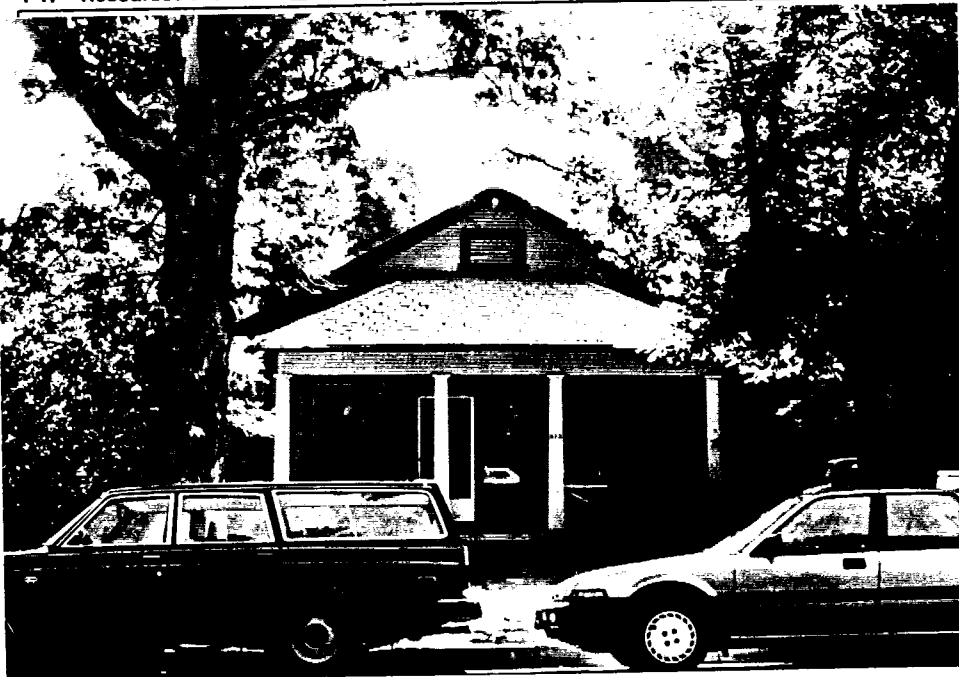
This one story, Colonial Revival house has an overall symmetrical composition and is set in an informal landscape. The foundation is wood and stone. The cladding is of white painted stucco. The house has a gable roof perpendicular to the street with an attic vent piercing the gable. The front porch has a hipped roof that intersects the front gable. Four classically detailed columns support the porch giving the house its Colonial Revival flair. Criss-cross wood slats form the porch railing. Several steps access this feature. The front door is wood with a single, large light. The front facing windows are double hung. The house appears to be in good condition.

P5b. Description of Photo: (View, date, etc.)
Front Facade

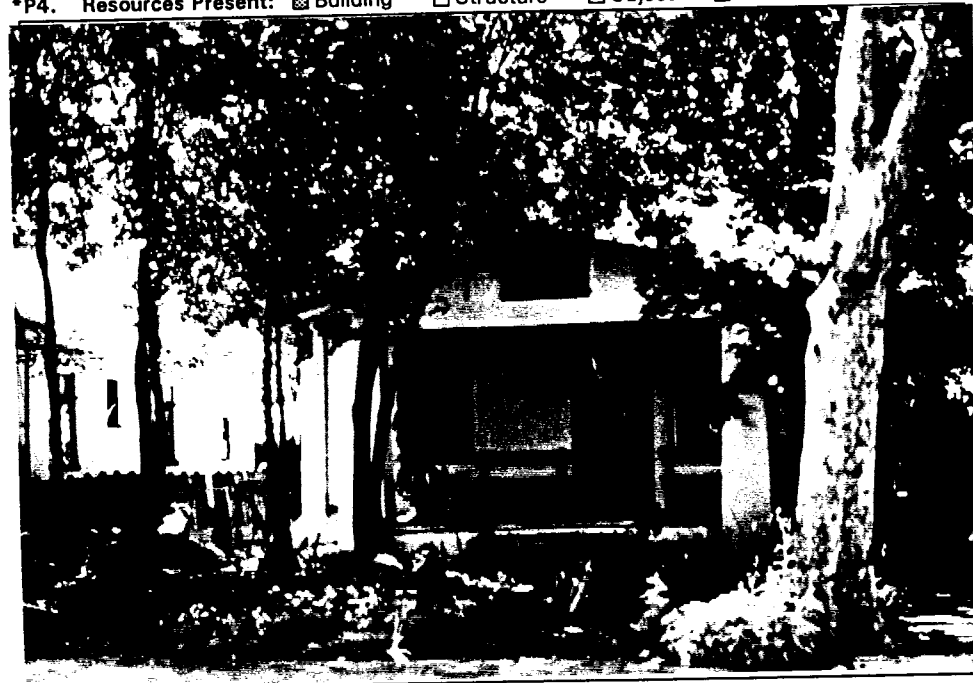
This is a classic one story, stuccoed Craftsman bungalow. The house is rectangular in plan and has a gable roof with a small window in the street facing gable. A porch runs the entire length of the facade. The main entry to this dwelling is off center and is flanked by two one over one double hung windows. The front door is wood with a single, large light on the upper portion of this feature. Two steps lead up to the porch which is supported by two canted piers on either end. No railing exists on the porch. The house is painted white and is in fair condition, appearing to be in need of some maintenance.

P5b. Description of Photo: (View, date, etc.)
Front Facade
Looking south

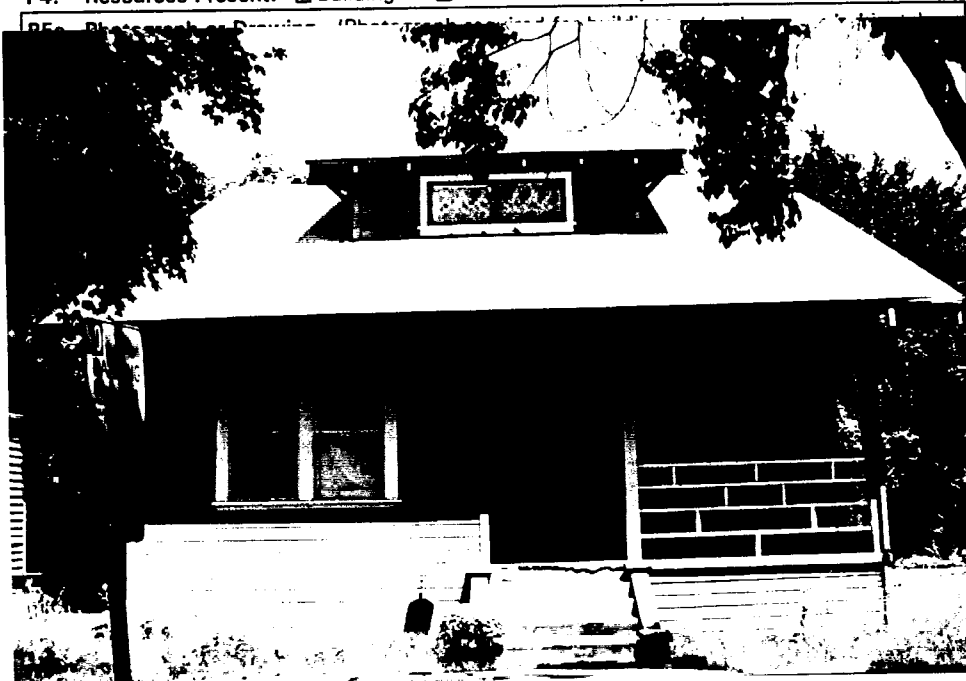
This one story clapboard Craftsman house has a gabled roof with the ridge parallel to the street. The roof has a symmetrically placed shed dormer with louvered vents. The detailing is quite simple, with very little of the rusticity sometimes associated with Craftsman design. There is a brick chimney in one end gable. The porch is located on the east side of the front elevation accessed via a small stair and with a rail consisting of a series of horizontally placed boards. Two windows occupy the front elevation, one placed beneath the roof of the porch.

P5b. Description of Photo: (View, date, etc.)
Front elevation
Looking north

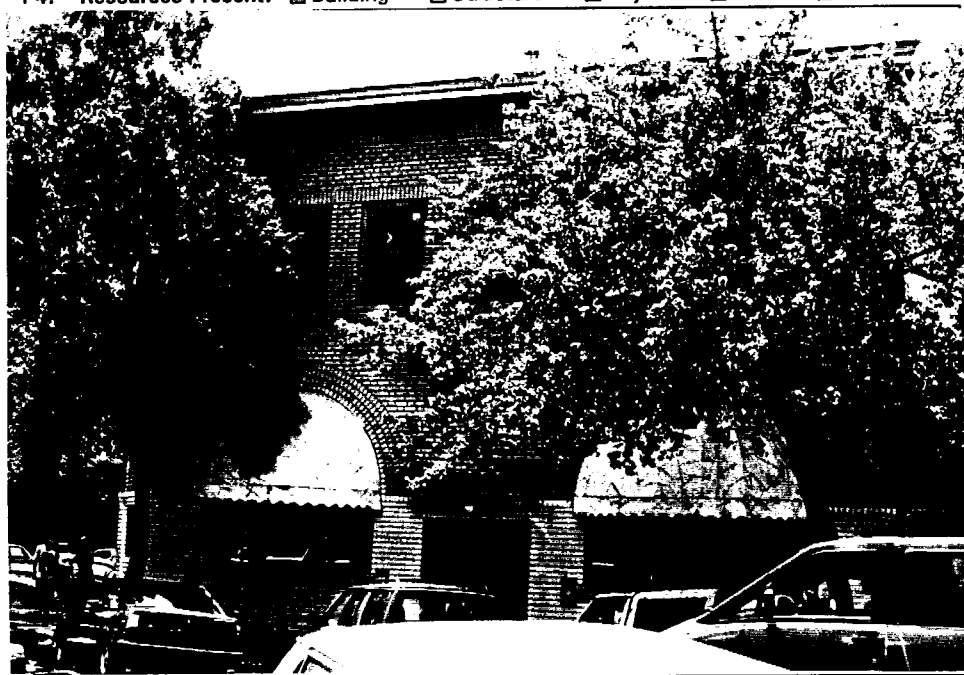
P5b. Description of Photo: (View, date, etc.)
G Street Elev.

Looking west

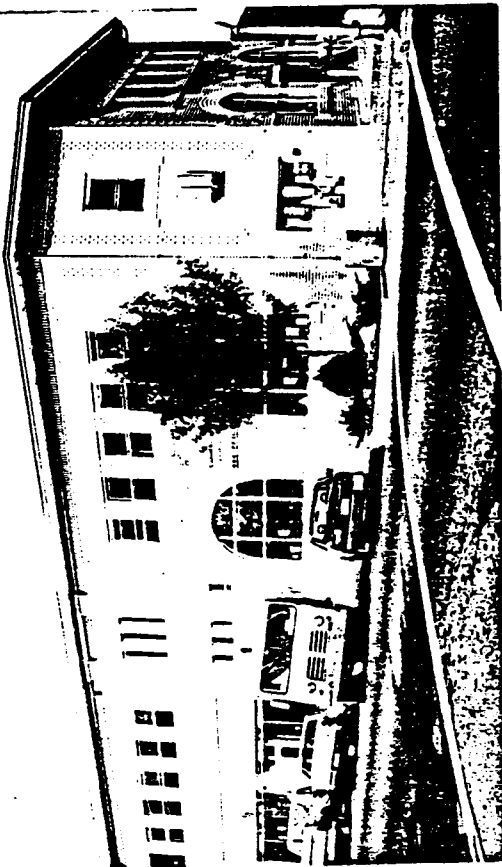
This two story brick Prairie School commercial building has a flat roof with a pronounced overhang. Portions of the ground floor are pierced by massive arched windows. The other windows are organized in horizontal ribbons. Most of the ornament is achieved by simple relief modulations in the brick surface, but there are some decorative terra cotta insets. There have been some alterations to the ground floor commercial spaces.

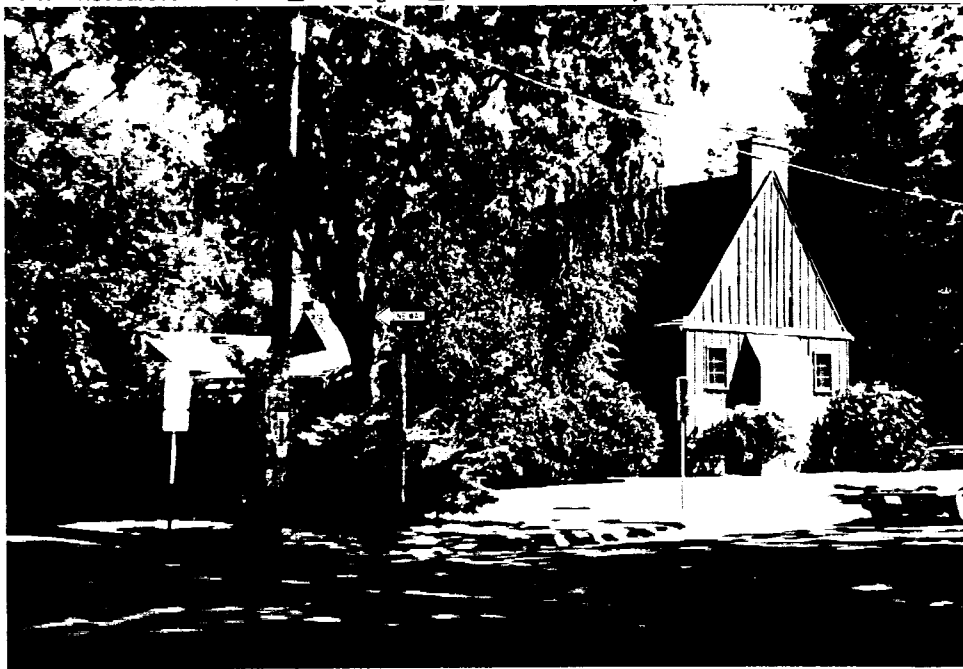
P5b. Description of Photo: (View, date, etc.)
Front Elevation

Looking North
