P1. Other Identifier: Hattie Weber Museum

*P11. Report Citation: Davis, California: Citywide Survey and Evaluation of Buildings Constructed Prior to 1976

- *Resource Name or Address 445 C Street
- P1. Other Identifier: Hattie Weber Museum
- *P2. .Location: *a. County Yolo
- b. Address 445 C Street
- *c. City Davis Zip 95616
- d. UTM: N/A
- e. USGS Quad: Davis Quadrangle
- *f. Other Locational Data (APN #): 70-201-001

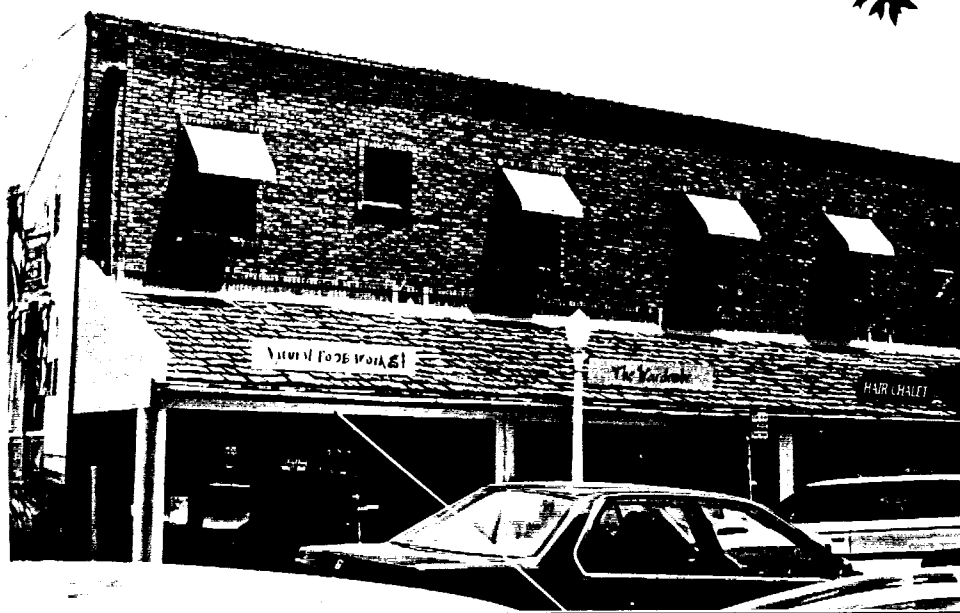
This two story flat-roofed brick building has a rustic wooden gallery with exposed rafters covering the sidewalk at the ground floor level. The building occupies a prominent corner site near the train station and is in the center of Davis' commercial area. The siding is stucco and there are blue aluminum awnings at the second story windows. The overall composition of the building is symmetrical. The doors are wood with lights. The trim and sash are green, purple, and white. The condition is good however some alterations have taken place. On the end of the building, facing a parking lot, is a mural of G Street before the destruction of its Mission Revival welcoming arch. The interior consists of a central corridor with doors opening off the hallway.

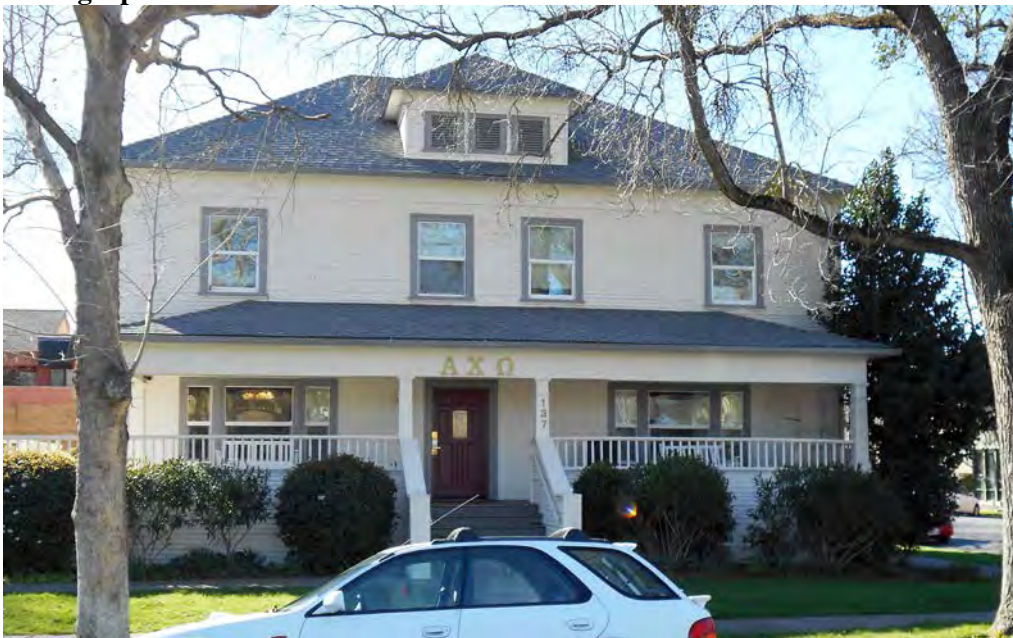
*P3a. **Description:** See original form for architectural style and features. 2015: New Aluminum double-glazed windows replace all former doubled hung wood windows. Style is compatible with original. New front door is wood with glazing, generally compatible with the previous [likely not original] door. Original house is now 89 years old. Building is maintained in good repair.

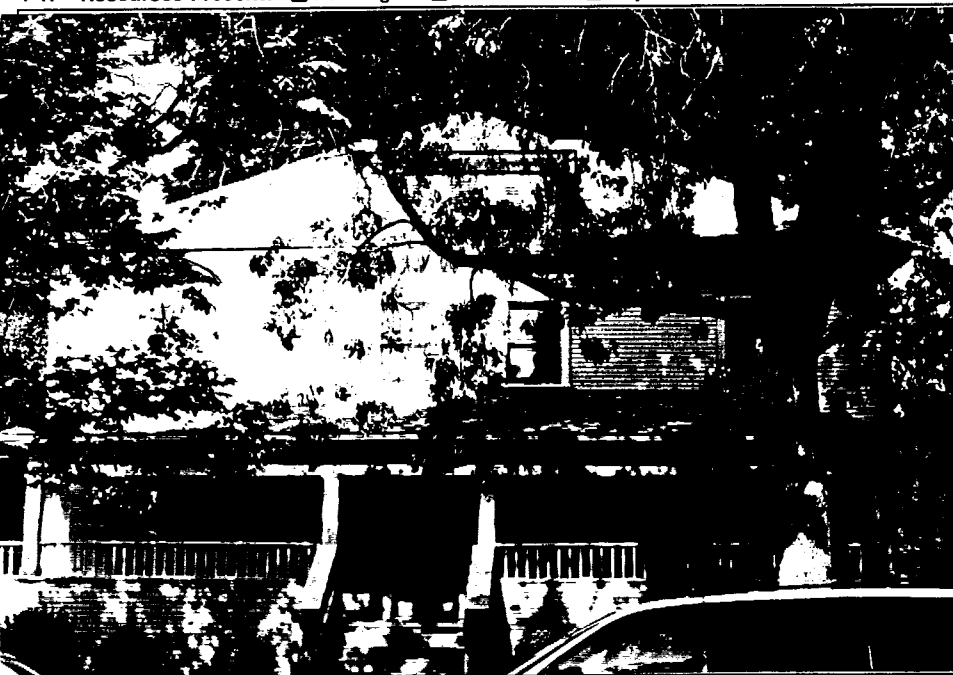
P5b. Description of Photo: (View, date, etc.)
Front Facade

Looking west

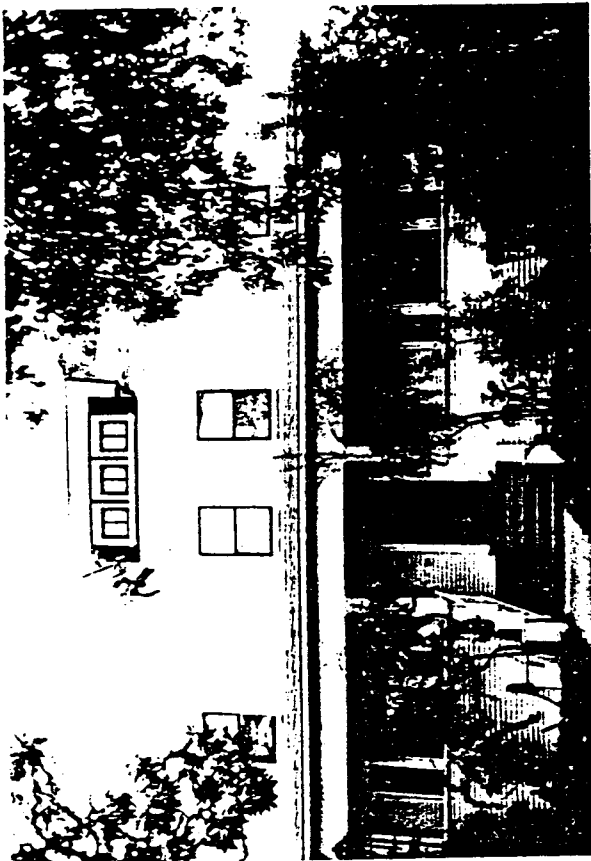
Stylistically, the two and a half story residence is a variation of Colonial Revival modes popular in California in the early 20th century. The structure has a shingled canopied porch supported by pillars that extends the full width of the house. The building has a hipped roof and is surfaced in clapboard. A dormer window protrudes from the roof in the center of the building.

The structure contributes importantly to the character of the city in terms of both landscaping and architectural design.

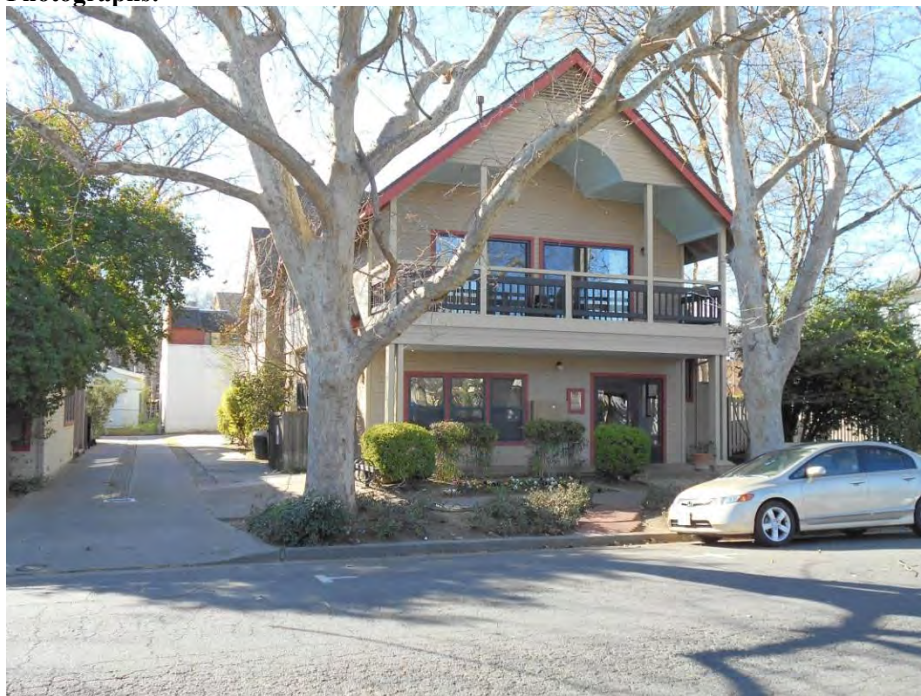
*P3a. **Description:** 129 C Street appears to have been completely replaced sometime in the 1980s with a new two-story building.

129 C Street as it existed in the 1980 survey was demolished sometime before 1996 and replaced with a new building. The new building is not eligible for listing in the National Register, California Register, or Davis City Register.

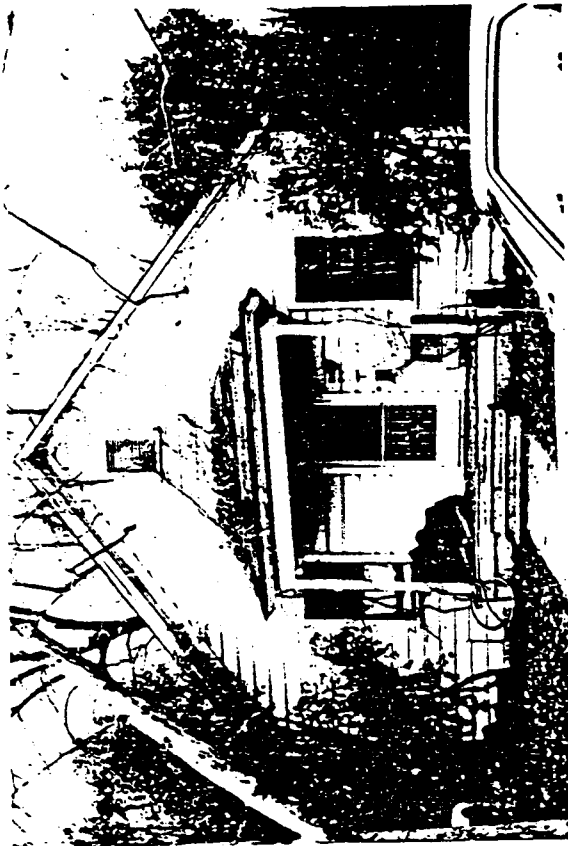
This modest one story vernacular structure derives its form from Greek Revival stylistic ancestors. A gabled roof surmounts the simple building which is framed in wood and surfaced in shiplap. The small centrally placed porch is supported by simple turned posts, the only decorative element on the building. Some alterations to the porch may have occurred. The garden is somewhat overgrown with mature planting.

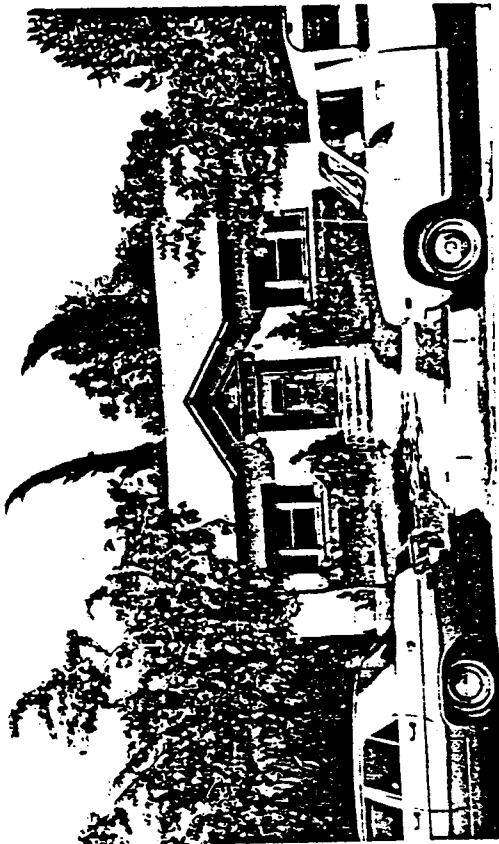
This one story stuccoed Colonial Revival building, originally a public library, has a jerkinhead gable roof with its ridge parallel to the street. A cross gable in the center of the street facade marks the entrance of the symmetrical composition. The door is flanked by stockily proportioned pilasters, and topped by a broken pediment. The windows are divided into a tripartite format.

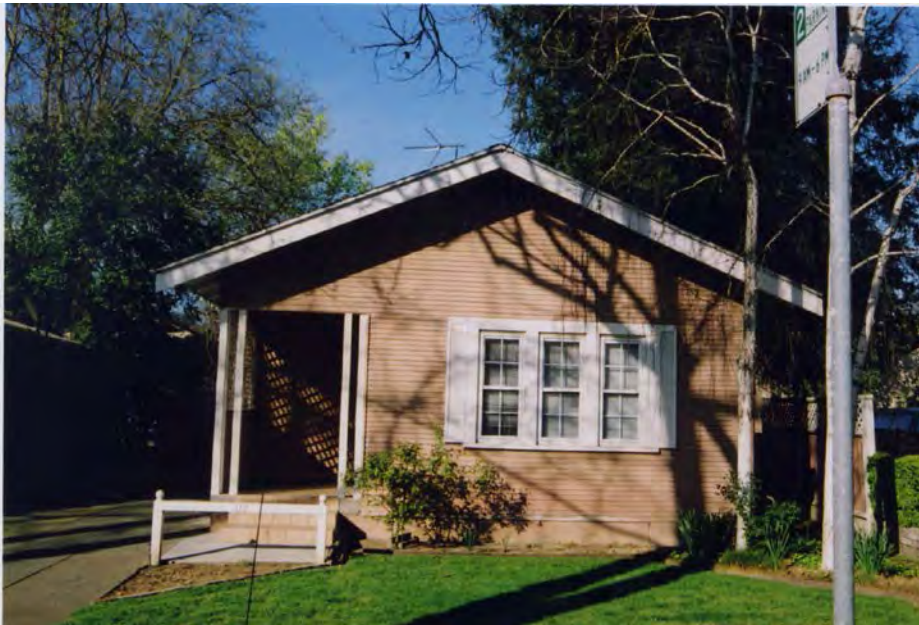
This 1918 Craftsman Bungalow is a relatively unadorned example of its style type. Rectangular in plan, it is surmounted by a moderately pitched front gable roof. Gable and eave overhangs are modest, with the gable trimmed with a plain fascia. A small, cut-in porch is found on the south side of the façade with the gable end supported by paired 4X4 columns. A closed rail runs along the south side of the porch. The entry is located on the side (north) wall of the porch. Fenestration on the front façade consists of a ribbon of narrow, four-over-four double hung windows framed by small faux shutters. Cladding is narrow novelty siding. The building is a good example of its style, retains integrity of design, materials, workmanship, location, setting and association. It appears to contribute to the historic character of the Downtown/ Commercial area of the Conservation District.

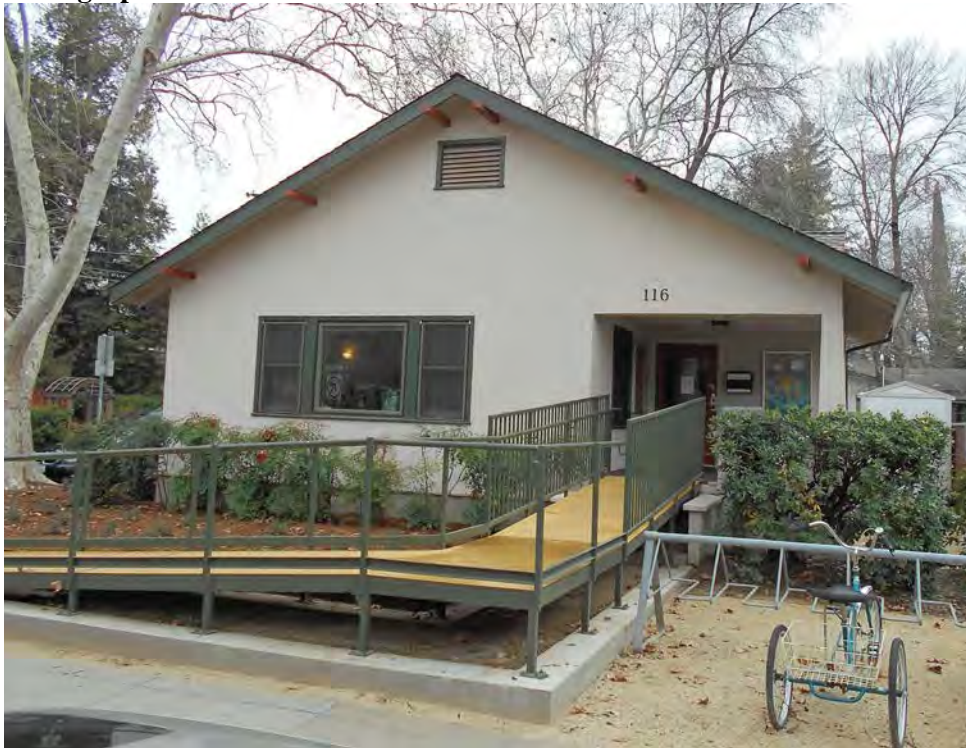
*P3a. **Description:** See original form for architectural style and features. The access ramp present in 2003 has been replaced with a steel ramp that is less dominating. The entry door on the porch faces West (correction). Well maintained.

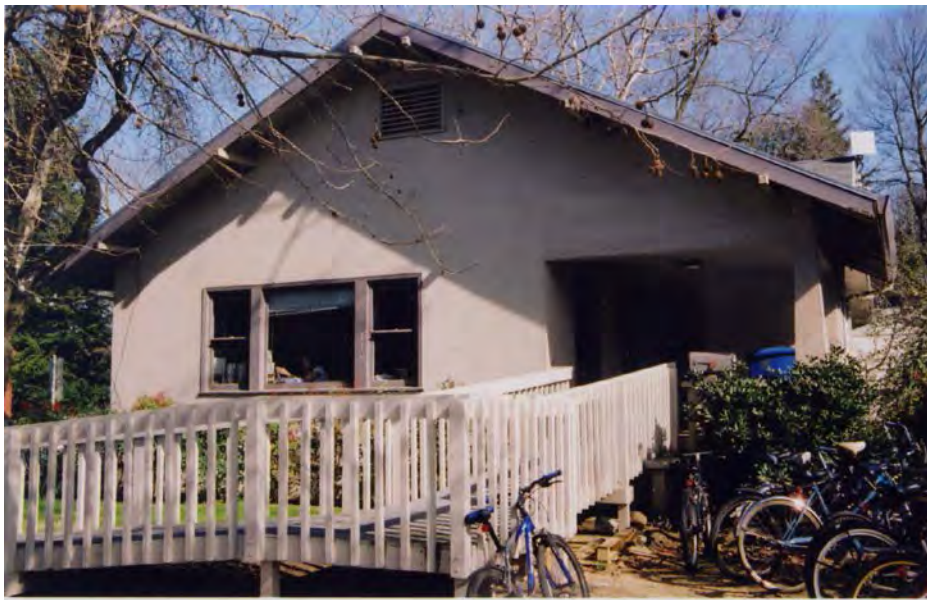
***P3a. Description:**
 This is a front gable Craftsman Bungalow with a moderately pitched roof. Gables and eaves have wide overhangs with the gable supported on exposed purlins. A horizontally emphasized louvered vent accentuates the apex of the gable wall. A cut-in side porch is found on the south side of the façade, with the entry door on the side wall facing south. The south end of the gable is supported on a battered column and an open rail is found on the south side of the porch, but has been removed on the front of the porch to accommodate a handicap ramp. This ramp visually obscures the front façade but is lightly attached and can be removed. A ramp entering from the south side of the porch would be more compatible with the historic appearance of the house. A single central fixed window with one-over one double hung sidelights occupies the center of the front façade. Other fenestration consists of double hung windows. Cladding is stucco. The house retains its integrity of materials, workmanship, setting, location, feeling and association. It contributes to the historic character of the neighborhood.

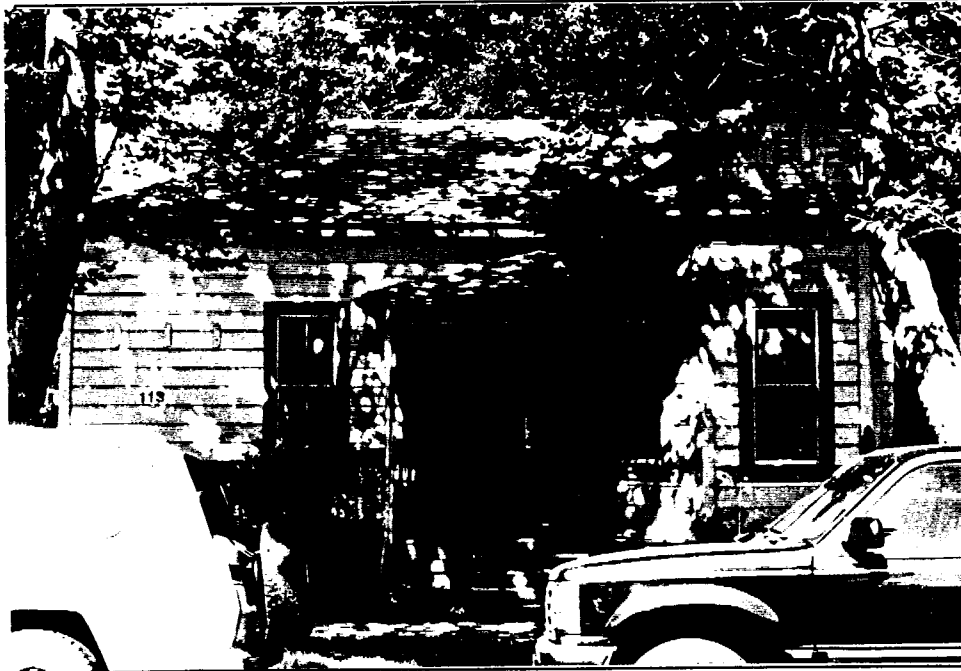
This one story Queen Anne cottage has an L-shaped plan. The primary roof is hipped, but a gabled section projects toward the street, terminating in a slanted bay window. There is a vent opening in the gable facing the street. There is a small hipped-roofed porch supported by a single turned column. The house is otherwise without ornament. The iron porch, step railing, and handicap ramp are all recent alterations. The house is currently used for commercial purposes and appears to be in good condition.

*P5b. Description of Photo: (View, date, etc.)

Front Facade

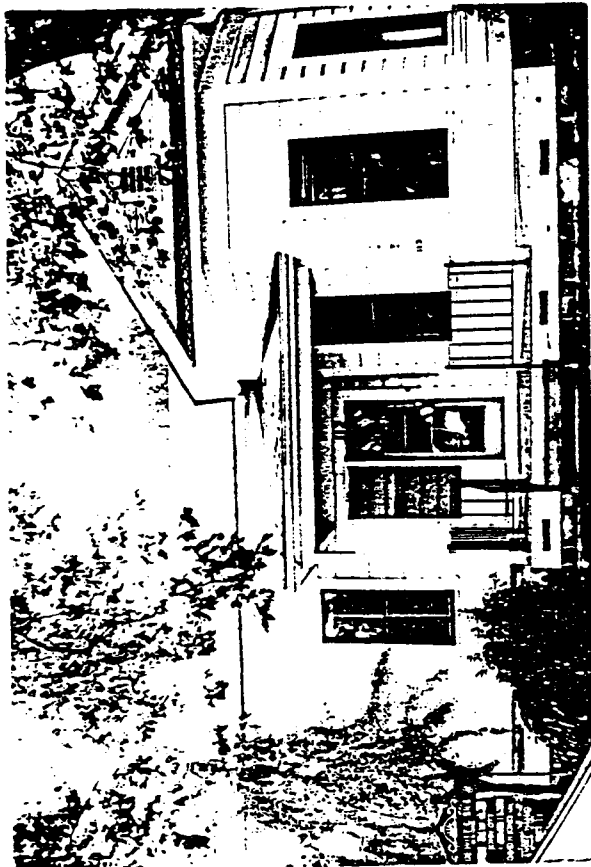
This one story Queen Anne cottage has an L-shaped plan. The primary roof is hipped, but a gabled section projects toward the street, terminating in a slanted bay window. There is a small hipped-roofed porch supported by a single turned column. The house is otherwise without ornament. The iron porch and step railing is a recent alteration.

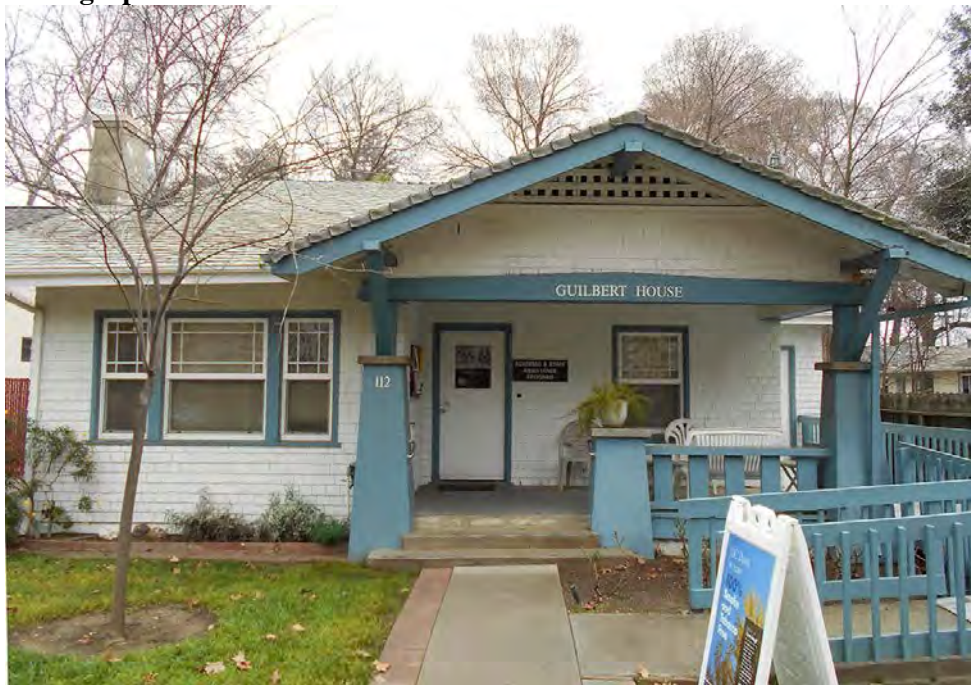
*P3a. **Description:** See original form for architectural style and features. 2015 Update: the original planter box below the north window has been removed. The building is otherwise intact and in good condition.

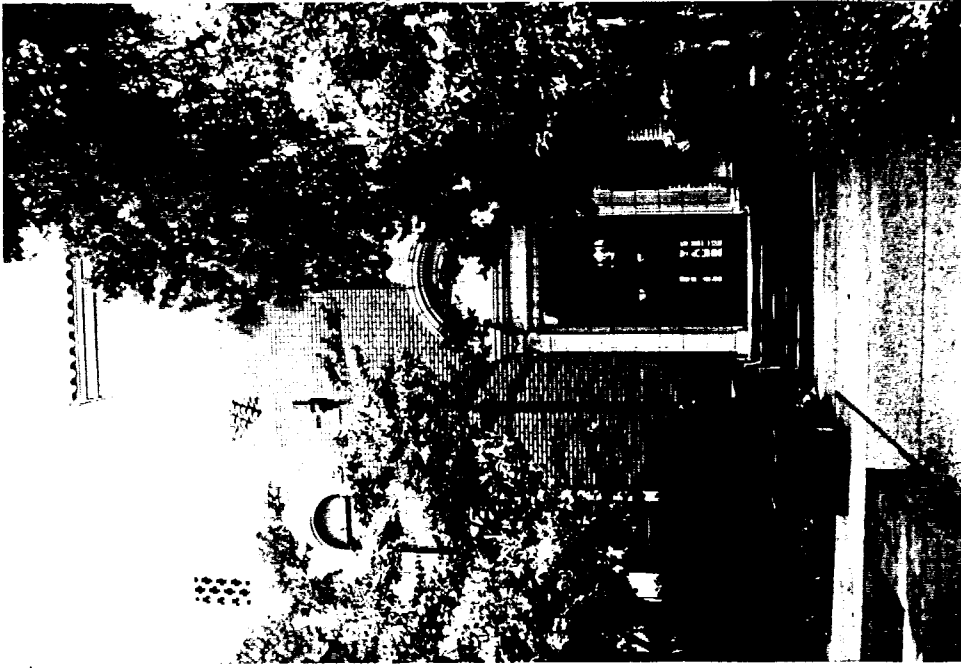
P5b. Description of Photo: (View, date, etc.)
Russell Facade

Looking North
