State of California The Resources Agency  
 DEPARTMENT OF PARKS AND RECREATION  
**PRIMARY RECORD**

Page 1 of 6      \*Resource Name or #: (Assigned by recorder) 205 G Street

State of California The Resources Agency Primary #  
 DEPARTMENT OF PARKS AND RECREATION HRI#  
**BUILDING, STRUCTURE, AND OBJECT RECORD**

\*Resource Name or # (Assigned by recorder) 205 G Street \*NRHP Status Code 6Z

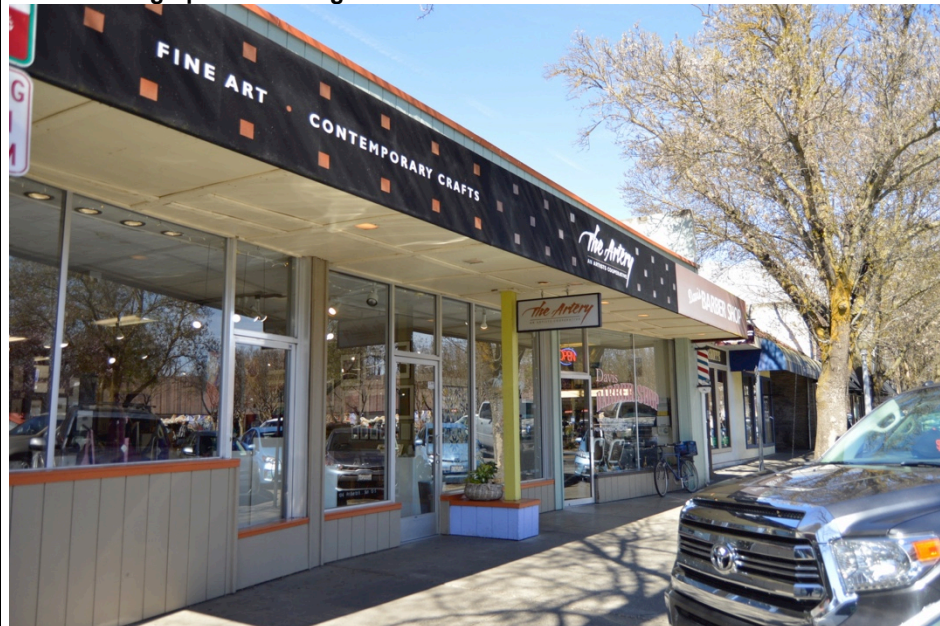
P5a. Photograph or Drawing

Primary (east) facade viewed from G Street, looking northwest.  
 March 14, 2019.

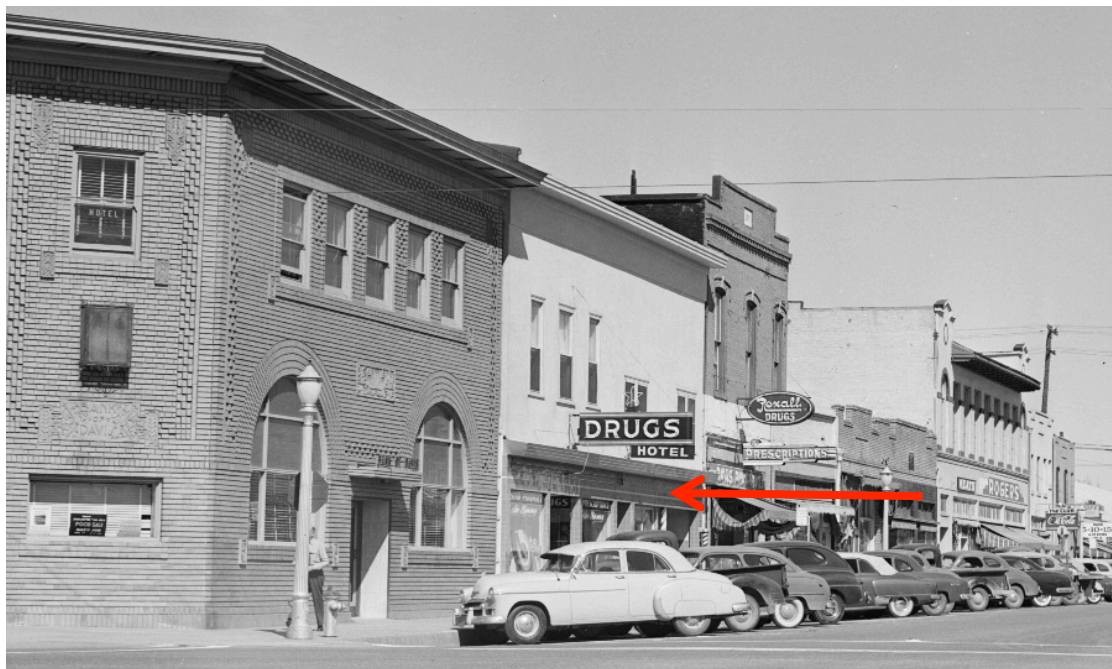
**Figure 1.** West side of 200 block of G Street photographed in 1951. Red arrow points to future location of subject building ((UC Davis Special Collections, Eastman Originals Collection))

205 G Street was constructed ca. 1957 during a period of gradual commercial development in downtown Davis following World War II (**Figure 1 and Figure 2**). The subject building was built on a site formerly occupied by the Etna Hotel based on review of 1921 and 1953 Sanborn maps of Davis. The building did not appear on the 1953 Sanborn map, but appears in a 1957 photograph depicting G Street looking northward from 2nd Street. The 1957 photograph shows the building's original storefront featured a similar angled recess, a storefront with nearly full-height glass set on a short bulkhead, and an overhanging canopy with a streamlined fascia. The canopy appears to have been replaced or encased by the existing boxed canopy in 1999 per available building permit records. A sign for Styler Jewelers was mounted to the parapet.

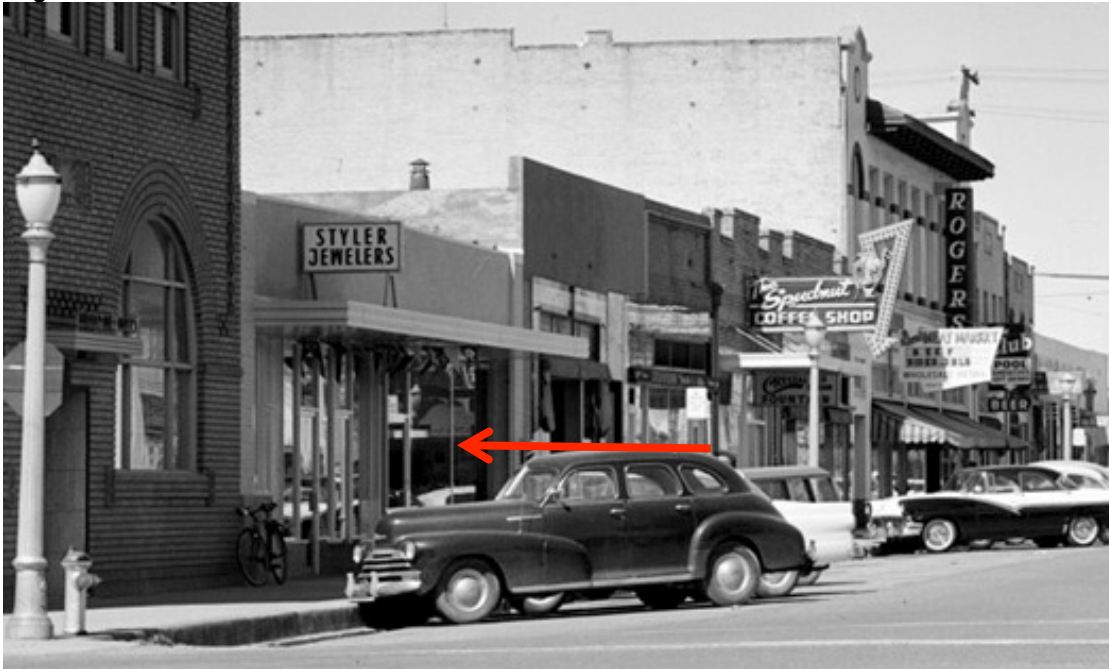
**Figure 2.** 205 G Street (indicated with red arrow) pictured in 1957 (UC Davis Special Collections, Eastman Originals Collection)

\*B6. Construction History: Built ca. 1957 as a one-story commercial building. Historic photo shows an aluminum-frame, angled (recessed) storefront and an streamlined canopy that projected over the sidewalk above the storefront. The building was not recorded on 1953 Sanborn map of Davis, but appears in a 1957 photograph. In 1981 sign installations were completed. In 1993, four storefront windows and one door were replaced. In 1999 a new awning was installed at the facade, which appears to be the existing box awning that projects over the sidewalk. In 2006 the building was re-roofed.
