State of California The Resources Agency  
 DEPARTMENT OF PARKS AND RECREATION  
**PRIMARY RECORD**

Page 1 of 3      \*Resource Name or #: (Assigned by recorder) 317 D Street

\*Resource Name or # (Assigned by recorder) 317-319 D Street \*NRHP Status Code 6Z

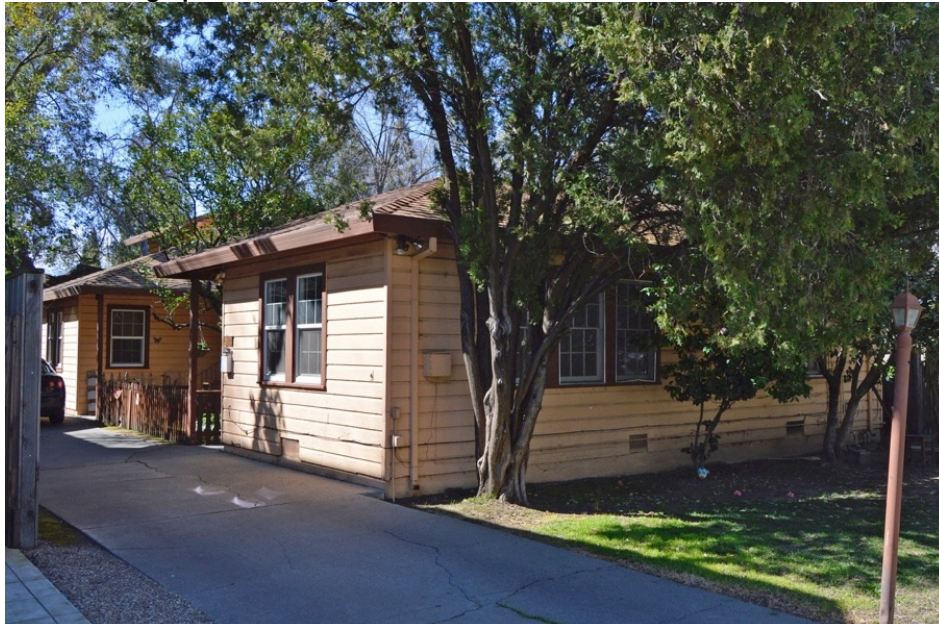
**P5a. Photograph or Drawing**

West and south elevations of subject building viewed from D Street, looking northwest. March 14, 2019.

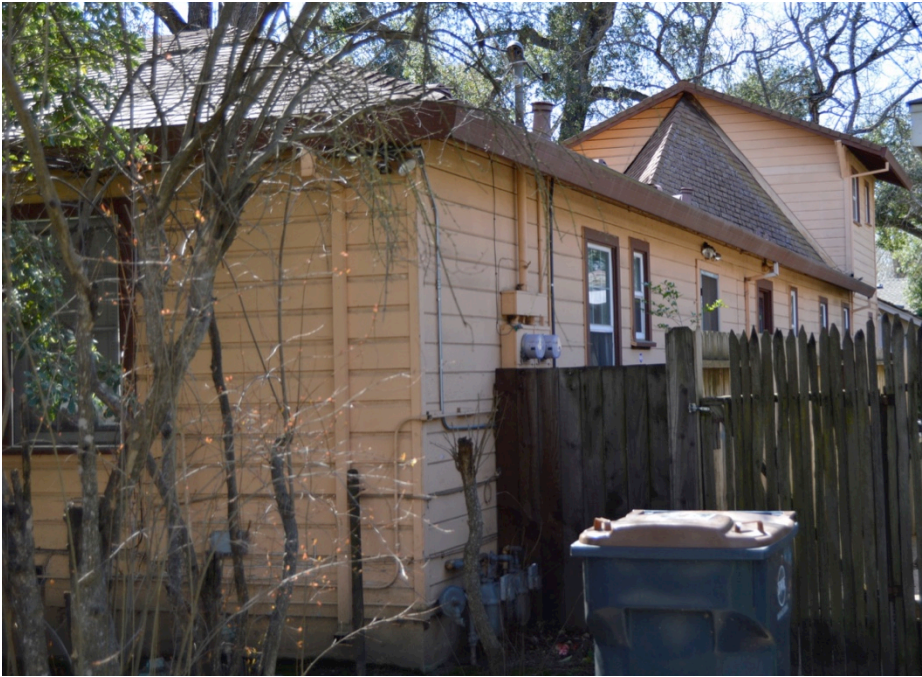
Figure 1. North elevation and rear, two-story addition, looking west.
