State of California The Resources Agency  
 DEPARTMENT OF PARKS AND RECREATION  
**PRIMARY RECORD**

Page 1 of 4      \*Resource Name or #: (Assigned by recorder) 630 2nd Street

P1. Other Identifier: UC Davis Store

# BUILDING, STRUCTURE, AND OBJECT RECORD

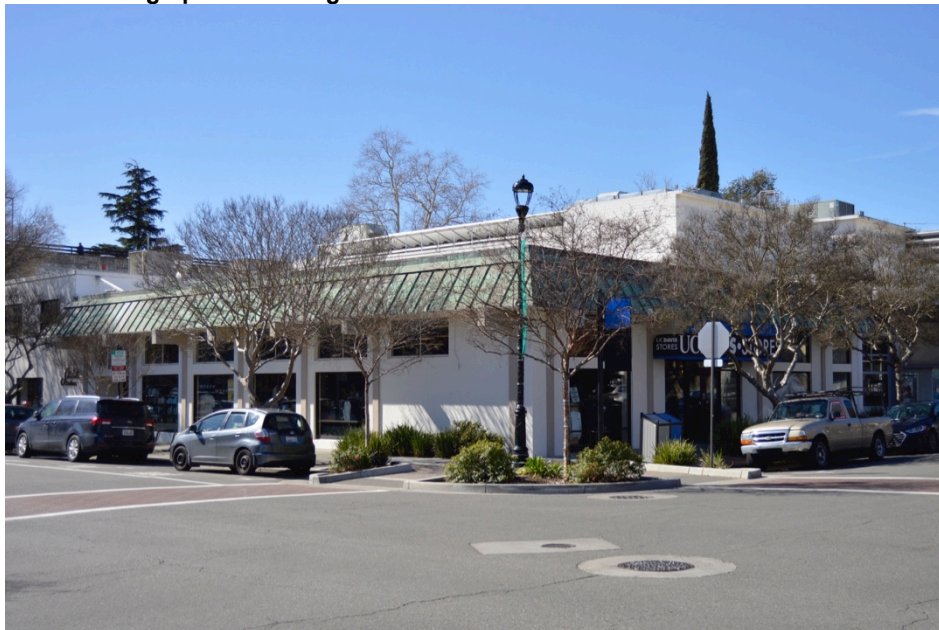
**P5a. Photograph or Drawing**

\*P3a. Description: (Describe resource and its major elements. Include design, materials, condition, alterations, size, setting, and boundaries)  
 630 2nd Street is a concrete, commercial building with a rectangular plan, set on a concrete foundation situated at the southwest corner of 2nd and F streets in downtown Davis. The building mass is comprised formed from a one-story-plus-clerestory primary rectangular block and an adjoined two-story rectangular block at the rear of the building. The building's exterior is covered with painted plaster and is fenestrated with plate glass windows set into first story and clerestory openings. The building spans four bays in width along 2nd Street and seven bay along F Street. Each bay is separated by a concrete pier that extends upward and transitions to a cantilevered beam above. A non-original mansard canopy wraps around the street-facing elevations above the clerestory level, resting on the cantilevered beams below. The main entrance at 2nd Street has anodized metal doors with plate glass and plate glass sidelites. The canopy is covered with standing-seam copper. The residence has a stucco exterior and is capped by a hipped roof covered in diamond-cut shingles with clay ridge tiles. (P5a.)

630 2nd Street viewed from intersection of 2nd and F Streets, looking southwest. March 14, 2019.

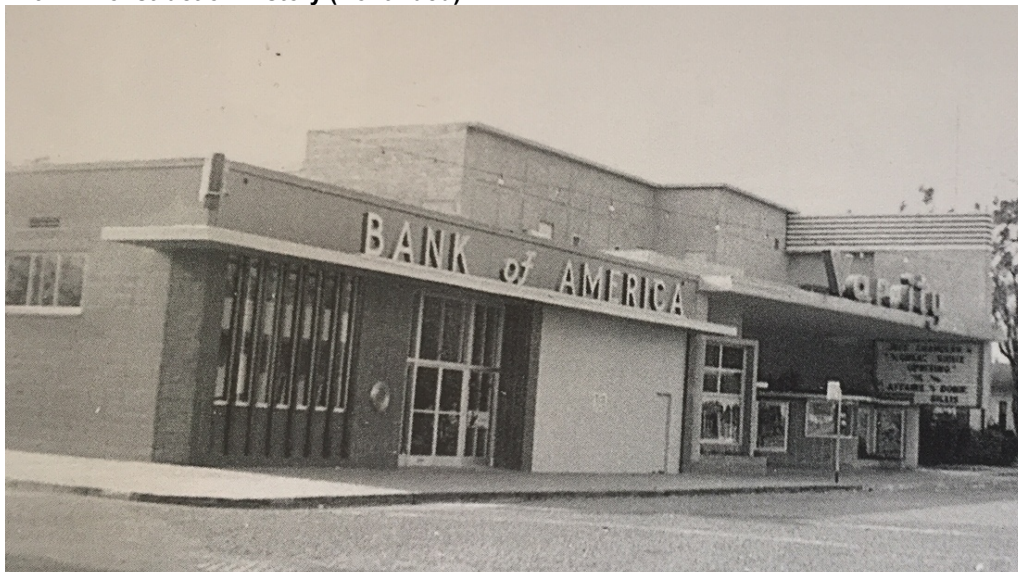
**Figure 2.** Subject building photographed in 1953 during original occupancy by Bank of America. This photograph shows the building's original appearance, prior to 1972 alterations. (Lofland and Haig, *Images of America: Davis California 1910s-1940s*, photograph credit to John W. Brinley)

footprint, flat roof with a parapet, a flat canopy at the facade, and glass storefront system at the facade. The east elevation appears to have featured clerestory windows. The building was modestly adorned, and was easily identified given its "Bank of America" signage above the facade canopy. As is the case with many other buildings of the period in downtown Davis, the subject building has been heavily altered to the degree that its original design is largely obscured.

Design. The subject property does not retain integrity of design. The building's design has been altered to the degree that its original appearance is no longer apparent. The building's storefronts, exterior materials, and canopy were altered in 1972, replacing original features while retaining the building's height and flat roof. Little evidence remains of the building's original design.
