State of California The Resources Agency
 DEPARTMENT OF PARKS AND RECREATION
PRIMARY RECORD

Page 1 of 7 *Resource Name or #: (Assigned by recorder) 703 2nd Street

Property Name: 703-707 2nd Street

*Resource Name or # (Assigned by recorder) 703-705 2nd Street *NRHP Status Code 6Z

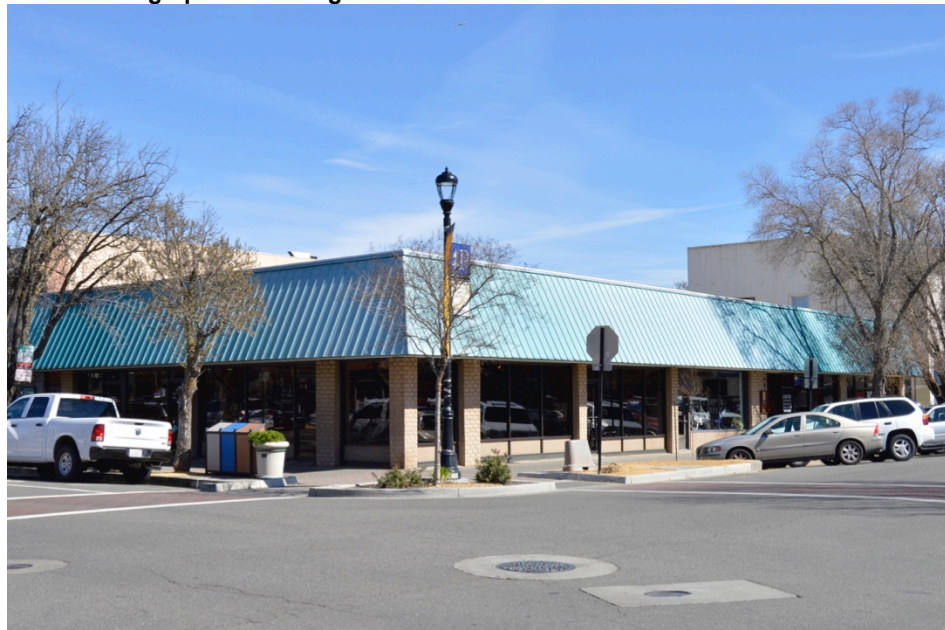
P5a. Photograph or Drawing

*P3a. Description: (Describe resource and its major elements. Include design, materials, condition, alterations, size, setting, and boundaries)
 703 2nd Street is a one-story commercial building situated at the northeast corner of 2nd and F Streets (**P5a.**) The building appears to be built to the property lines of its rectangular lot has a flat roof with a prominent mansard canopy overhanging the sidewalk below. Originally built ca. 1940, the building's current design reflects alterations undertaken in 1976. Overall the building is categorized as a vernacular commercial building. The exterior features beige brick columns separating storefronts at the west and south (street-facing) elevations. Each storefront is fenestrated with an anodized, aluminum-framed storefront system. Storefronts along the west elevation have full-length plate glass windows, and storefronts along the south elevation feature an opaque panel at the base and tall plate glass windows above. One bay on the south elevation features a concrete bulkhead at the base of the storefront (**Figure 1**). Entrance doors for the storefronts are similar anodized, aluminum-frame with plate glass.

*P5b. Description of Photo:
 703 2nd Street from intersection of 2nd and F streets, looking north.
 March 14, 2019.

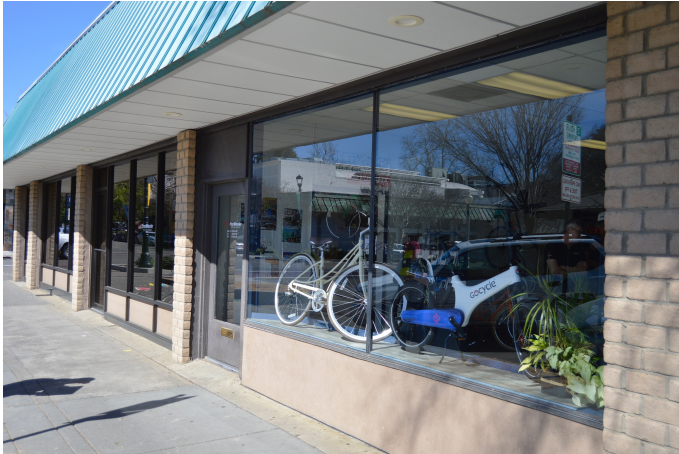
Figure 1. Storefronts along south elevation with opaque base panels (left), and one storefront with a stucco-covered bulkhead (right), looking northwest.

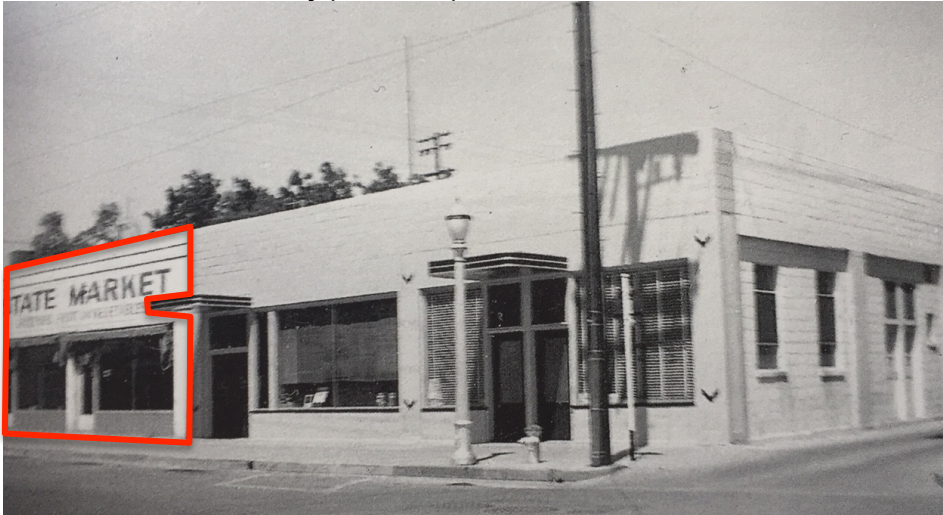
Figure 2. View of original commercial building (left-outlined in red) addressed 703-705 2nd Street is outlined with red. In 1975, each of the buildings pictured was altered to create the appearance of one building (Lofland and Haig, *Images of America: Davis 1910s-1940s*. Amended by author)

Permit records note storefront repair in 1967. In 1975, the subject building and the abutting commercial building to the south were remodeled concurrently to create a larger commercial property spread across two parcels that featured a cohesive architectural appearance. Alterations included: a mansard style roofline to consist of brown ribbed-aluminum with the ribs; columns or posts made of brick; glass storefront windows with anodized brown aluminum around the windows and doors; wood gate at the west side.⁴ Accordingly, both buildings were remodeled to feature a combination of light blue block, light green block, light brown block, and wood-framed storefronts facade, and the prominent mansard canopy that currently wraps around the street-facing elevations of the building.⁵ Thus, in 1975, the building's exterior appearance was heavily altered resulting in its present general appearance. In 2014, the building underwent reroofing.

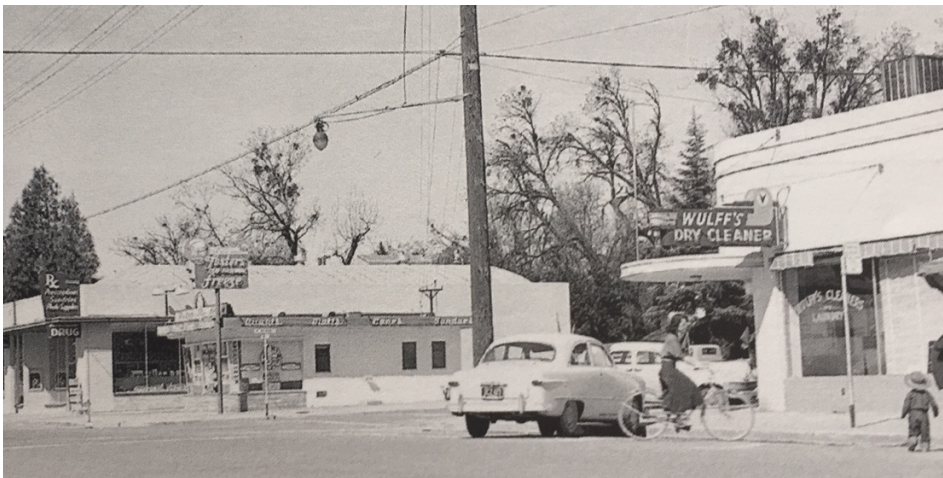
Figure 3. 703-705 2nd Street pictured at right, 1951. The south elevation of the subject building was altered by 1951 with a corner entrance and curved canopy, emphasizing the streamlined facade of the building. ((Lofland and Haig, *Images of America: Davis 1910s-1940s*. Amended by author)

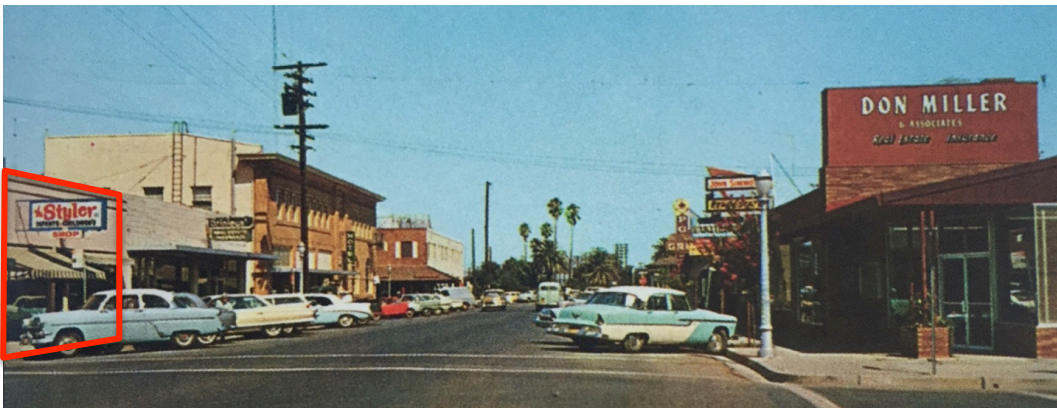
Figure 4. View of 2nd Street from F Street in the 1960s. A red box outlines the subject building (John Lofland, *Davis: Transformation*. Amended by author)
