State of California The Resources Agency
 DEPARTMENT OF PARKS AND RECREATION
PRIMARY RECORD

Page 1 of 6 *Resource Name or #: (Assigned by recorder) 707 2nd Street

P1. Other Identifier: UC Davis Store

BUILDING, STRUCTURE, AND OBJECT RECORD

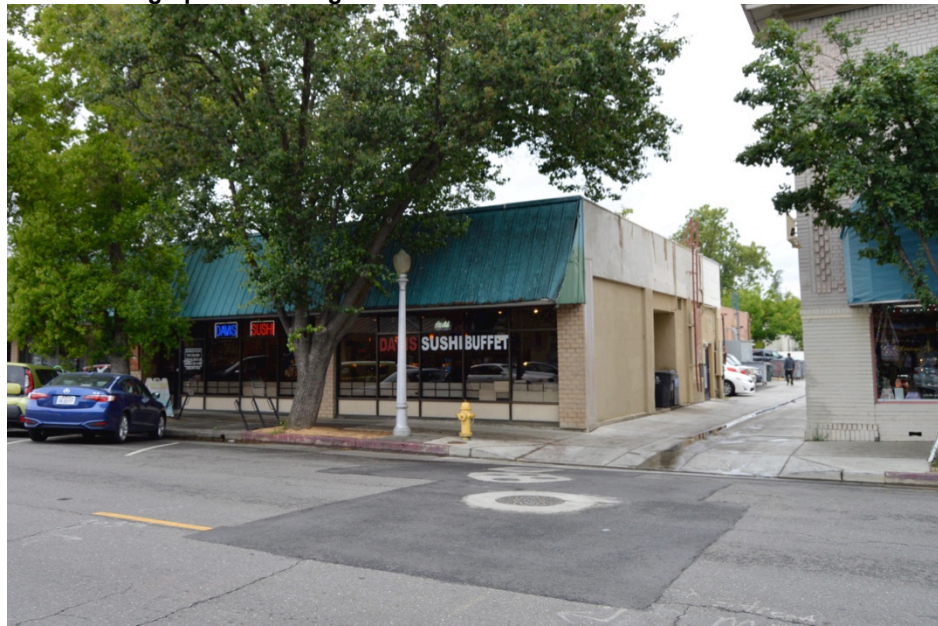
P5a. Photograph or Drawing

Primary (south) facade viewed from 2nd Street, facing north.

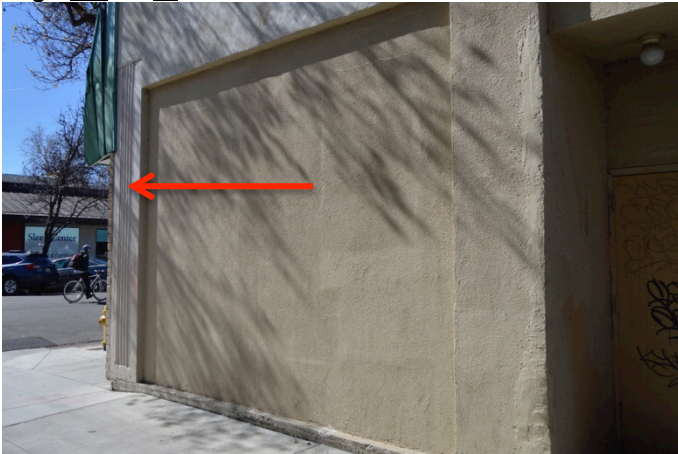
Figure 1. East, alley facing elevation. Red arrow points to formed concrete Art Deco detail at corner. Looking south.

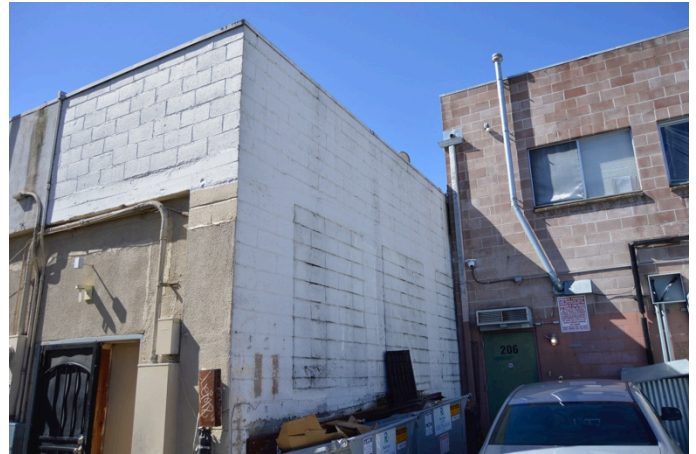
*P3a. Description: (Describe resource and its major elements. Include design, materials, condition, alterations, size, setting, and boundaries)
 707 2nd Street is a one-story brick and concrete commercial building situated on the north side of 2nd Street between G Street (east) and F Street (west) The building's west elevation abuts the neighboring building at 703-705 2nd Street to the west. The east elevation faces a mid-block alley. The building shares a mansard canopy with the neighboring building at 703-705 2nd Street, a feature added in 1975 (P5a.) The exterior features beige brick columns separating storefronts that contain anodized-aluminum-framed storefront systems. Entrance doors for the storefronts are similar anodized aluminum with plate glass. The east elevation is visible from a mid-block alley and features stucco covering over concrete block. A formed concrete pilaster detail is visible at the southeast corner of the east elevation and appears to be an Art Deco style feature from the building's pre-1975 design (Figure 1). At northeast corner of the building, concrete blocks and windows in-filled with such blocks are visible from the alley (Figure 2).

Figure 2. Rear of building viewed from alley. Concrete block and window openings infilled with concrete block are visible at this corner of the building, looking southwest.

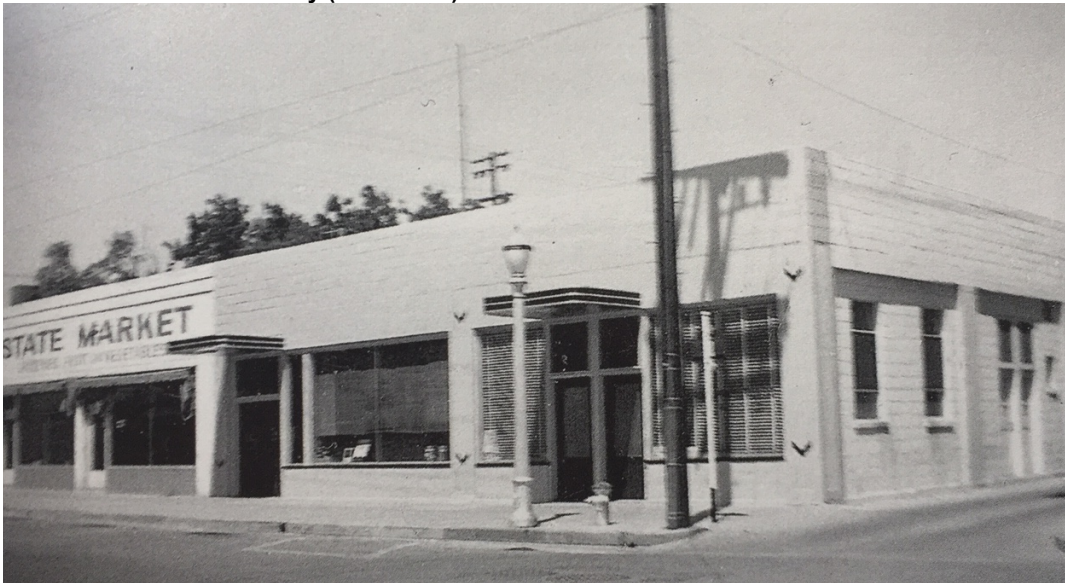
*B6. Construction History: The subject building was constructed ca. 1940 as a one-story brick and concrete commercial building containing a post office and an office for Dr. Leo Cronon in separate units. The building was recorded on the 1945 Sanborn map of Davis and was captured in several historic photographs taken ca. 1947-1960s. When originally completed, the building's west elevation abutted or shared a party wall with the neighboring building at 703-705 2nd Street. The building's storefronts featured rectangular plate glass windows set on concrete or stucco bulkheads. Concrete piers with fluting and arrow details separated each storefront. Streamlined canopies were mounted to the facade above each entrance. Entrances appear to have featured wood doors with tall upper lites and transoms above. The east elevation was more utilitarian, with rectangular windows set into a brick wall. Two additional side entrances were visible along the east elevation (Figure 3 and Figure 4).¹

Figure 3. View of original commercial building (right) addressed 707-709 2nd Street. In 1975, each of the buildings pictured was altered to create the appearance of one building (Lofland and Haig, *Images of America: Davis 1910s-1940s*. Amended by author)

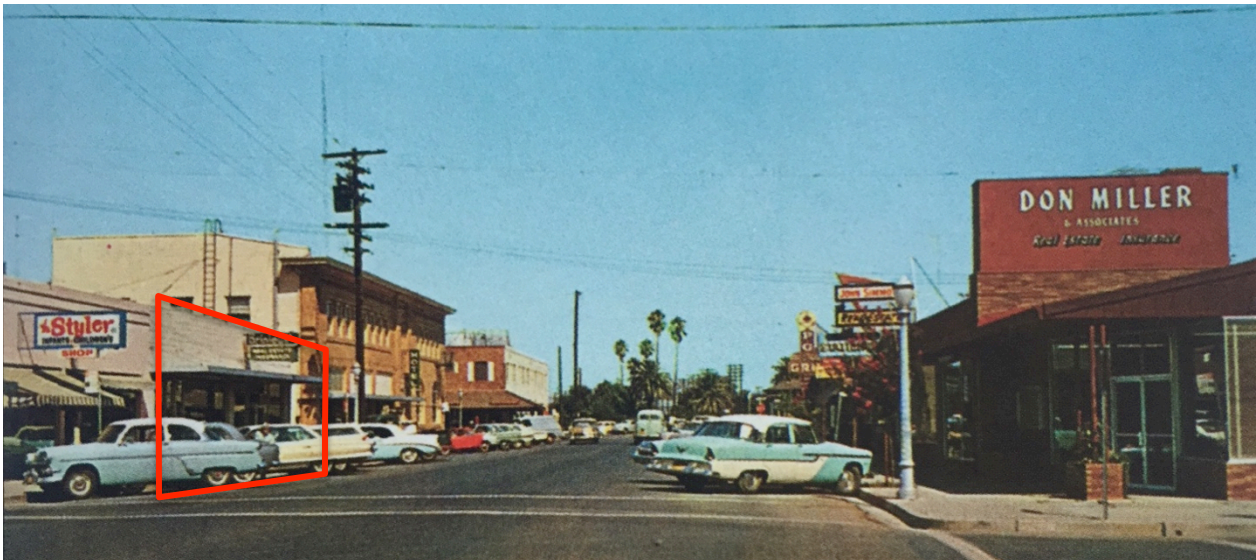
Figure 4. View of 2nd Street from F Street in the 1960s. A red box outlines the subject building (John Lofland, *Davis: Transformation*. Amended by author)
