PRIMARY RECORD

_	1 of 5 *Resource Name or #: (Assigned by recorder) 802 2nd Street	
*P2. Lo	ocation: Not for Publication XUnrestricted	
*a.	County Yolo and (P2c, P2e, and P2b or P2d. Attach a Location	Map as necessary.)
*b.	USGS 7.5' Quad Davis, CA Date 2018 T; R; G of Gec	; B.M.
C.	Address 802 2nd Street City Davis, CA Zip 95616	<u> </u>
d.	UTM: (Give more than one for large and/or linear resources) Zone , mE/	mN
e.	Other Locational Data: APN 070 252 06

Property Name: 802 2nd Street

BUILDING, STRUCTURE, AND OBJECT RECORD

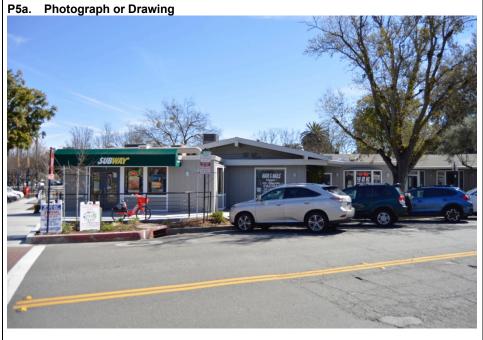
*P5b.Description of Photo:

West elevation viewed from G Street, looking east.

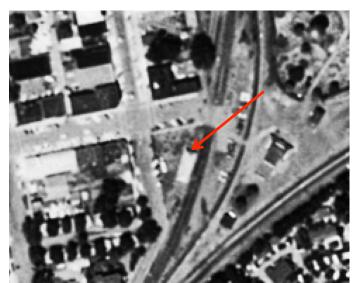
Figure 5. 1957 aerial photograph of subject property and vicinity. Red arrow points to pre-existing freight depot. (UC Santa Barbara Library, Frame Finder, Cartwright Aerial Surveys, CAS 1957, Davis)

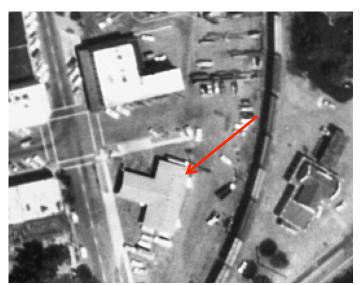
Figure 6. 1965 aerial photograph showing T-plan subject building without additions of more recent origin. (UC Santa Barbara Library, Frame Finder, Cartwright Aerial Surveys, CAS-65, 130, Frame 14-213)

The subject property does not appear to be individually eligible under Criterion A/1 for listing in the NRHP/CRHR or local register. 802 2nd Street was built ca. 1965 as a T-plan building to west of (opposite the rail road tracks) the Southern Pacific Depot in downtown Davis. The building was built during a period of rapid growth in Davis, driven by the upgrading of the University of California's Agricultural College to a full university, which brought increased enrollment and an influx of new residents and accelerated development the to the downtown. Evidence was not found to suggest the subject building played an important role within that context.
