Historic Districts

Historical Archaeology in Davis

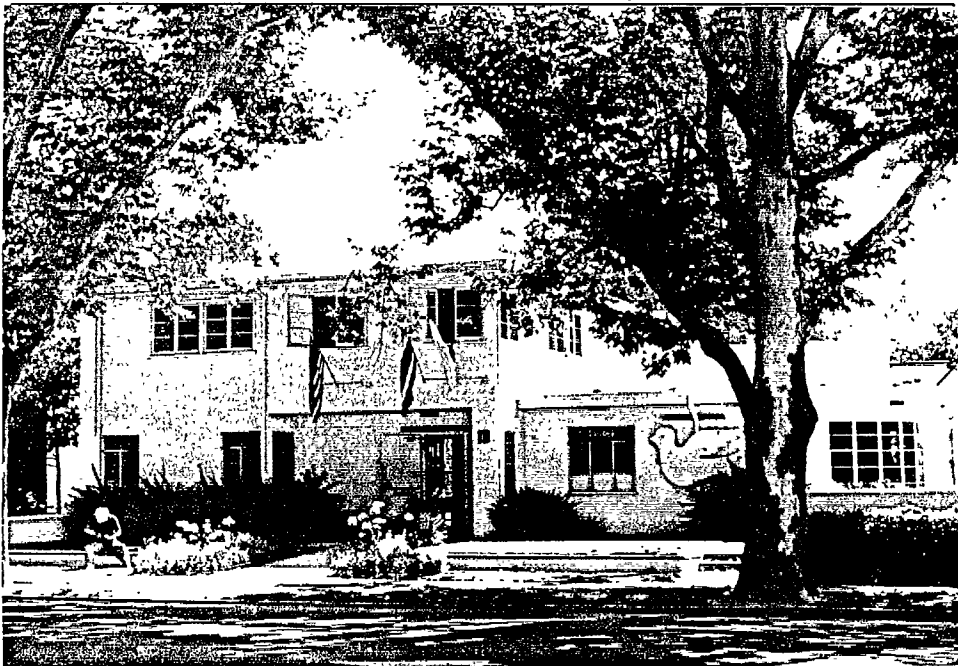
*P3a. Description: (Describe resource and its major elements. Include design, materials, condition, alterations, size, setting, and boundaries.)
This asymmetrical composition of several intersecting curved and rectangular forms embodies the Streamline Moderne and International Styles. It has both one and two story parts and includes an addition constructed circa 1990. The addition, on the east side, has a large stuccoed chimney and french doors opening onto the patio. The exterior finish is white stucco and the roofs are flat. Casement windows predominate, and consist of rectangular panes of glass that are larger than those used in most other College Park houses. The front door is made from vertical boards and is flanked by sidelights of glass brick. Another panel of glass brick is set into a sheltering wall next to the entry. Low stuccoed walls around the garden are not original, but do not detract from the character of what is now the International House for the University of California, Davis.

*P5b. Description of Photo: (View, date, etc.)
front facade
looking east

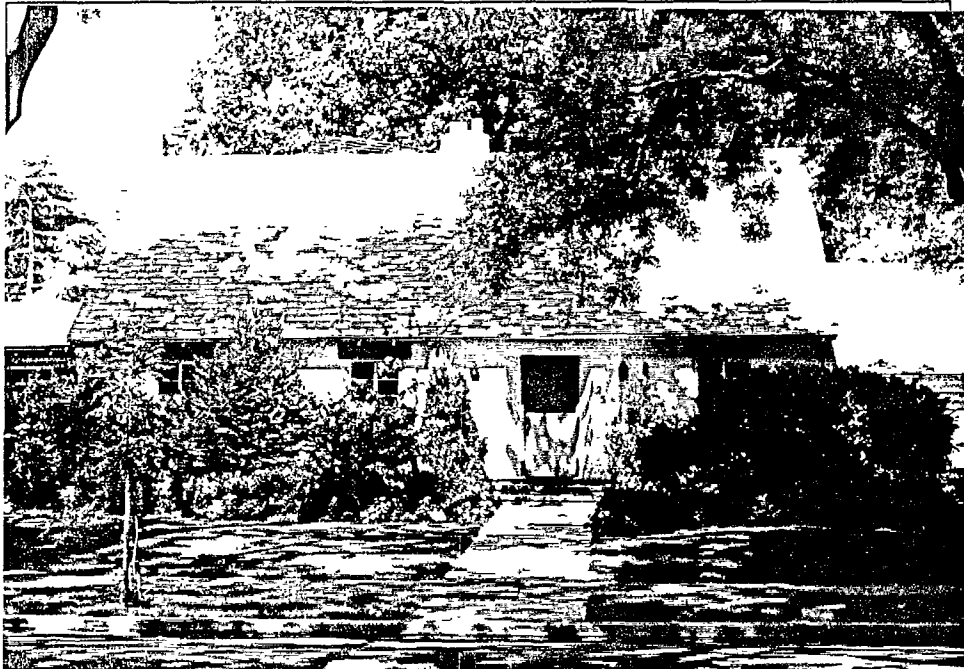
The main body of this one and one and a half story English Cottage is a simple rectangle covered with a steeply pitched gable roof, with its ridge parallel to the street. The roof of a small section of the house, perhaps a sun room, at the south end of the house has a gentler pitch. The walls of the house are stuccoed, while the roof is composition in imitation of slate. The roof has overhangs and the rafters are exposed. There is one brick chimney. The windows are casements with those on the upper floor original and the lower floor replacements. The front door is of vertical boards. The front stoop is of brick and is probably not original. The most striking features of the house are the very large lintels over the first floor windows on the main facade. On either side of the front door are lantern-style light fixtures of dark metal with small panes of glass.

*P5b. Description of Photo: (View, date, etc.)
front facade
looking west

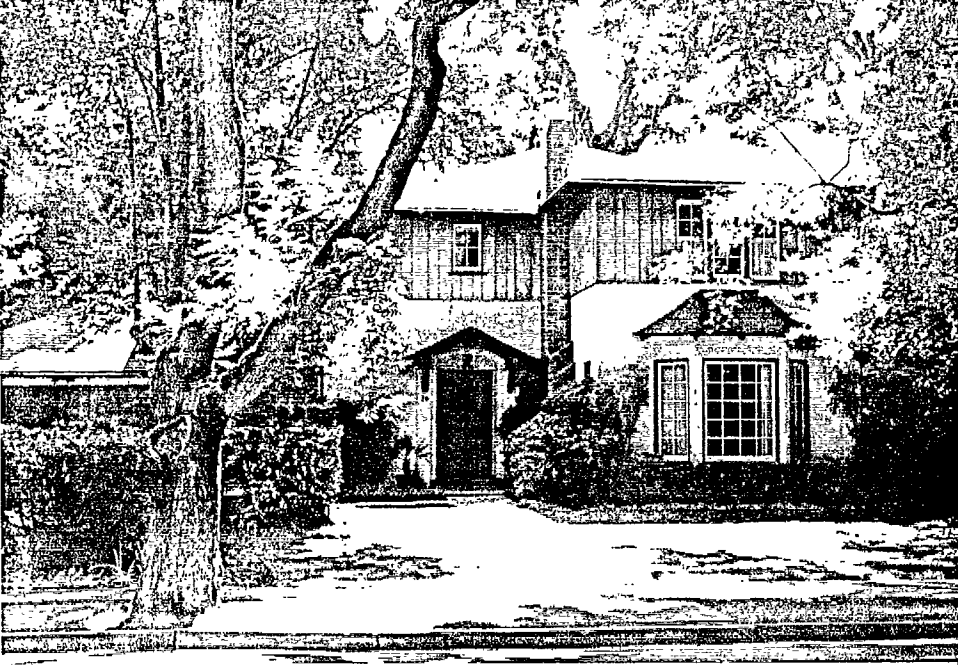
*P3a. Description: (Describe resource and its major elements. Include design, materials, condition, alterations, size, setting, and boundaries.)
This two story Medieval Revival residence is characterized by asymmetry and abundant decorative detail. Stucco siding predominates, with vertical board of variable width applied to the second story. The house has a hipped roof, currently covered in composition shingles, with an overhang and exposed rafters. The chimney is brick, including some clinker bricks. Windows are casement with small panes and include a bay window on the main facade. The front door is made of vertical boards and is varnished; it has a square light divided by turned mullions. There is a small entry porch with a gabled overdoor supported on carved brackets. Pilasters flank the door. There is a dark metal lantern-style light fixture in the entry.

P5b. Description of Photo: (View, date, etc.)
front facade
looking east

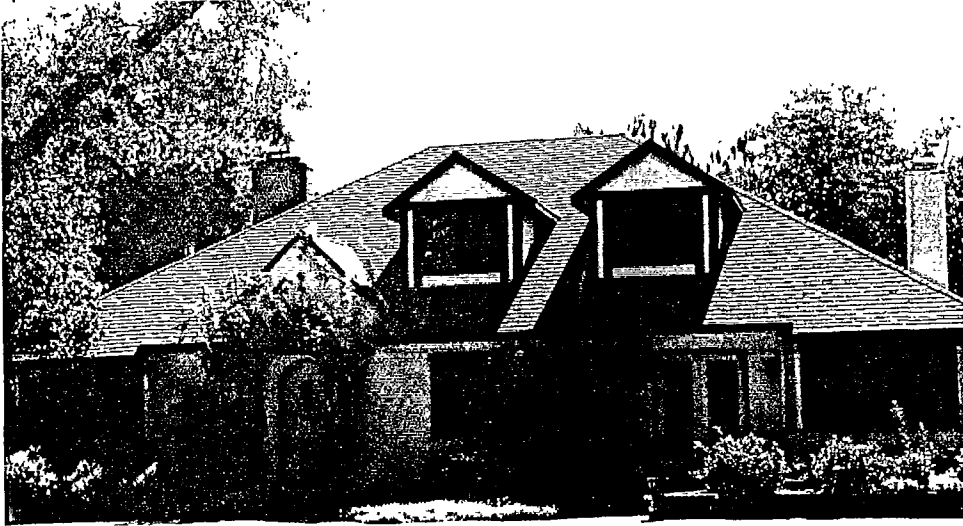
*P3a. Description: (Describe resource and its major elements. Include design, materials, condition, alterations, size, setting, and boundaries.)
This one and a half Medieval Revival cottage has been significantly modified. The cottage has stucco siding and an overhanging hip roof covered in composition shingles. It has two chimneys, one brick and the other stucco. The asymmetrical main facade includes two doors, the original round-arched front door (of vertical boards with a small, leaded-glass window) and a much later set of French doors, each with a single large light. There is a small entry porch with a gable roof. Downstairs windows are the old casements; the new dormer windows upstairs are casements with different proportions. The windows have large, flat surrounds that suggest half-timbered. Original details include round clay pipe vents over the entry and the front door hardware.

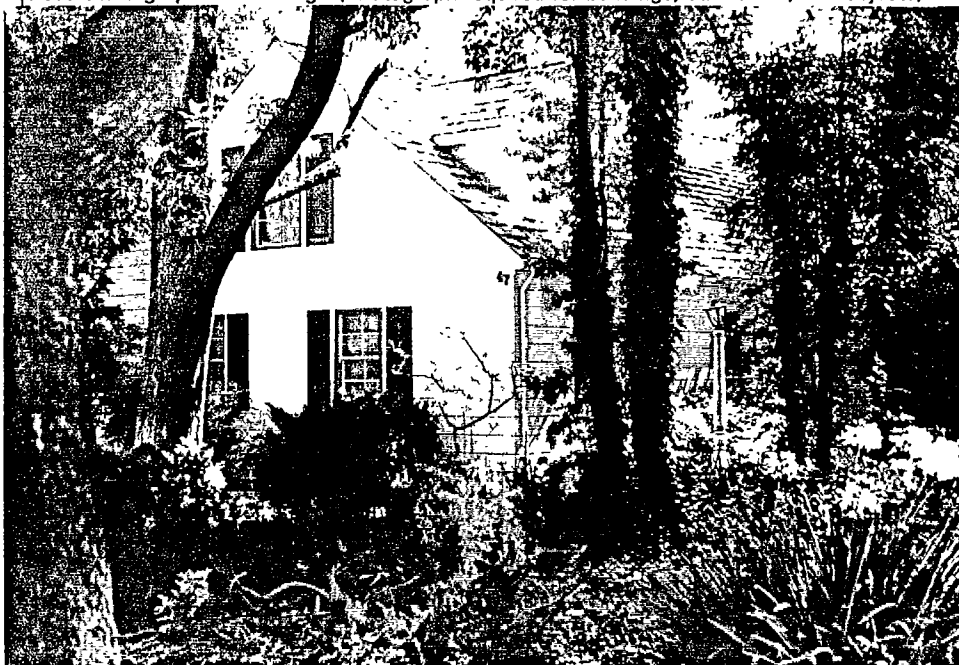
This one and a half story Colonial Revival has wide board siding and gable roofs with wood shingles. Elements on the main front facade are arranged symmetrically, but the overall composition of the house is asymmetrical. The windows are double hung, four over four, and there are roof dormers. There is a fixed semi-circular window over one double hung window on the upper level of the front facade. The front door is paneled, and there are louvered exterior shutters. The house has one red brick chimney. Dark metal lamps can be found on the house and on freestanding posts in the yard. There appears to be a sun porch with a shed porch at the rear of the house.

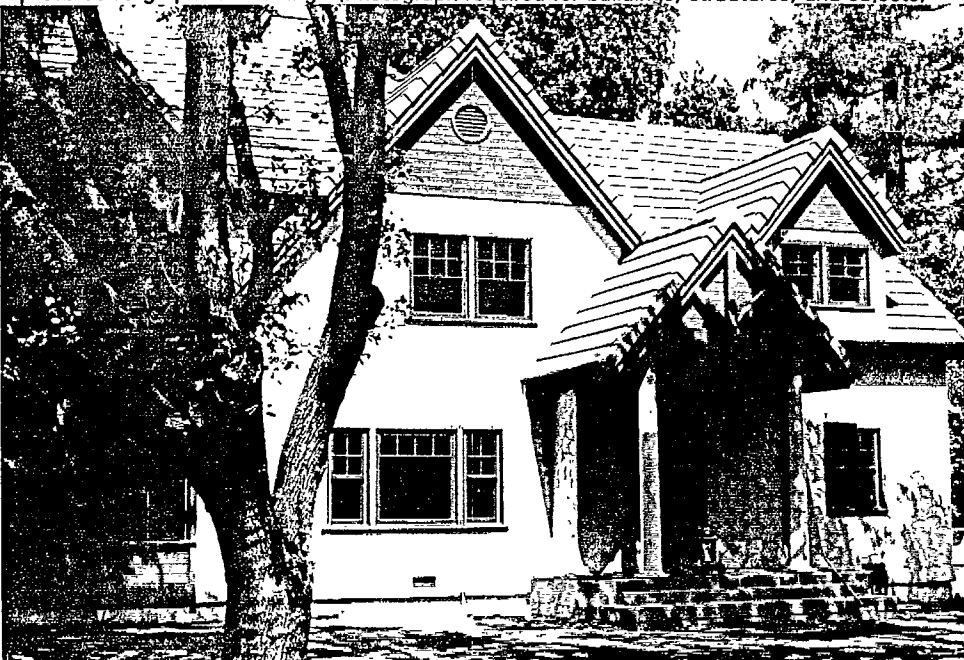
This large, two story Tudor Revival house has been recently remodeled. The house has a gable roof and composition shingles or tiles. The dominant finish material is patterned stucco. Horizontal siding is used in some areas of the exterior including the gable ends. The chimneys are of red brick. The windows have all been recently replaced and are double hung or fixed with the panes in various configurations. The door is of vertical boards, with one leaded-glass light. There is a gabled overdoor supported on two Tuscan columns. The decorative detail included a touch of half-timbering and a circular vent in one gable end.

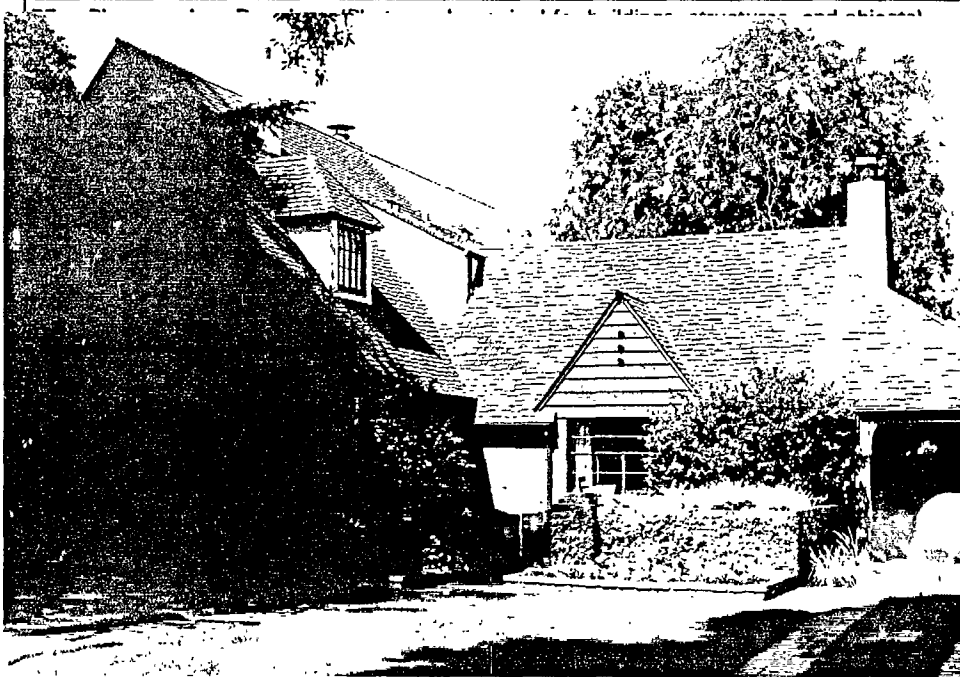
*P3a. Description: (Describe resource and its major elements. Include design, materials, condition, alterations, size, setting, and boundaries.)
This grand two story Tudor Revival house has several types of siding: stucco, brick, half timbering, and horizontal boards (below the eaves on the gable ends). The house is an irregular composition of masses, with large, steeply pitched roofs covered in wood shingles. Shed and hipped dormers add more complexity to the roof. The house has three chimneys. The windows are various sizes of casements with small panes. The door is of vertical boards and is varnished with two-foot long decorative wrought iron hinges. A lantern-style lamp hangs nearby. Clay pipe vents are present on some gable ends under the eaves. A low brick wall with wooden gates extends from the house around the entry area.

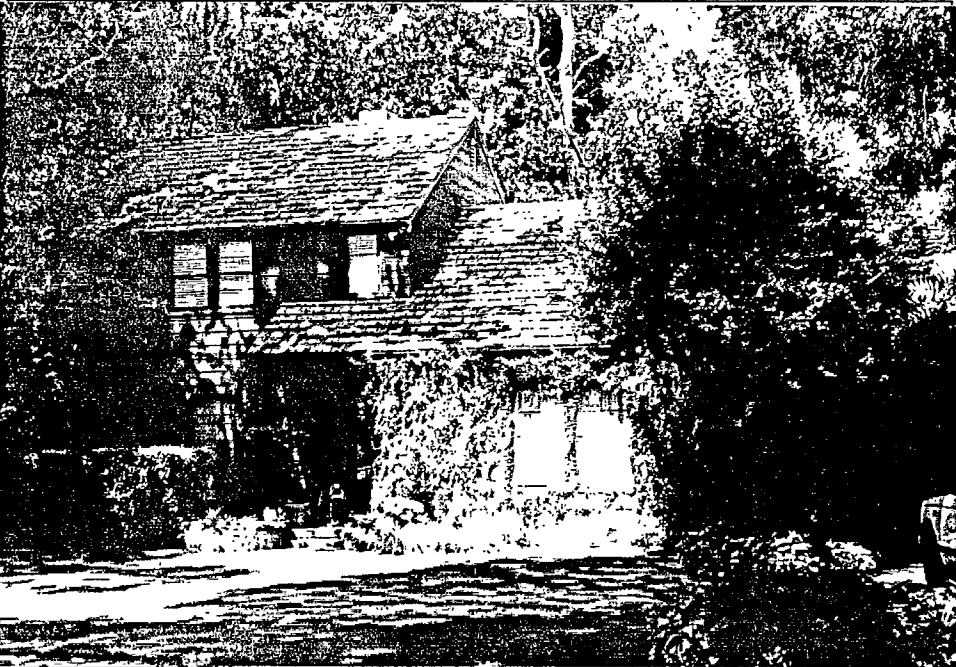
This asymmetrical two story Colonial Revival is unusual in College Park because of its dark-stained clapboard siding. It has a gable roof with wood shingles and a brick chimney. Double hung windows (two over two) are used throughout. In what looks like a garage conversion, a large fixed window with 72 small panes was installed, as was an outside stairway on the north side. The front door is mostly glass, subdivided into fifteen lights. There is a small covered entry porch with a single plain post serving as a corner support.
