**ARBORIST REPORT
HALLMARK MICRO PROJECT, OLIVE DRIVE
DAVIS, CALIFORNIA**

**Prepared for
HALLMARK PROPERTIES
Davis, California**

**Prepared by
TREE ASSOCIATES
John M. Lichter, M.S.**

January 17, 2020

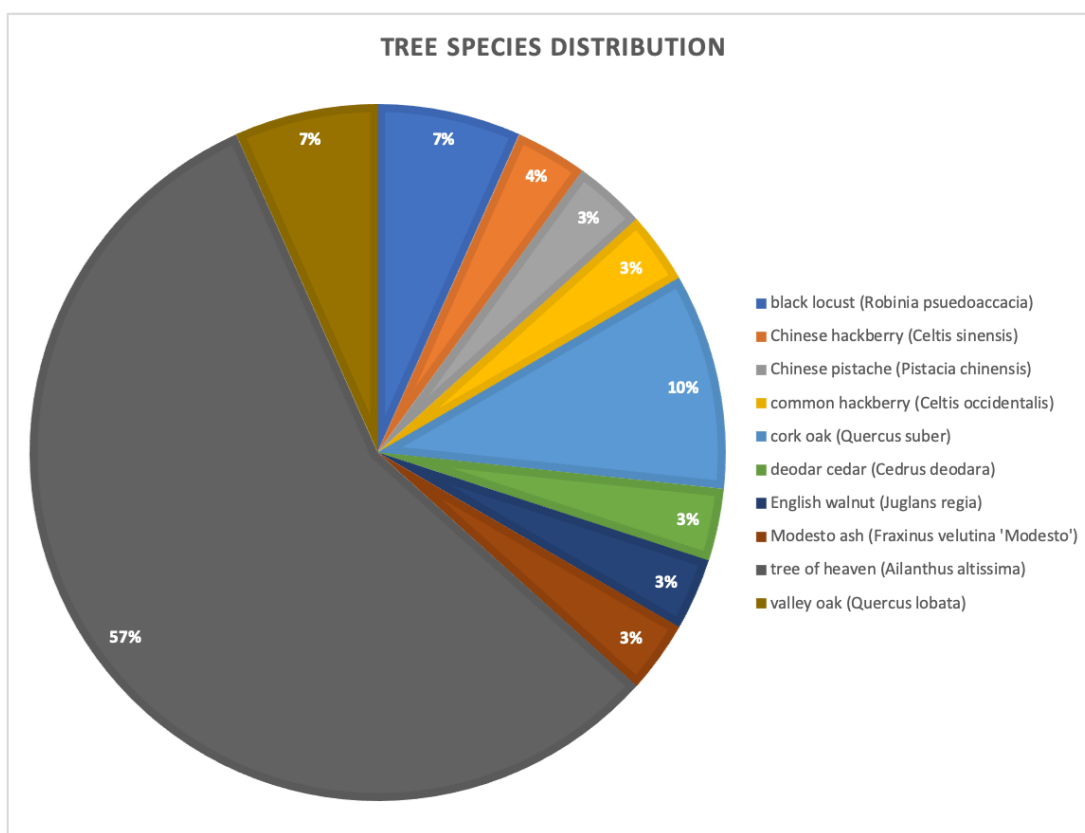
A total of ten different species were represented on site (Figure 1). The majority of the trees (17 or 57%) were relatively young tree of heaven (*Ailanthus altissima*). Many of the remaining trees other than those near the street were relatively young volunteers (not planted).

Figure 1. Tree species distribution.

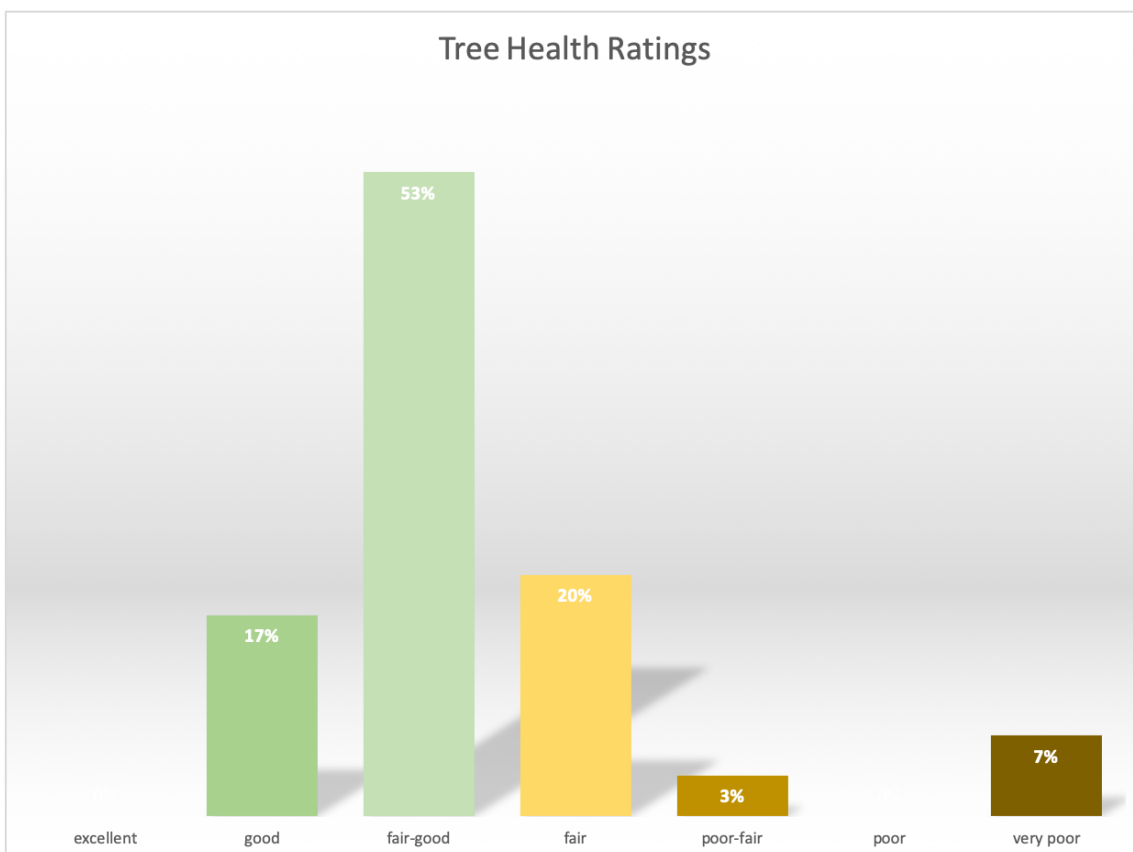
I rated the health of the trees from very poor to good (on a scale of very poor to excellent) (Figure 2). Seventy percent of the trees (21 trees) were in fair-good or good health with no significant health concerns. Twenty percent were in fair condition and ten percent (3 trees) were in very poor or poor-fair health. The mature deodar cedar (tree #918) was in poor-fair and declining health (Figure 6). An old English walnut in the back yard of one residence (tree #909) was in very poor health.

Figure 2. Health ratings of on-site trees.

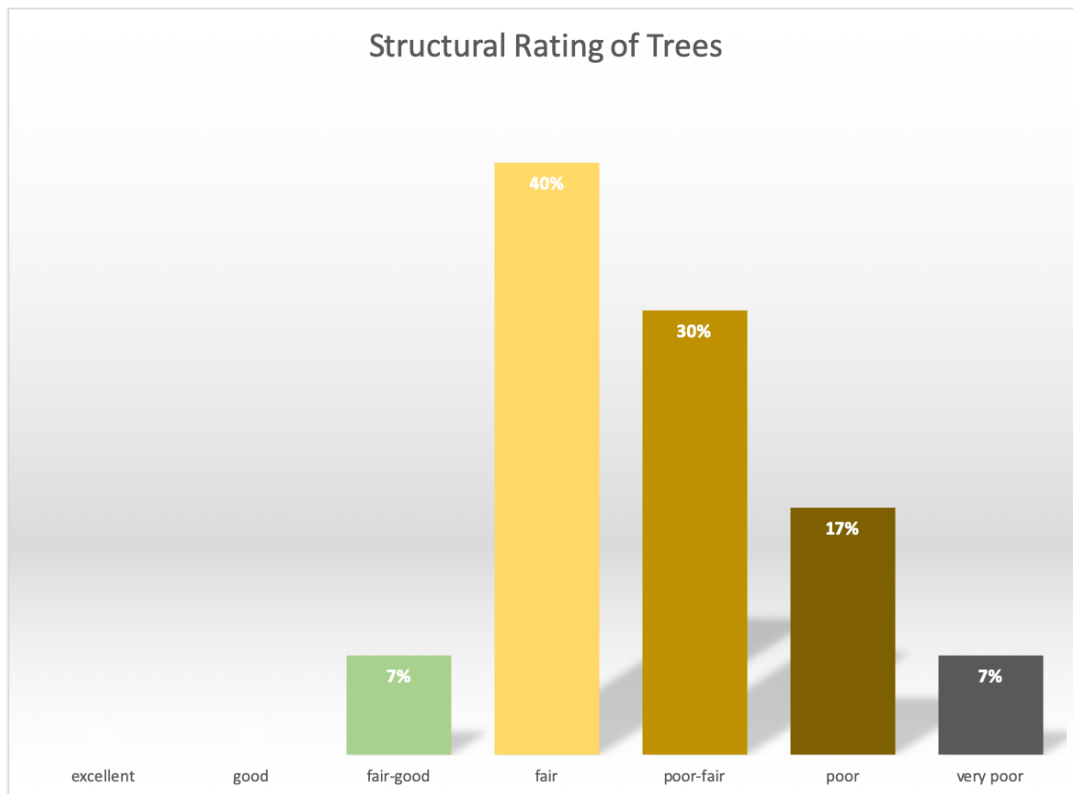
I rated the health of the trees from very poor to fair-good (same scale as above) (Figure 3). Only two trees (7% of the total) had fair-good structure. Forty and thirty percent of the trees had fair and poor-fair structure, respectively. The remaining thirteen percent of the trees were in poor or very poor structure.

The relatively poor structure of this population of trees was in large part due to the fact that most of the trees were volunteers which had not been pruned. Many of the trees were located close to walls or fences or other trees; this also influenced their structure and form.

Figure 3. Structural rating of on-site trees.

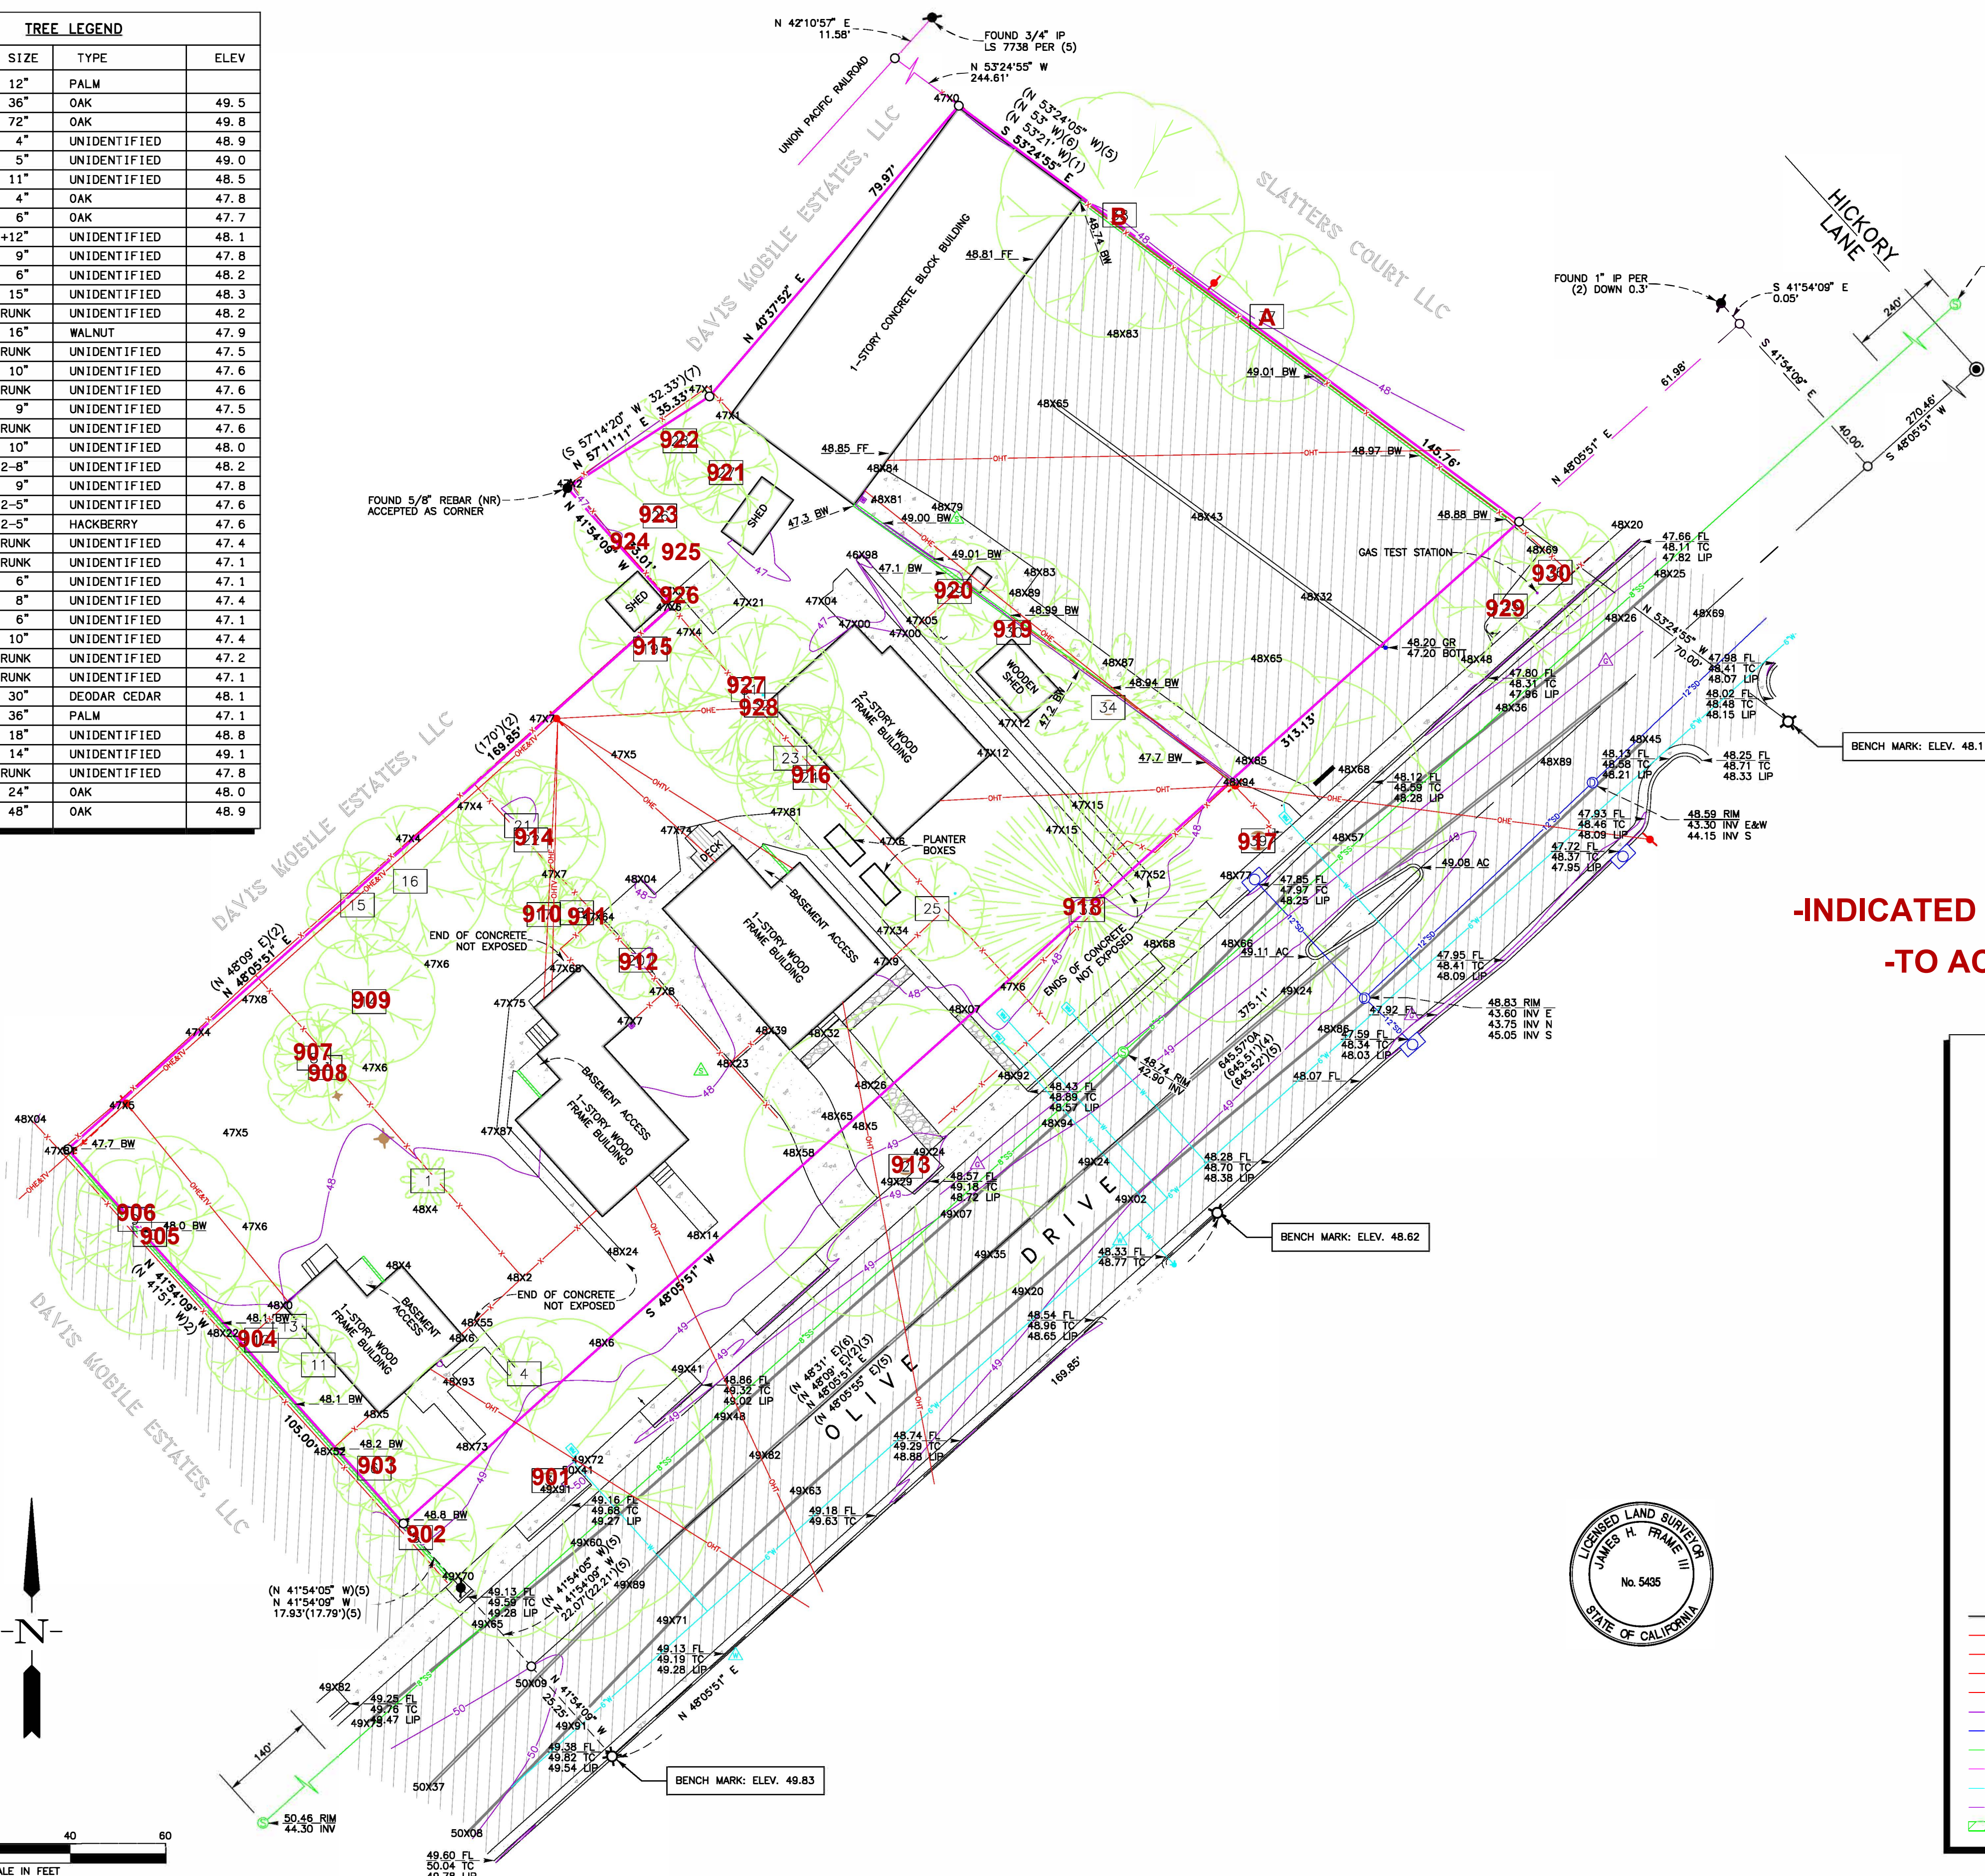
TREE LOCATIONS

**-INDICATED ON SURVEY BY FRAME SURVEYING AND MAPPING
 -TO ACCOMPANY TREE ASSOCIATES, INC. REPORT**
