Painter Preservation
HISTORIC PRESERVATION & URBAN DESIGN

Re Survey and Evaluation for 523 G Street

P1. Other Identifier: Smith, Fred P. and Edna Lea, House

Property Name: **523 G Street**
Page 2 of 39

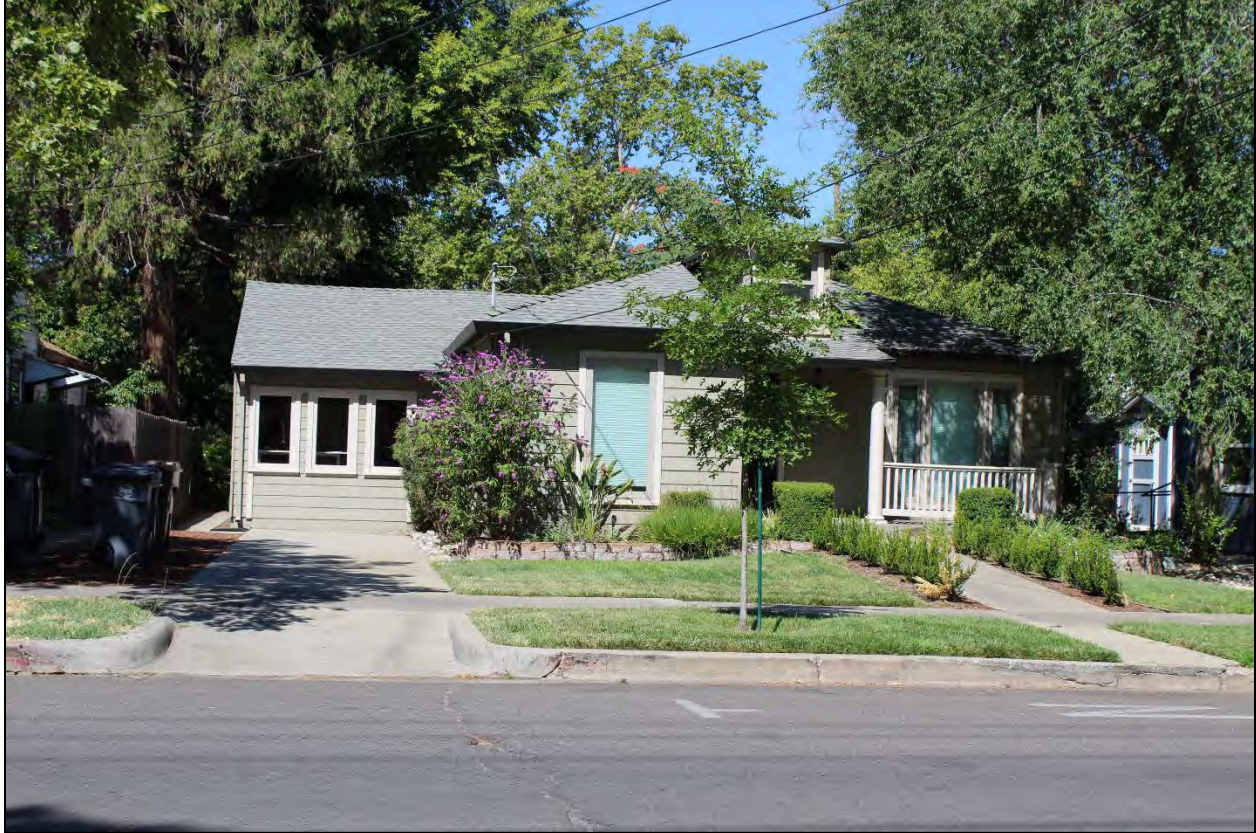
Front (east) façade. The front façade of the house at 523 G Street has a slightly offset projecting wing with a low-pitched hip roof to the left (south) and the main entry to the right on the main body of the house. The entry is set back under a very slightly pitched shed roof that extends from the low-pitched hip roof of the main portion of the house. It covers roughly two-thirds of the front façade, forming a covered porch across the frontage to the right of the projecting wing. To the left of the projecting wing is the attached garage, which is utilized as part of the building. At the center of the main roof is a long dormer with a one-over-one-light, double-hung window under a slightly pitched hip roof with exposed rafter ends (this feature is actually a skylight). The porch roof is supported by a large round column with a capital and base and enclosed with a balustrade of simple square balusters between this column and a half column at the northeast corner. On the back wall of the porch is a three-part window that is nearly full height, with a broad, fixed light flanked by narrower lights. The entry door, which is at the apex of the projecting wing and the main body of the house, displays a tall, oval-shaped, faux stained-glass window above two faux panels. It is accessed by a concrete walkway. Centered on the projecting wing is a tall narrow fixed light. To the left (south) of the projecting wing is the attached garage, which has been converted to an office. Located at the end of the concrete driveway, it displays three tall, fixed windows linked by a continuous lintel, in place of what was originally no doubt a garage door. The windows are covered by an extension of the side gable roof on this portion of the building.

Photo 1 of 15: Front (east) façade, looking west

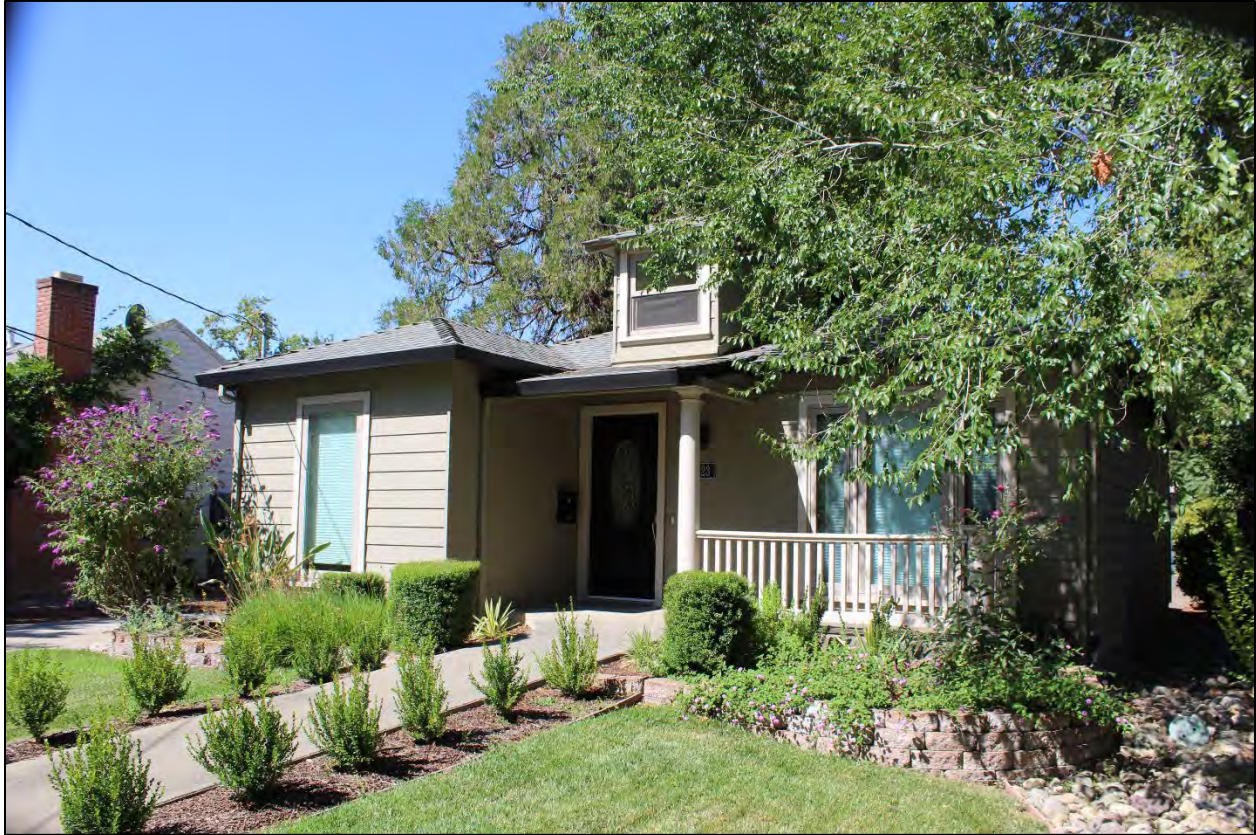
Photo 2 of 15: Front (west) façade, looking southwest

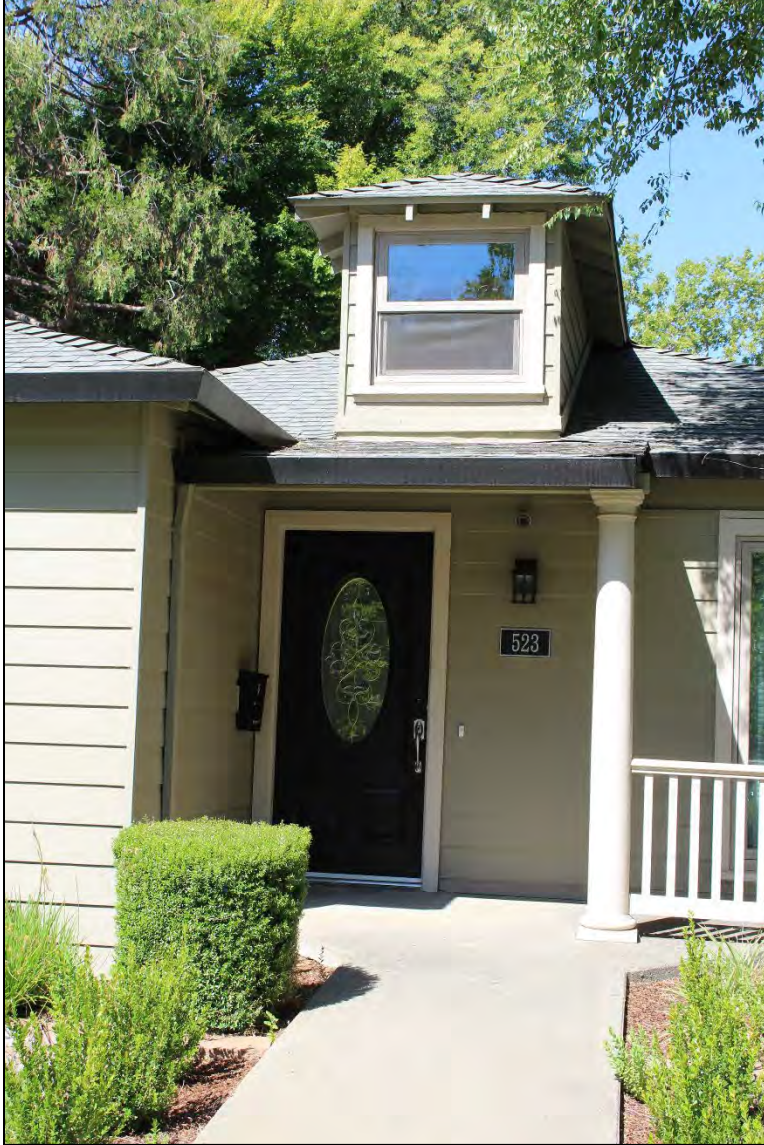
Since a photograph taken about 1997 for a walking tour of Old North Davis, the front porch was remodeled. The porch roof had previously been supported by a simple post, rather than the full-height column present on the building today. The balustrade was added as well. The former front door was also replaced with one with a decorative oval insert.

Photo 3 of 15: Front entry detail

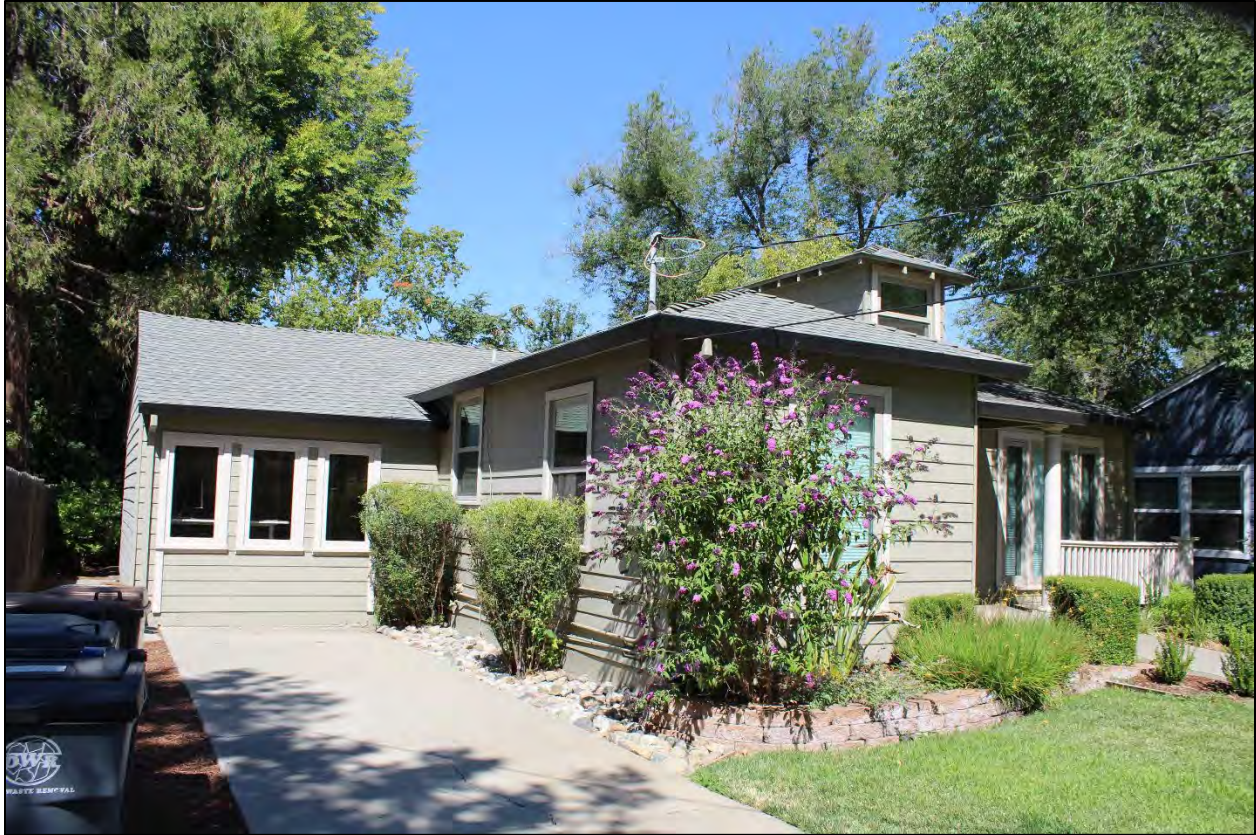
South side façade. The south side façade reveals two individually placed one-over-one-light, double-hung windows on the side façade of the projecting wing. The shorter window is placed high under the eaves, while the window to its right has a standard placement. The south side of the garage has no openings, as the distance of this façade to the property line (less than five feet) prohibits an opening. A concrete walkway is located here that accesses the rear parking area.

Photo 4 of 15: East and south facades, looking northwest

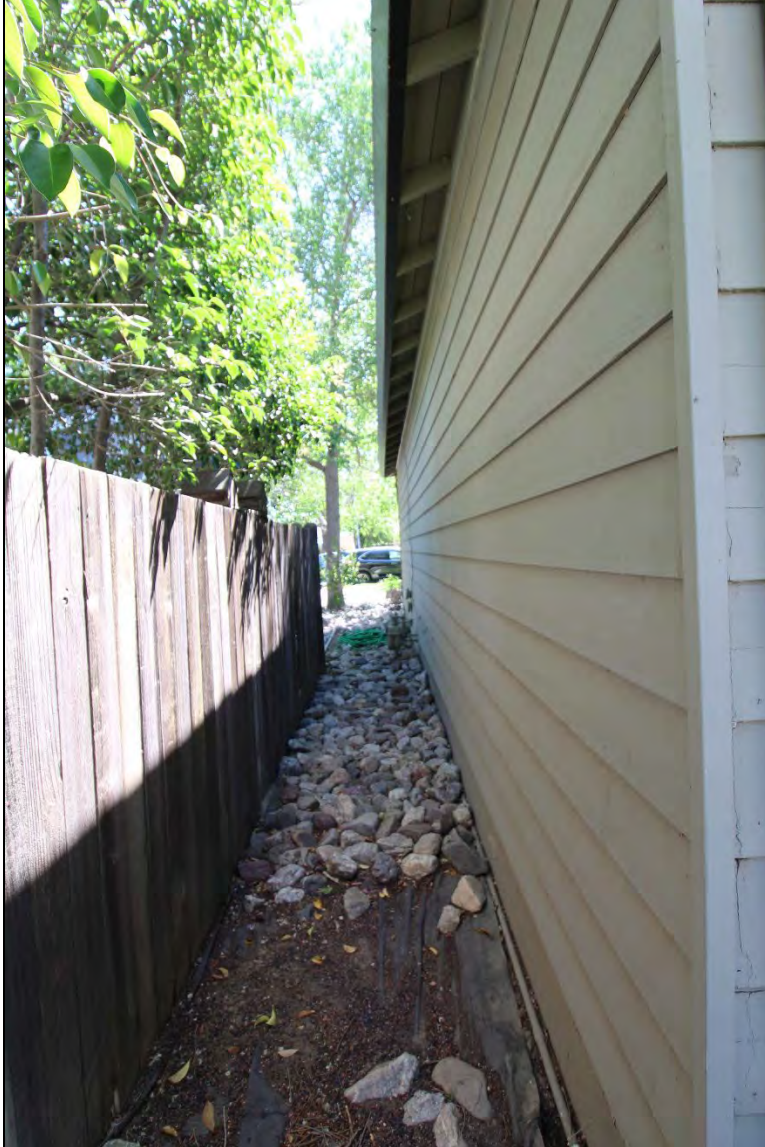
North side façade. The right (north) side façade has no openings. The distance of this side façade to the property line (less than five feet) prohibits an opening. The space here between the wall of the house and the side lot line is finished in stone. It abuts the neighboring property, which is treated in a similar way.

Photo 5 of 15: North side façade, looking east

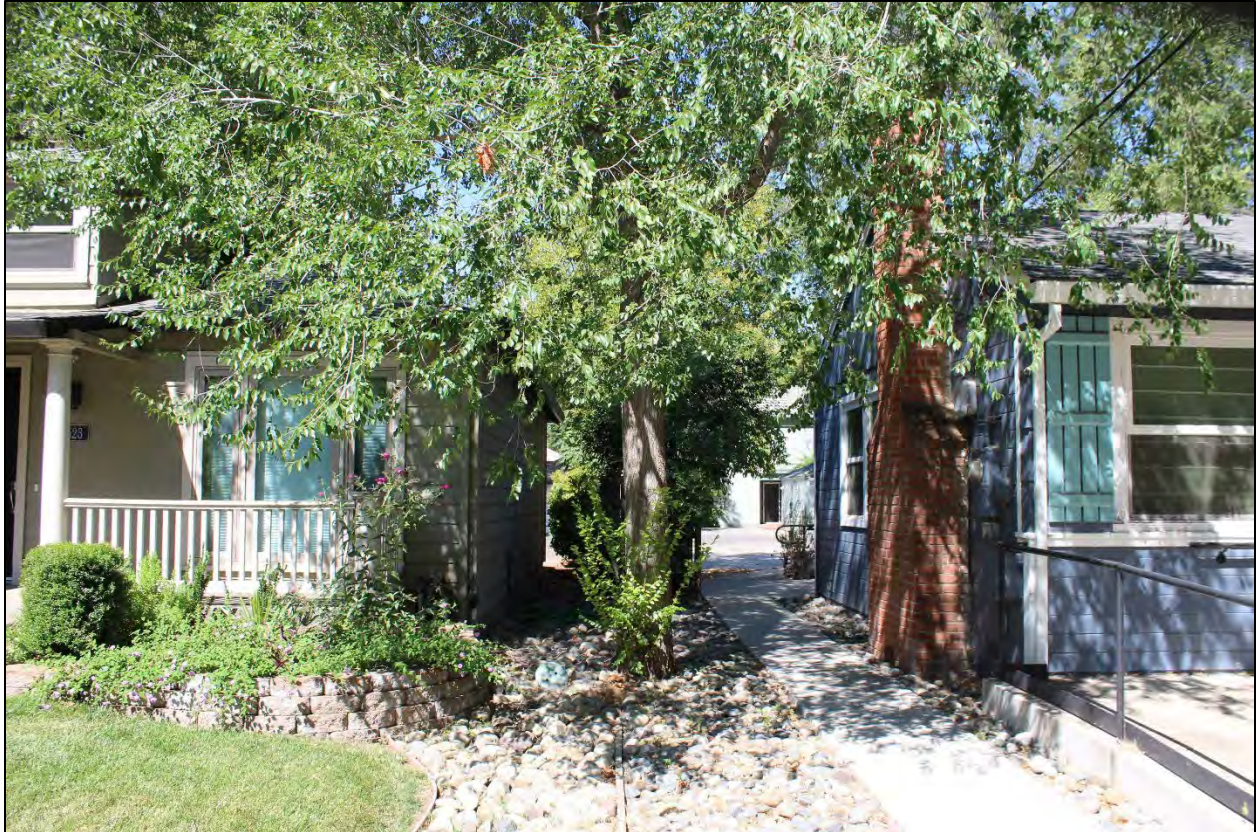
Photo 6 of 15: North side façade, looking west

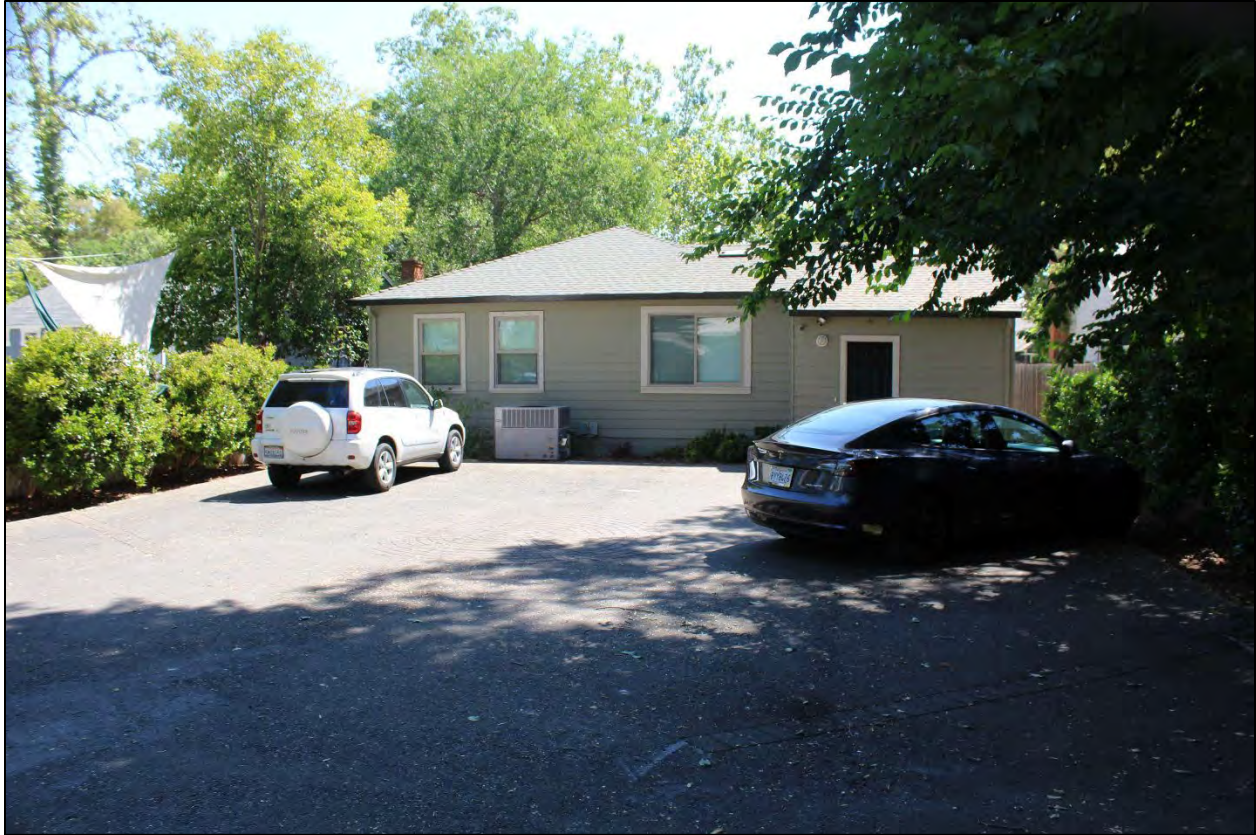
Rear (west) façade. The rear of the house has back entry door on the right side, within what would be the garage. It has a faux six-paneled door. At about the center of this façade is a large, two-part sliding window with vinyl frames. To the left are two individually placed, one-over-one-light, double-hung windows with vinyl frames.

The house is placed closer to the front property line than the rear, allowing for an asphalt parking lot with a brick inlay that is accessed via the alley between F and G Streets, which is paved in concrete. The front yard is formally landscaped, with planting beds that parallel the front entry walkway and raised planting beds along the front foundation. The side setback along the north side of the house is finished in loose stones. A concrete driveway leads to the former garage on the south side of the building, and serves as parking. To its right, underneath the two double-hung windows, is another rock-finished bed with two mature shrubs. A narrow concrete sidewalk with a tall wood fence on its south border leads to the back of the lot. Bordering the rear yard is a narrow planting bed to the north that displays mature shrubs with an adjacent wood fence. On the south side of this parking area is a mature Elm tree with an adjacent wood fence.

Photo 7 of 15: Rear (west) façade and parking area

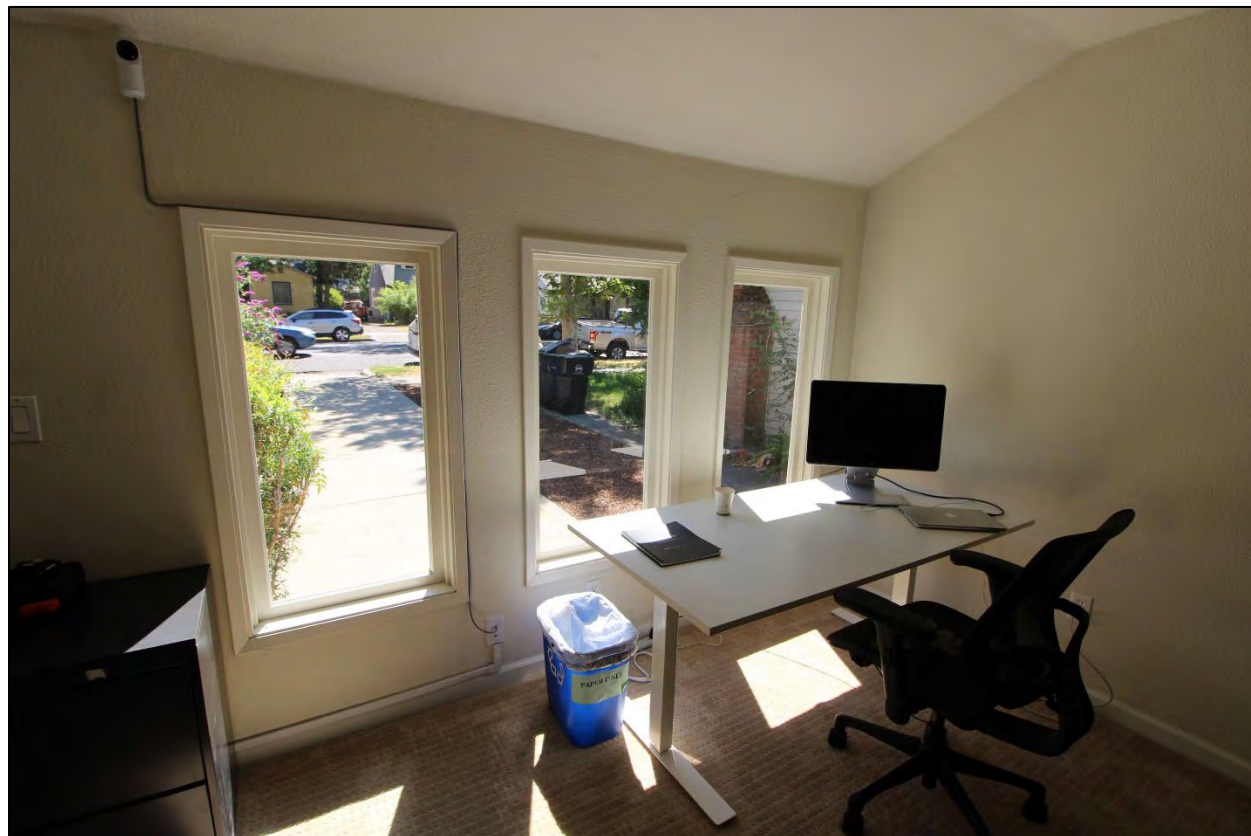
While not part of this review, the interior of the house has been completely changed to convert the house to an office, including the construction of a lobby, central hall, several enclosed offices, an open kitchen area, a half-bath, and conversion of the garage to an office with an exit to the rear parking lot.

Photo 10 of 15: Office in garage, typical

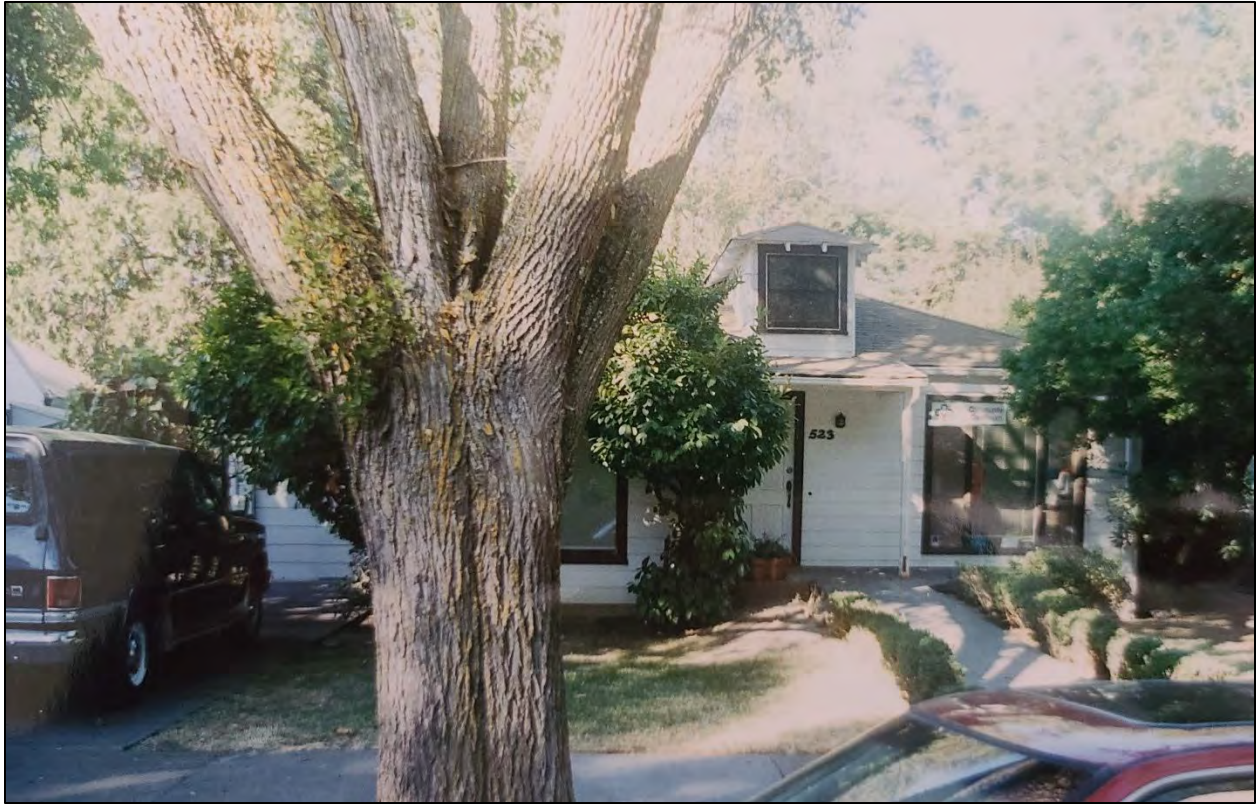
Figure 10: Building at 523 G Street photographed circa 1997
